Hidden Under the Skin: Examination of an Ecuadorian Polychrome *Madonna of the Immaculate Conception*

Bianca M. García • 2016 Graduate Fellow, Winterthur/ University of Delaware Program in Art Conservation • ANAGPIC 2015

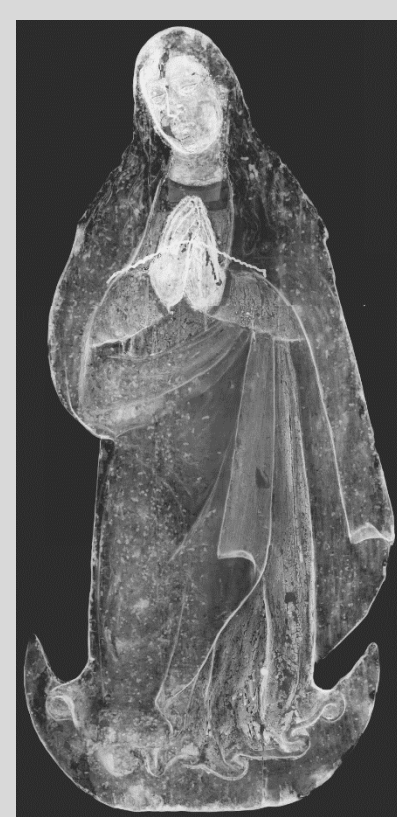
X-Radiography

X-radiography provided information on the construction of the sculpture which was made from three vertical planks of wood adhered together. No metallic joinery was revealed; planks are likely held together with an adhesive and/or wooden dowels (not yet detected). X-radiography also revealed the extent of the degradation of the wooden support from past insect infestations, losses in the ground and paint layers, and the possible use of a radio opaque filler (such as lead white) from past restorations.

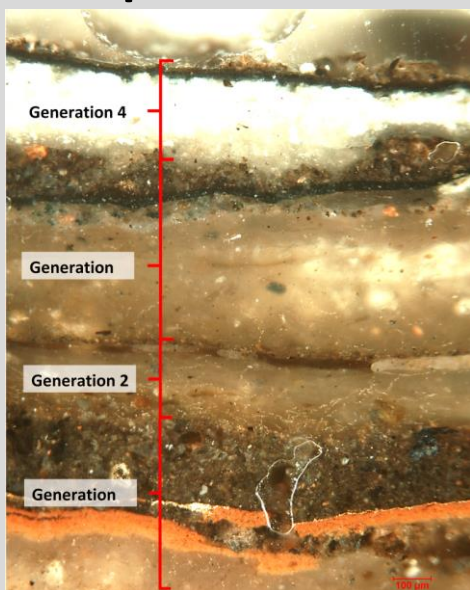
Sample 1

Cross-section microscopy performed on the sites identified in red revealed the presence of four generations of paint. A layer of gilding with paint applied over it in the first generation implies the use of the *estofado* technique. A layer of metal leaf was identified in the second generation. UV fluorescence and fluorescence indicate the use of a carbohydrate and protein binder in the first three generations of paint and an oil binder for the fourth generation.

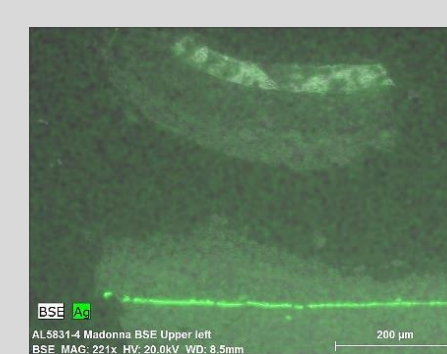
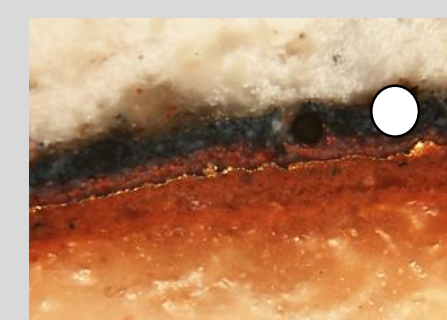
SEM-EDS analysis of sample 1 (CS1) revealed a layer of gilding in the first generation. The metal was identified as gold, with an iron-rich layer underneath the gilding, most likely a bole. A layer of metal leaf was detected in the second generation of sample 2 (CS2). EDS results identified the metal as silver.

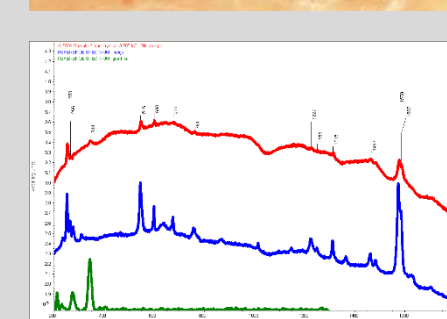
Raman spectroscopy was performed on CS2. Sample location identified in white. The layer of blue over the gilding in CS2 was a match for an indigo reference spectrum.

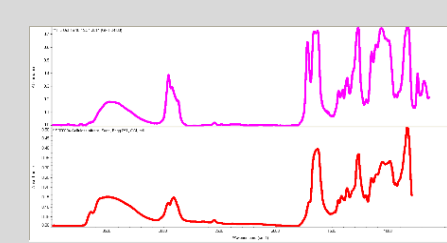
FTIR analysis of the adhesive used in a previous restoration showed characteristic absorbance peaks for cellulose nitrate. [Cellulose nitrate was used in the early 20th century as an adhesive -Duco Cement.] Sample location identified in blue.

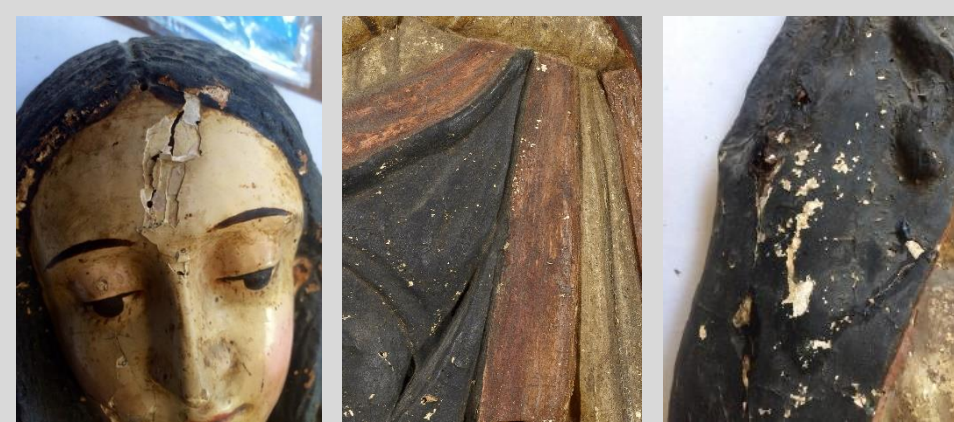
The sculpture had an overall layer of grime. There were remnants of a partially removed, discolored varnish and areas of uneven overpaint. The paint and ground layers were actively flaking, and the insect damage created weak spots in the wooden support.
