Haddon Dine

Winterthur/University of Delaware Program in Art Conservation

A 19th-Century Aquarium:

How Collaboration Informed the Technical Study and Treatment

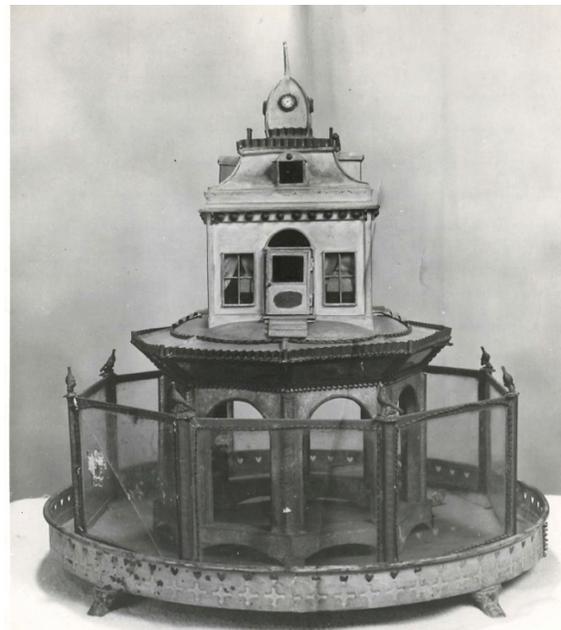
Fig. 5. Photo from George McKearin, the dealer that du Pont purchased the aquarium from. The fish, pebbles, and plants are absent, indicating they were added at Winterthur. (Orientation of pavilion to tank is offset.)

Side 8 seems to be a replacement, as it is broken in the photo sent to Mr. du Pont in the 1940s by the antiques dealer he purchased the aquarium from (fig. 5). Because of the similar elemental composition and similar unflawed visual appearance, it seems likely that Side 4 was replaced around the same time. The half of the panes (Sides 2, 3, 5, and 7) with similar composition are possibly original. Panes 1 and 6, containing arsenic, may be replacements, perhaps earlier than Sides 4 and 8, since they have the flawed appearance of older glass, but it is also possible that they are more recent replacements made to match the older glass. Additionally, it is possible that Sides 1 and 6 are the only original panes in the tank.¹⁶

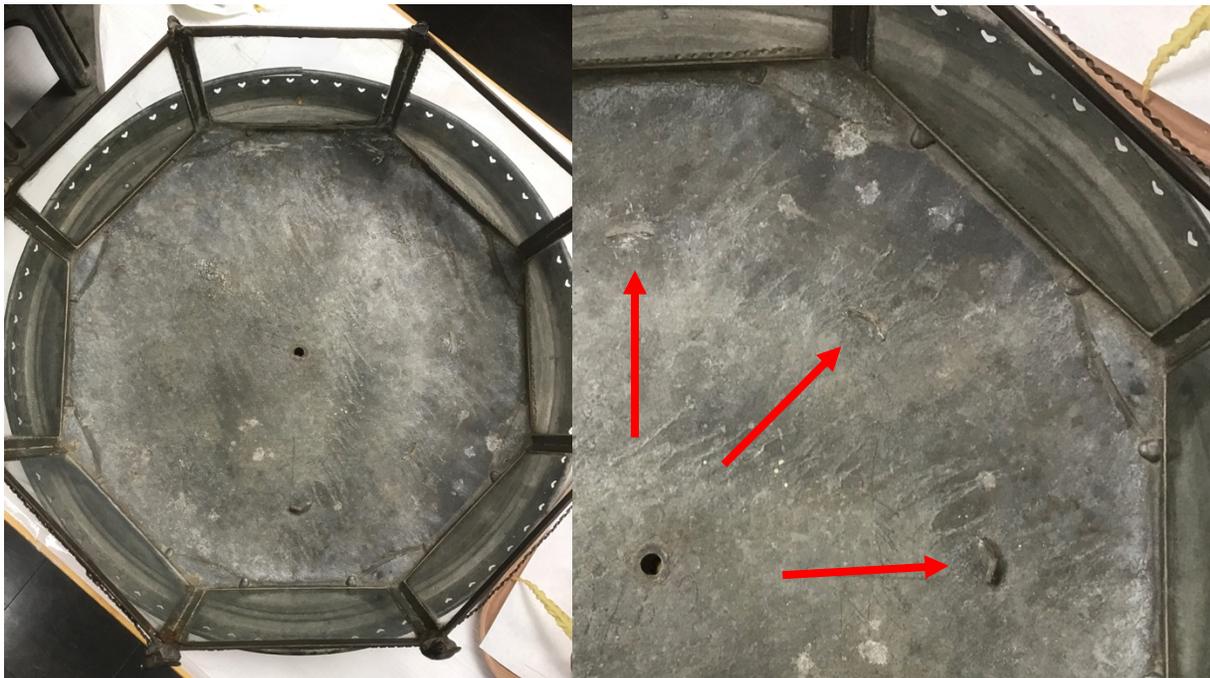
When we removed the pebbles we found metal tabs in the bottom of the tank (fig. 7). Only one was still attached, a second was detached, and the other six are missing, with only solder remnants marking where they were.

Fig. 7. Overall view of inside of tank (left) and detail (right) with arrows pointing at the one attached tab and two areas of solder where tabs used to be.

It seems that these tabs either fit just inside, or just outside, the corners of the base of the pavilion. This would put the corners of the pavilion in the centers of the tank panes. The sides of

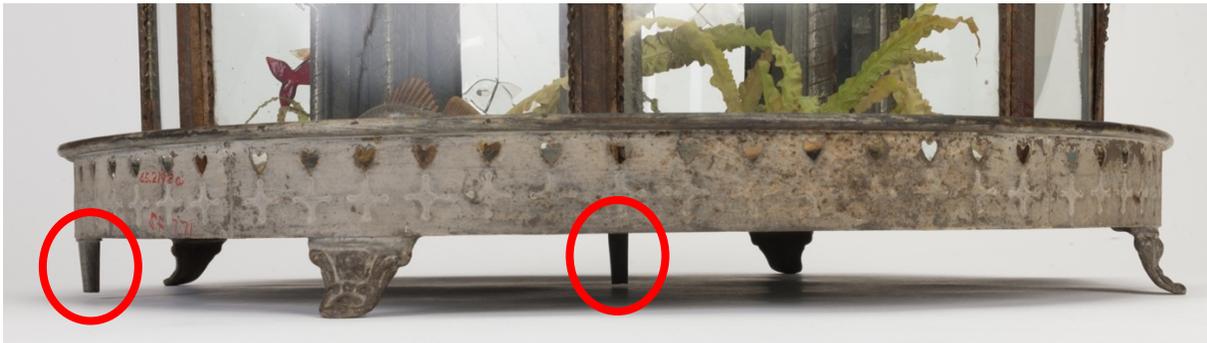
On the bottom of the aquarium, there are two things that seem to possibly be drains or spouts (fig. 10). The one in the center is part of the tank, and a hole was cut in the pan to accommodate it. The similar spout on the edge of the pan is integral to the pan. It is possible that there was a fountain in the tank, such as in the Fiske aquarium (fig. 2). Another possibility is that these spouts were part of a water circulation system.

Fig. 10. View showing the “spouts/drains” on the pan, which are circled in red.

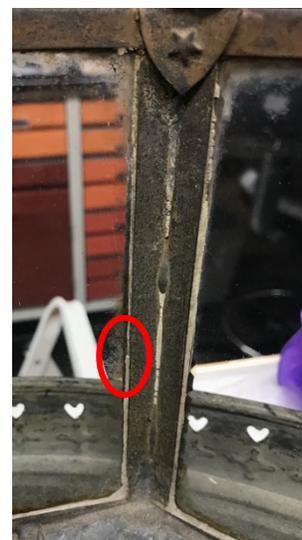
A sample of the material between the tank panes and framing (fig. 11) was analyzed. Results from both Fourier Transform Infrared Spectroscopy (FTIR)⁴ and Raman spectroscopy⁵ suggested the presence of barium sulfate. Gas chromatography mass spectrometry (GCMS)⁶ resulted in peaks for azelaic, palmitic, and stearic acids, suggesting a drying oil (such as linseed oil). The sample was also analyzed using x-ray fluorescence spectroscopy (XRF)⁷, which at first detected mostly lead and zinc, with iron and calcium. Flipping the sample and taking a spectrum from the other side gave a different result, detecting barium, more zinc, and less lead. This seems to confirm the presence of barium sulfate, although it could be contamination. Both XRF spectra confirmed the presence of lead and calcium.

Fig. 11. Inside the tank. Area of sampling of tank putty is circled in red.

Both the drying oil binder and the presence of lead in the tank sealant are consistent with literature for aquarium sealant and window putty. However, this still does not determine whether the aquarium was intended to be watertight, as window putty may have been used simply to keep the panes from shifting.

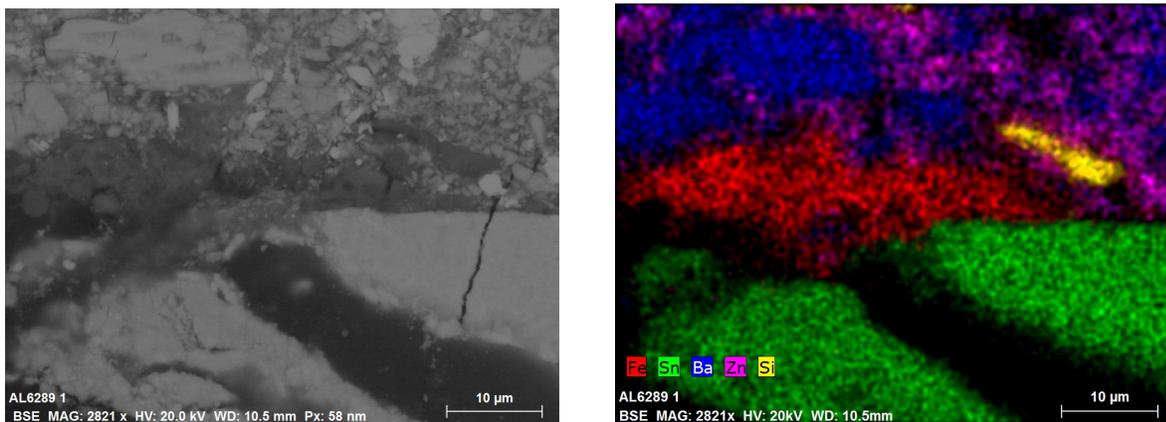
Fig. 12. Secondary electron image (left) and false color elemental map (right) of an area that appeared red in normal light photomicrographs at the interface between the grey paint layer and the tin in Sample 1. The red area was presumed iron corrosion, which is confirmed by the analysis.

There are areas of iron in both cross sections, probably corrosion coming up from below the tin (figs. 12 and 13).¹⁰

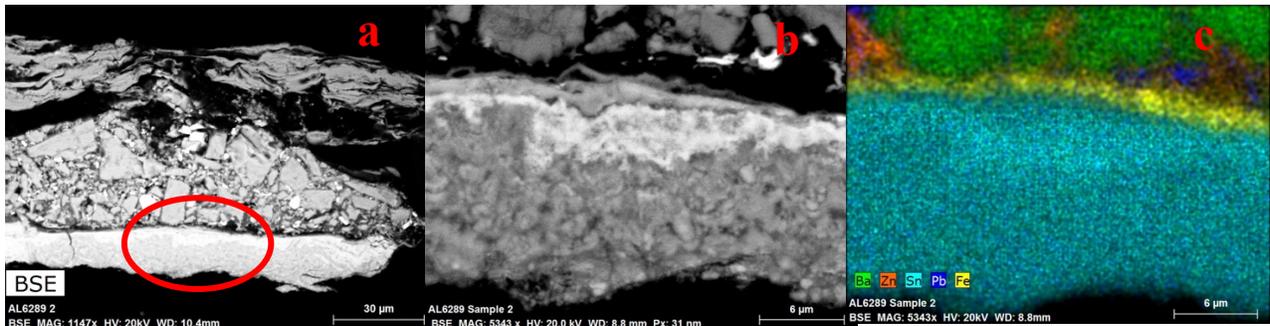
Fig. 13. Backscatter electron image (b) and false color elemental map (c) of an area of Sample 2 (circled in a) with a layered appearance in the tin. There is a layer of iron above the tin (yellow in the EDS map) but no elemental explanation for the difference in appearance of the tin layers. It may be a difference in concentration.

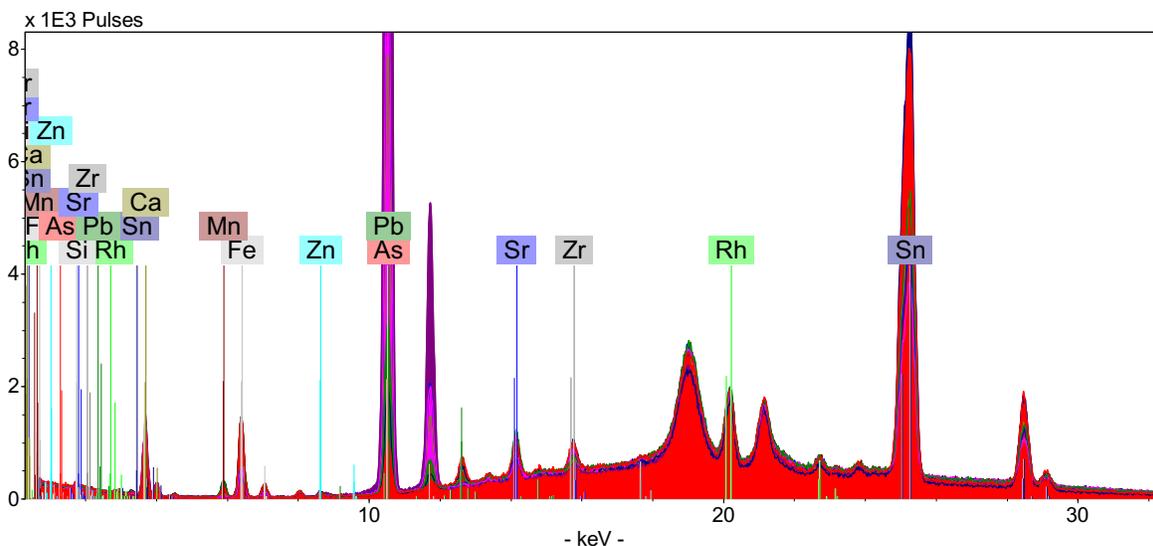
The handheld XRF spectra of the aquarium mirrors indicated tin in all eight mirrors. All eight spectra were similar (fig. 14). Based on the lack of silver and the detection of tin, the mirrors have been identified as mercury tin. They also display the characteristic deterioration of mercury tin mirrors. Further analysis of the data is needed to compare the glass composition between the mirrors as well as to the tank glass composition.

Fig. 14. Handheld XRF spectra of all eight mirrors on the pavilion.

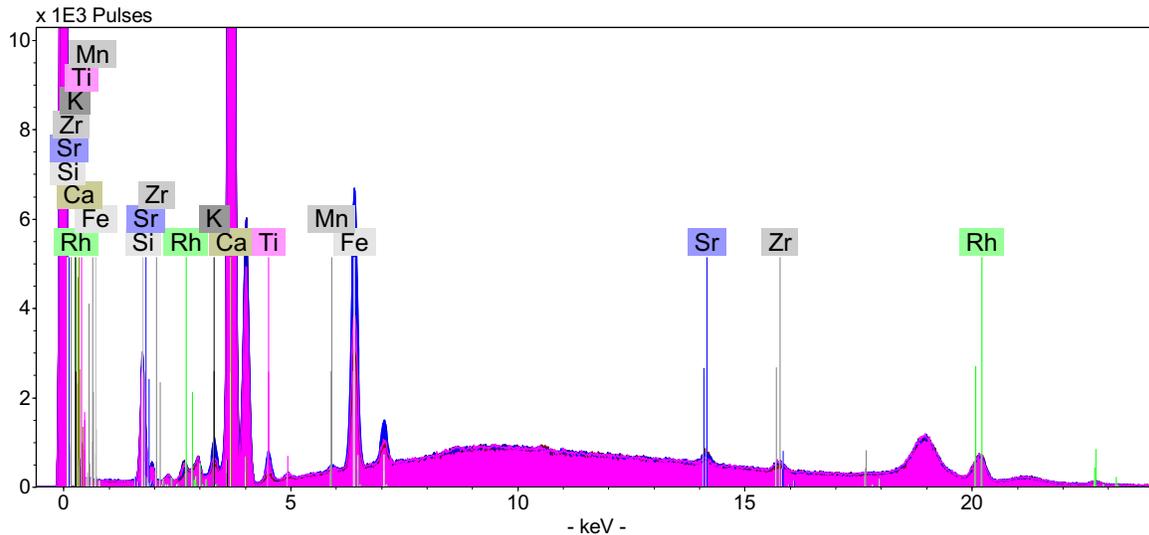
The glass panes of the tank differ in appearance from one another and were likely made by different manufacturing processes. This could suggest replacement of panes over the years. The glass panes with small bubbles and ripples are likely older than the other panes, and may possibly be crown or cylinder glass. The panes without noticeable flaws are likely replacements. Six of the eight panes have flaws and by appearance are possibly older glass. Sides 4 and 8 appear newer.

but both contain slightly higher Sr. Panes 1 and 6 contain arsenic, and the spectra are again very similar to each other.

Fig. 15. ARTAX XRF spectra of four of the glass tank panes with similar composition: panes from side 2 (dark red), 3 (pink), 5 (light blue), and 7 (dark blue).

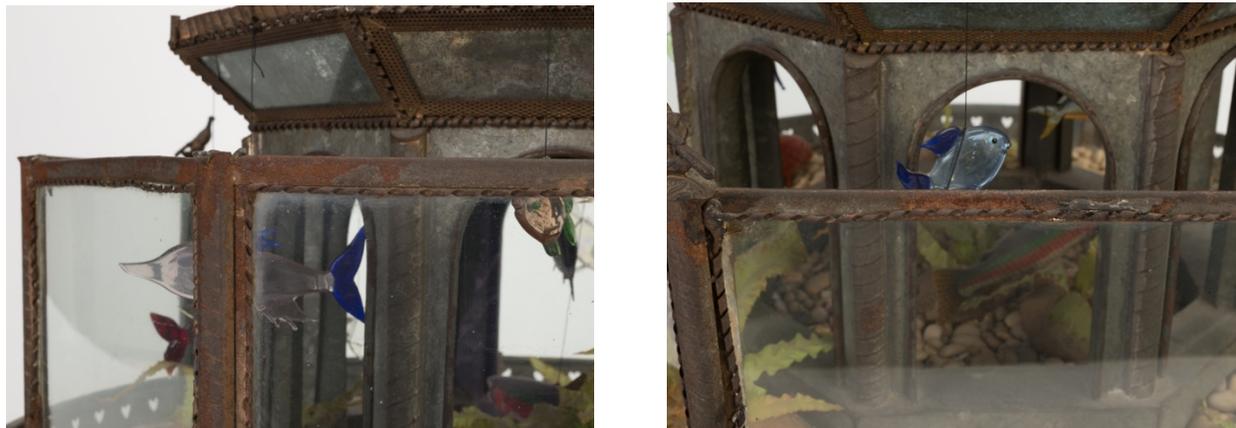
There are areas with iron corrosion present where tin and paint has been lost (fig. 16). The most textured, orange areas appear to be associated with solder repairs (fig. 16, right).

Fig. 16. Iron corrosion is present where paint and tinning is gone. There are some areas of more textured, more orange corrosion (right), which seem to be associated with solder repairs.

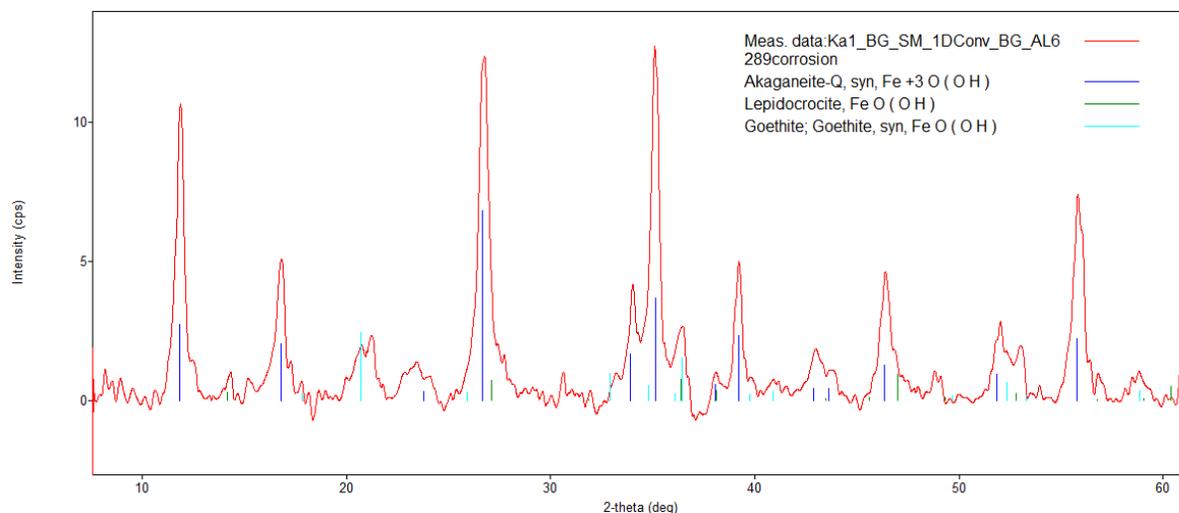
X-ray diffraction¹⁷ was performed on two samples of iron corrosion from the tank. The first sample was from more textured, orange corrosion on the outside of the tank that seems to be associated with solder repairs. Akaganeite (β -FeOOH) was identified as the main component (fig. 17). A sample of more stable-appearing iron corrosion on the inside of the tank framing resulted in various iron oxides, but not akaganeite.

Fig 17. XRD pattern from the orange iron corrosion on the outside of the tank framing, associated with solder repairs. The composition is mainly akaganeite, with other iron corrosion species including lepidocrocite and goethite.

Akaganeite is normally discussed in relation to, and found on, archeological iron or iron in a coastal environment. The presence of akaganeite indicates the presence of chlorides. Akaganeite itself is formed when there is a high concentration of chlorides in an acidic environment and is not itself a threat (Ståhl 2003). However, it can cause corrosion because it has adsorbed chlorides which are mobile in water or high humidity (Watkinson 2017), and it is hygroscopic, attracting water that can then allow the chloride ions to move (Watkinson 2004). Akaganeite may also release chloride ions when it transforms to goethite or hematite (Thickett and Odlyha 2013).

Akaganeite was found in an area of worse corrosion, not in the more stable appearing corrosion. Since these areas of more dramatic corrosion are associated with solder repairs, it seems possible that the explanation for the presence of chlorides is that a chloride-containing flux was used for the repairs. It is also possible that chlorine is present in the metallic flake paint (Ferreira et al).¹⁸

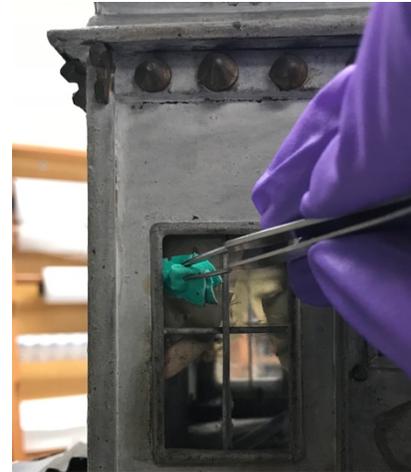
Fig. 19. Cleaning the windows with a small piece of Mr. Clean Streak Free cloth with 1:1 ethanol and deionized water.

The brown scum/corrosion material around the edges of the tank glass was reduced with a combination of mechanical reduction and a citrate solution (0.5% citric acid and 0.5% boric acid in deionized water, adjusted to pH 8.0 with NaOH, with phenoxyethanol) on cotton swabs, which removed the scum without damaging the paint. (This was followed with 1:1 deionized water and ethanol on swabs to clear the solution.)

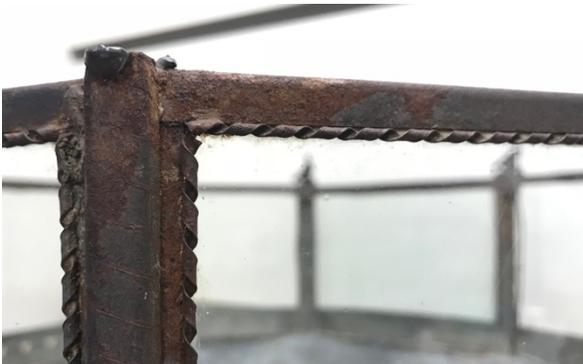
Fig. 20. Area of iron corrosion on the tank before treatment.

The corrosion on the tank framing was coated with graphite (figs. 20 and 21). This was chosen after testing corrosion reduction with a scalpel (while effective, it seemed unsafe for this painted tinware) and with an emulsion of an aqueous solution of a chelator in a silicone gel. A graphite stick (6B) was rubbed on the areas of corrosion and the graphite was then spread around with a swab wet with Shellsol D38.

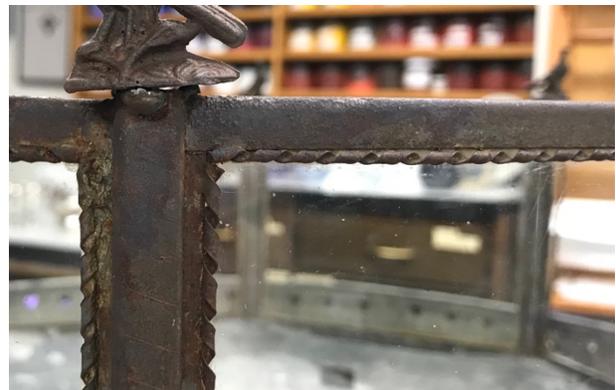
Fig. 21. Area of iron corrosion after coating with graphite.

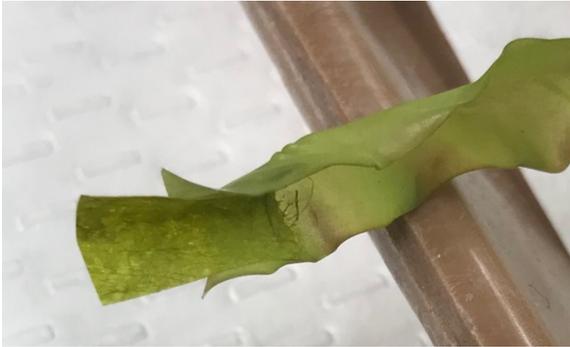
Fig. 22. Attaching the tissue paper to one side of the break.

Broken and detached pieces of plastic plant fronds were reattached. Japanese tissue paper was painted with Golden Fluid Acrylics and used to bridge the breaks with Aquazol® 200 in deionized water (figs. 22 and 23). Detached fish fins were also reattached with Aquazol®.

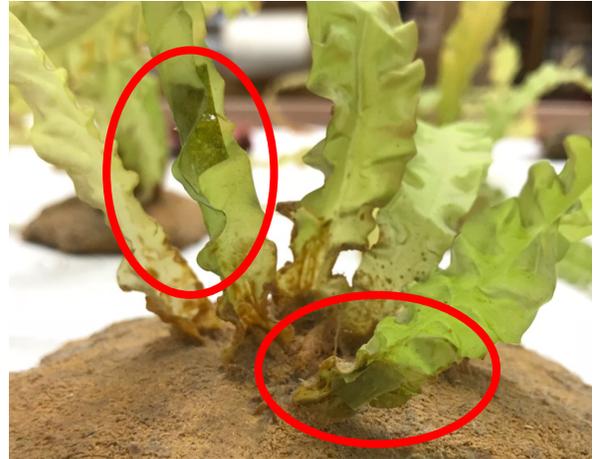
Fig. 23. Two repairs on the plants (circled).

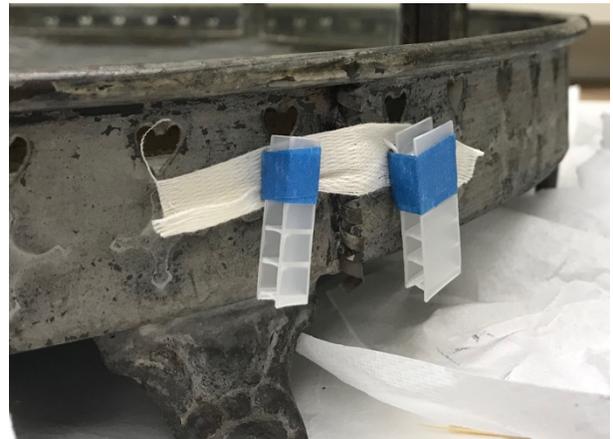
Fig. 24. Holding a reattached spiral in place with twill tape and magnets while the adhesive dried.

Detached and bent metal elements were repositioned and reattached with Paraloid® B-48N in xylene with 2-(butylamino)ethanol (fig 24.).
