**Gregory Bailey
Buffalo State College**

**About Time:
Analysis and Conservation of a 17th-Century Table Clock**

CNS 695 SPECIALIZATION PROJECT

May 7, 2010

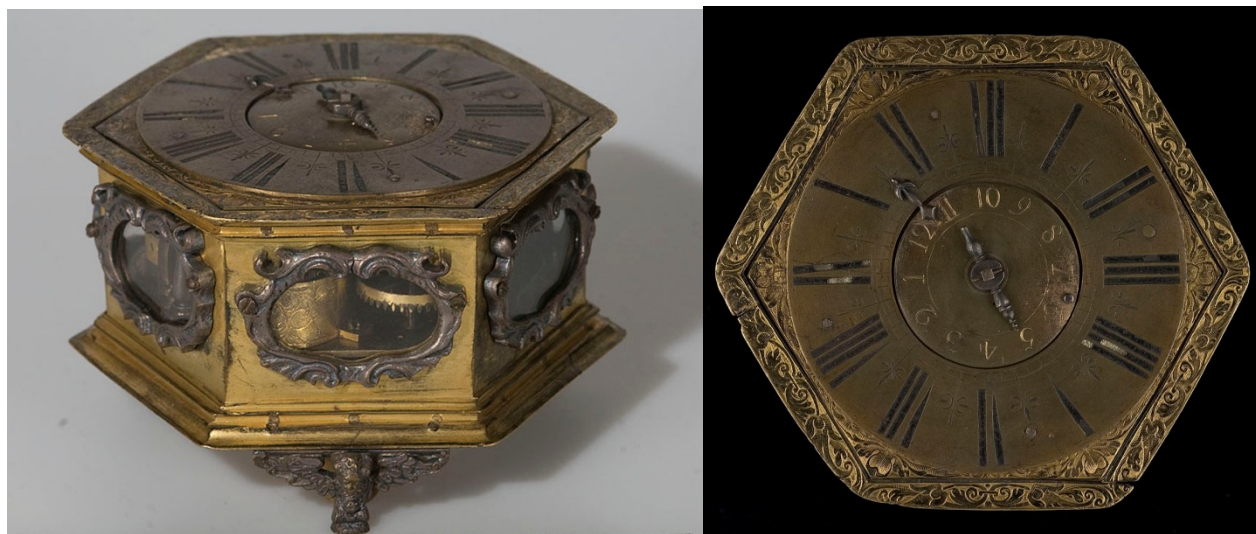
Figure 1, Buffalo Scheirer clock before treatment Left: oblique view Right: Top view

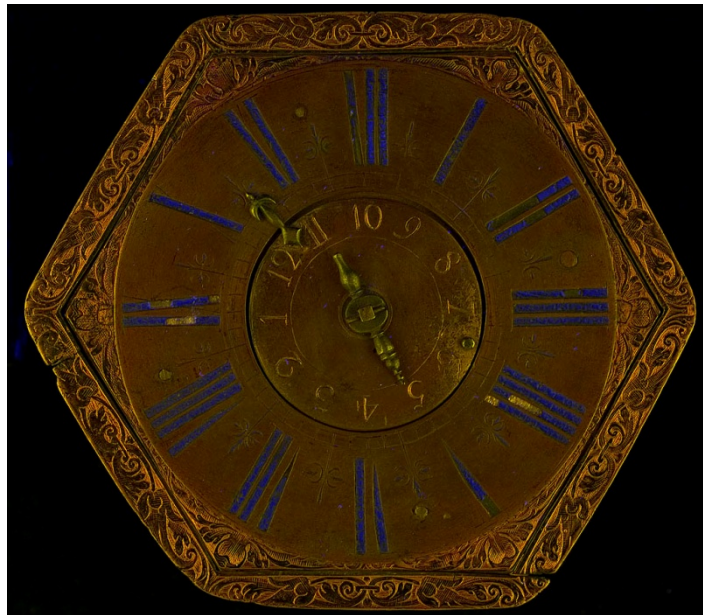
The material used to fill the engraved Roman numerals on the chapter ring of the clock appears dark, cracked, and is brittle when probed. The fill material fluoresces in the visible range under long wave ultraviolet radiation, suggesting that it is organic in nature. To better characterize this material, transmission Fourier Transform Infrared Microscopy (FTIR) was undertaken (See Appendix XIV i b: FTIR).

Figure 12, False color UVA image showing visible fluorescence of fill material

Analysis with FTIR suggests that the material used to fill the numerals is a softwood resin or pitch, though the similarity to other natural resins, such as that of the lac insect, makes it difficult to identify the material with absolute certainty. Pine pitch or

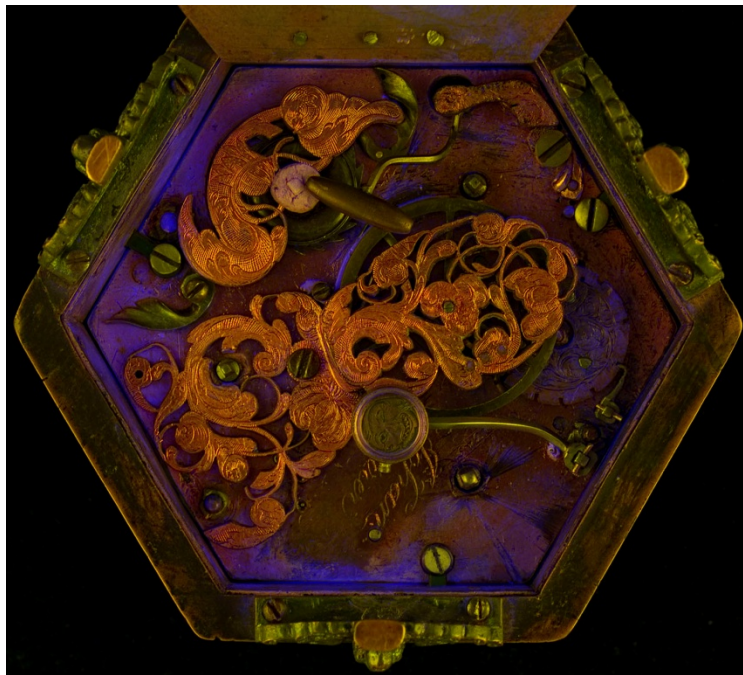
Oxidized oil residue is visible on the base plate and bell plate under far ultraviolet (UVC) irradiation. Identifying the type of oil is of interest because it may be indicative of the last time the clock was cleaned and oiled.

Figure 14, False color, far ultraviolet (UVC) induced visible fluorescence image, showing oil residue on base plate, in purple

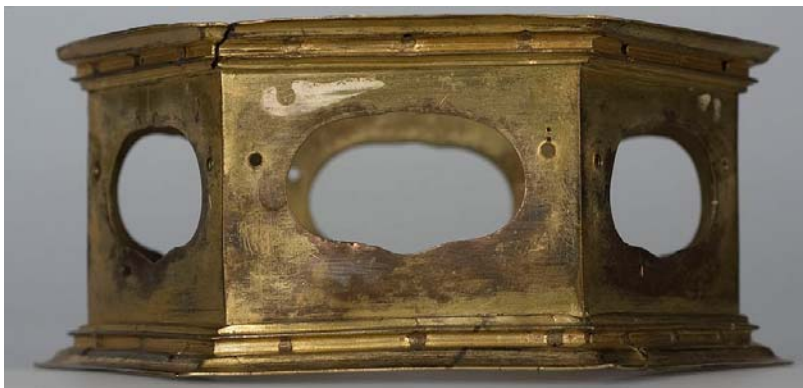
A hazy white residue is present on the exterior of the clock case, in the area underneath the frames, and appears to correspond closely to the edges of the frames. This residue is insoluble in water, but soluble in acetone. No white residue is observed on the reverse of the silvered frames, however, a very thick and discolored surface layer is present on the silvered surfaces. This discolored layer is also partially soluble in acetone.

Figure 15, Case of the Buffalo Scheirer, 4 o'clock side, showing white residue, at top left

To better characterize the residue and identify any potential coating on the silvered surfaces, FTIR analysis was performed on a sample of the hazy white residue from the exterior of the clock case at 4 o'clock. The spectrum for the sample was an extremely close match to white shellac, a form of processed shellac from which nearly all of the red lac dye has been removed. This shellac was likely applied as a protective coating to the silvered frames after they were polished at some time in the past two hundred years. Shellac was not in common use in Europe in the seventeenth century, and the coating is therefore unlikely to be original.

Analysis with FTIR clearly identified the presence of a deteriorated protective coating. Accordingly, appropriate solvents were used during cleaning and polishing to facilitate the removal of the degraded shellac.

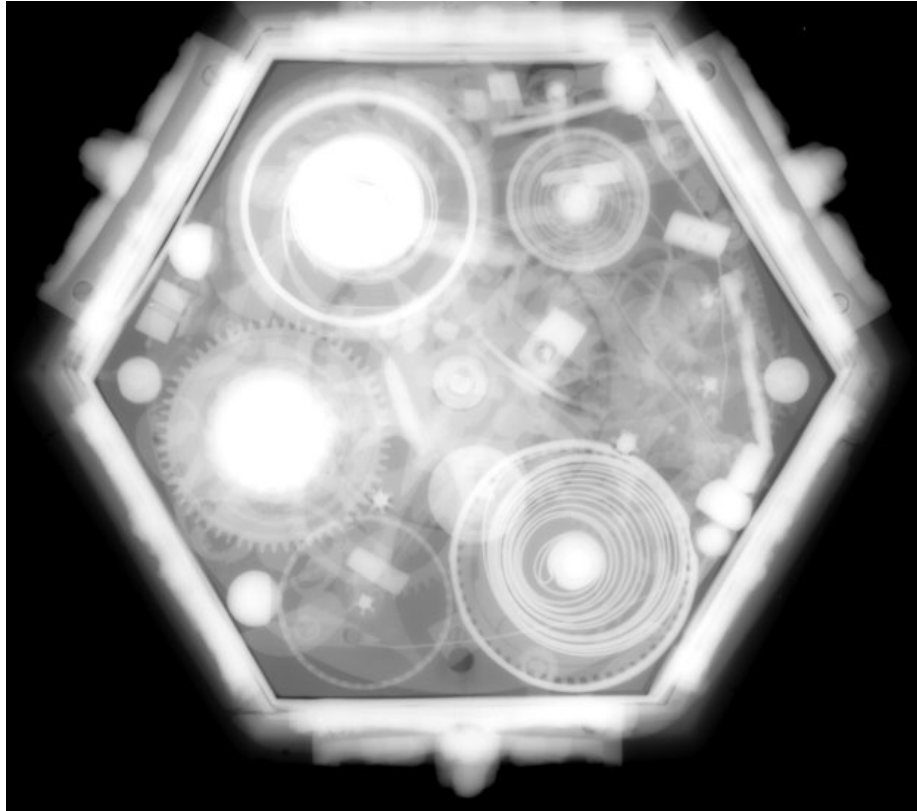
It is not advisable to maintain historic steel springs under constant tension for prolonged periods of time, as stress cracking may result in failure. Information from X-ray radiography allowed for each of the springs to be let down safely, reducing tension and the risk of cracking.

Figure 17, X-radiograph of clock works, showing springs under tension.

Hour train spring is at top left, alarm strike spring is at top right, hour strike spring is at bottom right.

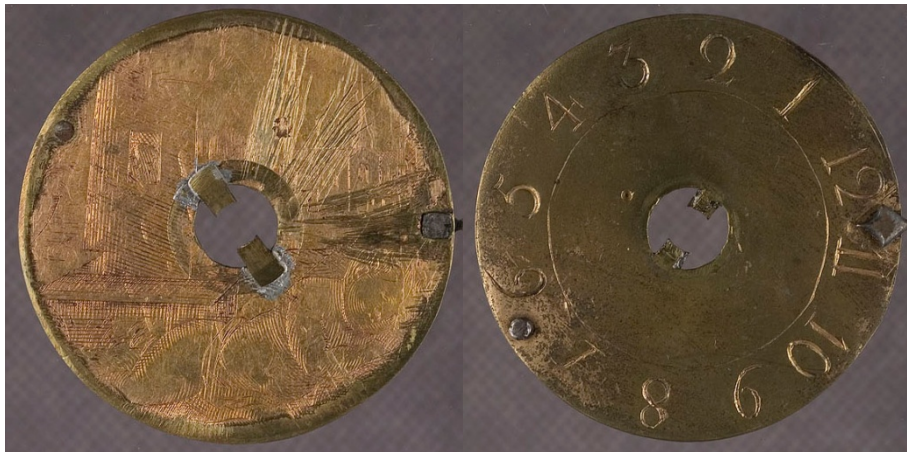
Figure 20, Alarm set dial Left: Original engraving on underside Right: Present appearance of set dial

The alarm set dial was returned to its position at the time treatment was begun. However, the underside of the dial, which likely represents the original face of the clock, was photographed in what may have been the original position. This record will serve to record the unique re-use of this original piece. It should be noted that during treatment of the works, the hour and alarm trains were advanced by approximately half an hour. This change has been recorded in photographic documentation.

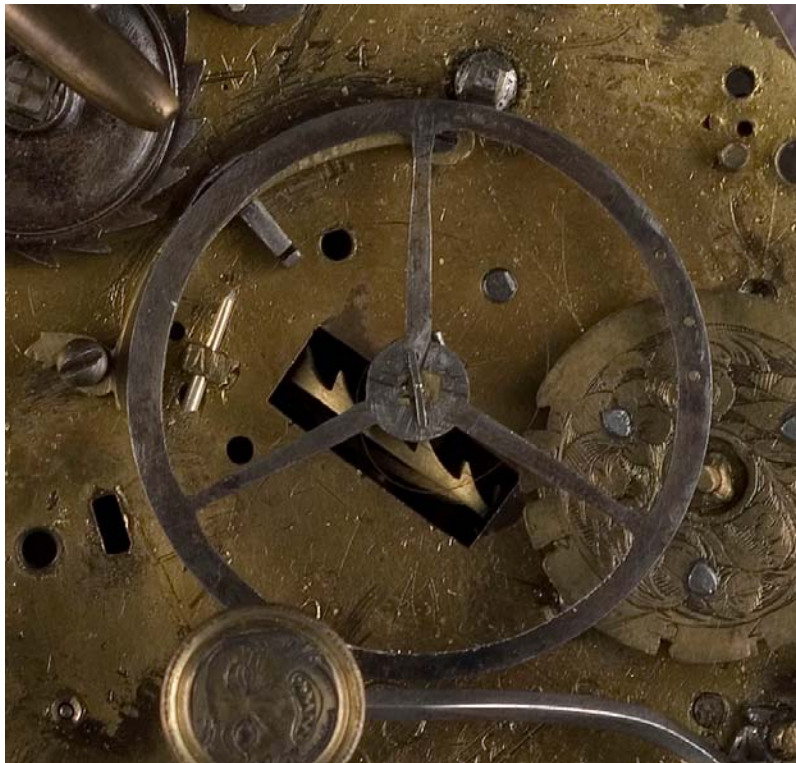
cock has been filled and replaced with a steel anchor for the arbor of the balance wheel, and the foot of the cock has been filed down so that the wheel just fits. The spring for the balance is relatively short and held in place by a peg and guide that have been inserted into the original guard. The balance wheel, pin, new anchor, and guide are steel, though the remaining portions of the original escapement are brass. Furthermore, the quality of workmanship evident in the spring balance wheel is decidedly poorer than that of the original movement; edges are left unfinished, mechanical elements are not symmetrical, and the base plate gilding is scratched by file marks. Finally, the balance wheel partially covers the signature of the maker. It seems unlikely that the maker would have intentionally chosen to obscure his identity. All of these reasons suggest that the spring balance wheel is a later addition, and not original to the clock.

Figure 27, Buffalo Scheirer clock. Spring balance adapted from foliot during the late seventeenth or early eighteenth century

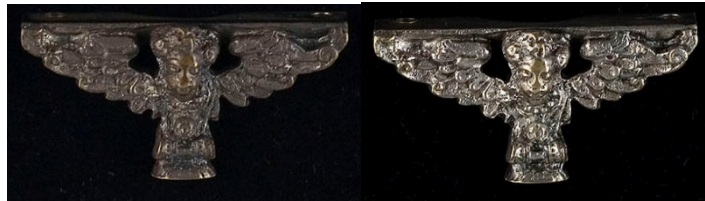
Figure 29, Silvered foot at 6 o'clock Left: Before treatment Right: After cleaning, polishing, and lacquering

Cleaning to reduce surface dirt and grime was undertaken. Cleaning not only improves the aesthetic appearance of the object, but minimizes the likelihood of further metal and glass corrosion by reducing the presence of microclimates and potentially reactive material. Screws were cleaned to ensure that they function smoothly, and are not damaged when removed and replaced in the future.

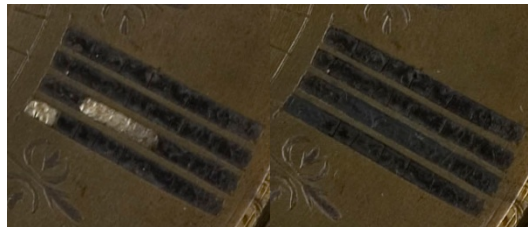
Figure 30, Detail of pigmented wax fills

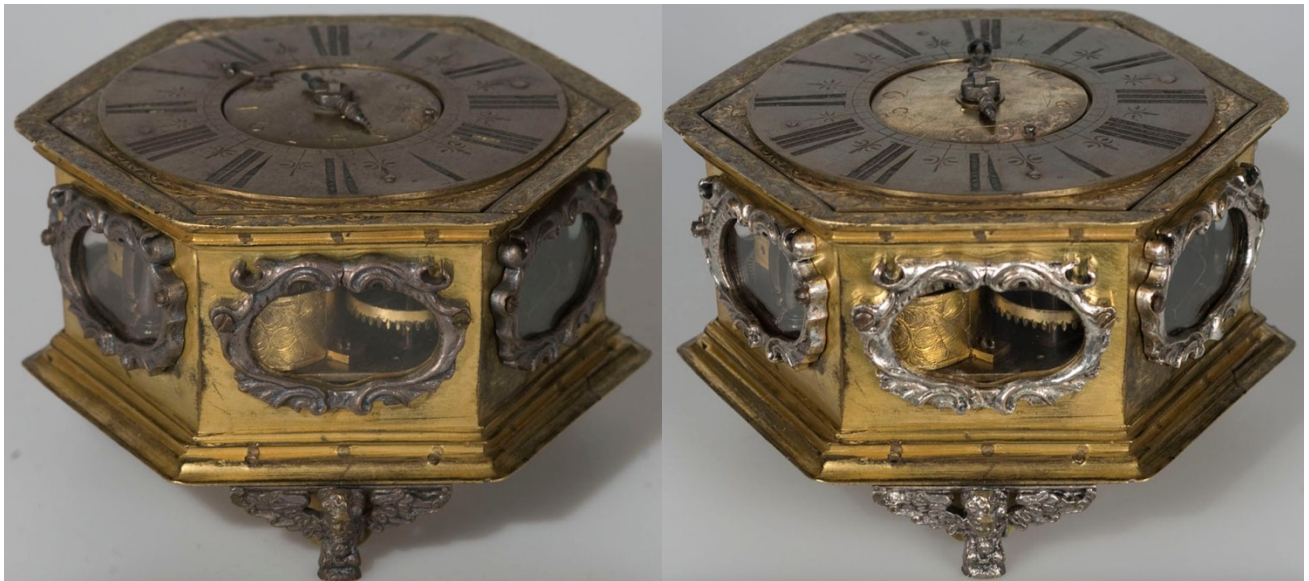
Figure 31, Buffalo Scheirer clock. Left: Before treatment Right: After treatment
