Article: An Examination of Duplicating Film Damaged by Water in 1986

Author(s): Robin Siegel

Topics in Photographic Preservation, Volume 8.

Conservator, National Geographic Society

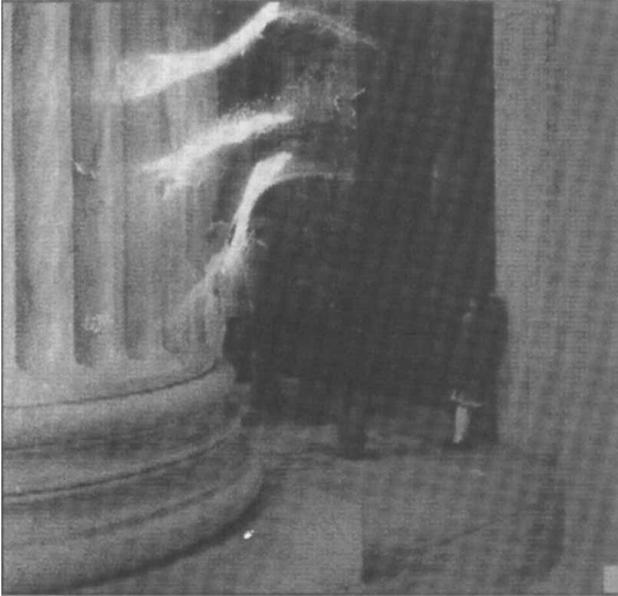
On the left you see a dupe just after it was removed from the plastic covers. It is warped and puddles of water still sit in several spots. I was worried that if dried too fast or too slowly, or not under pressure or under pressure with the wrong interleaving, these dupes would never return to their original shape and the emulsion might stain or shift. I used three recommended drying techniques: blotters, heat, and air. The blotters turned out to be impractical because of lack of supplies, but space made drip-drying difficult. I finally turned on all our light tables and threw dupes on the light tables.

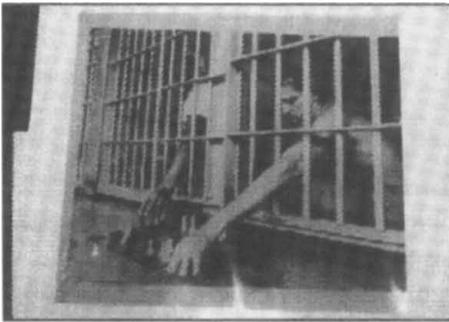
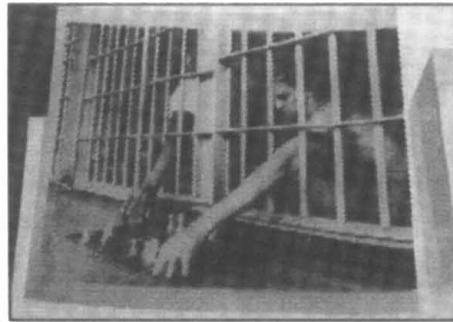
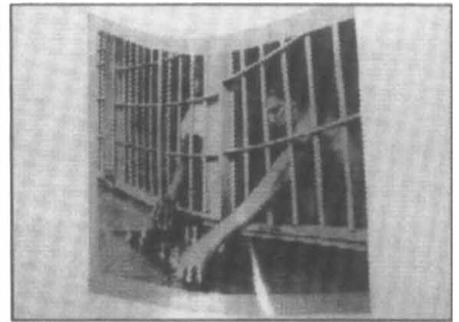
Below are three photographs of an engraver's dupe from the time it first hit the light table until it was removed.

You can see the staining start to fade as soon as the puddle dries, but then it starts to curl, so I used weights as it cooled and by the time it was cool, it was flat. I couldn't use the weights while the light table was on because both sides of the dupe were damp and I didn't want to trap moisture between the dupe and the heat source.

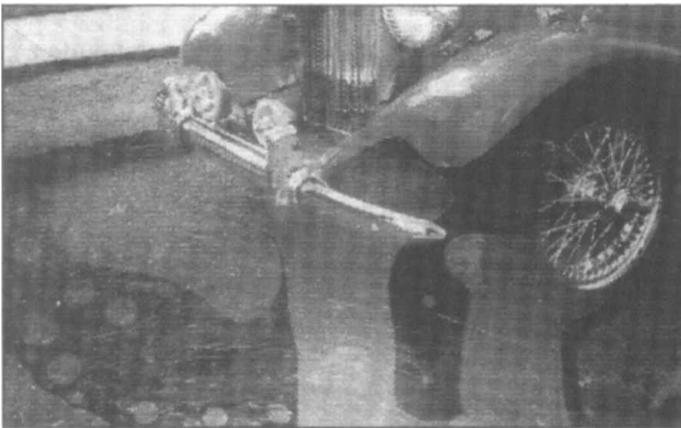
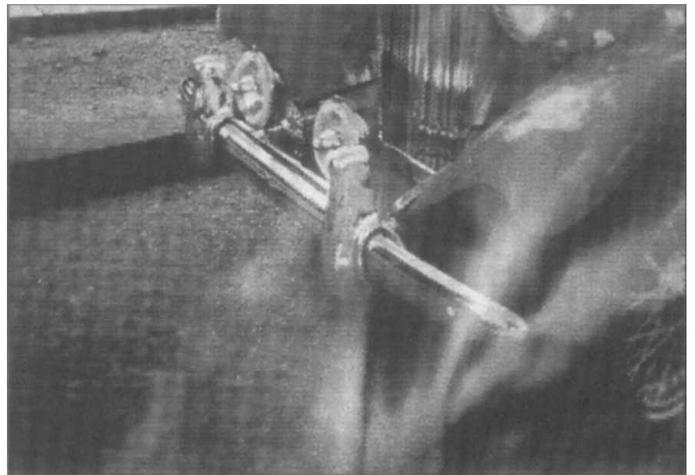
In 1998 I pulled some of the dupes that had been the most badly wetted in 1986. This spread from *National Geographic World* magazine must have looked pretty bad to me because I shot a couple of photos of it at the time.

Here is the red car still between the cover sheets, and on the right after drying. I hope the halftone will show the thin tide lines around the front tire and bumper.

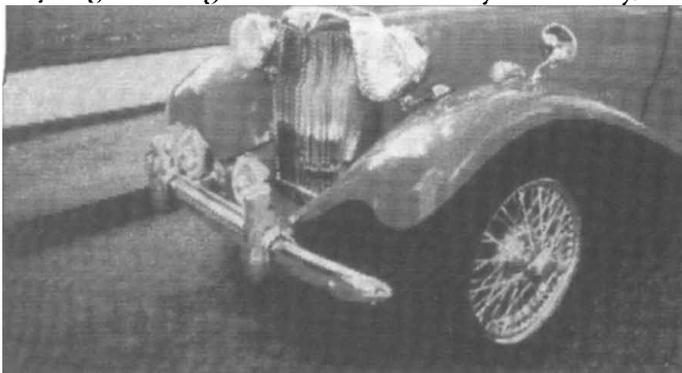
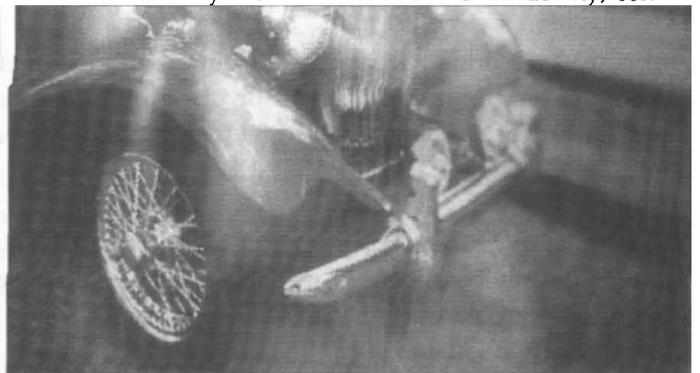
Here is the same dupe today, by transmitted and glancing light. You may be able to see a little line where the water stopped near the tire and bumper slightly visible in glancing light but not transmitted light. There are lines like those on nearly all the dupes where water migrated between the cover sheets, and also lots of particles in the emulsions, and a few scratches that may be older. However, there is no sign that the rewetting or method of drying had any negative long-term effect, such as dye instability, lack of adhesion of layers, other mechanical instability, etc.

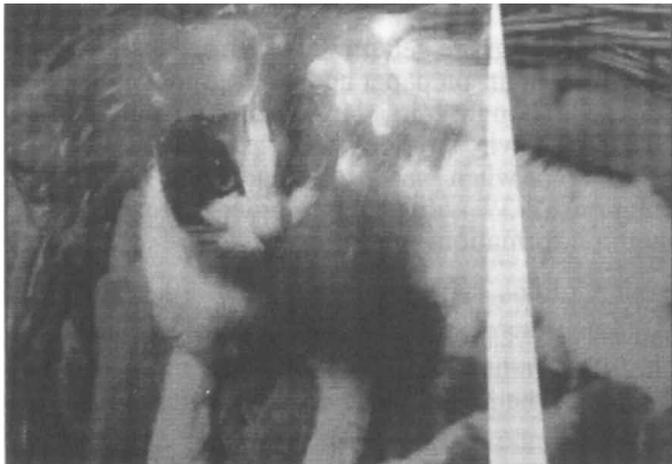
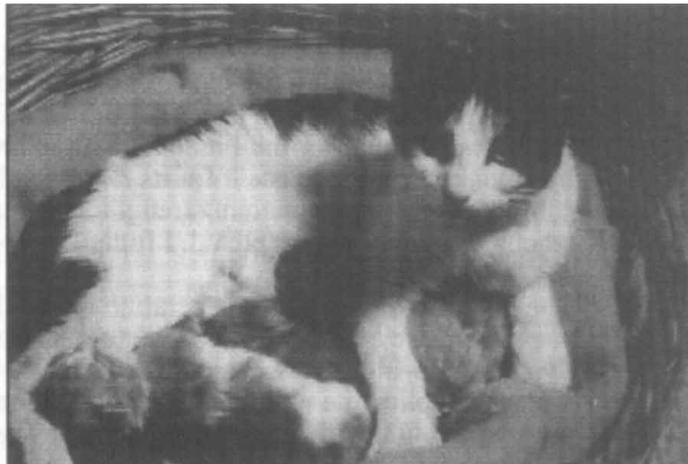
The red car layout was not among the sixteen worst, those that I kept an additional month to work on. On this page I have tried to reproduce some of those sixteen.

The additional bathing seems to have cleaned them up to at least the condition of the less damaged. Above left is an engraver's dupe shot with the emulsion side up to show the residual damage in glancing light. On the right, viewed right-reading and without glancing light, the damage is all but invisible. (The crack down the middle is the space between the two pieces of film, needed to produce the gutter in publication.)

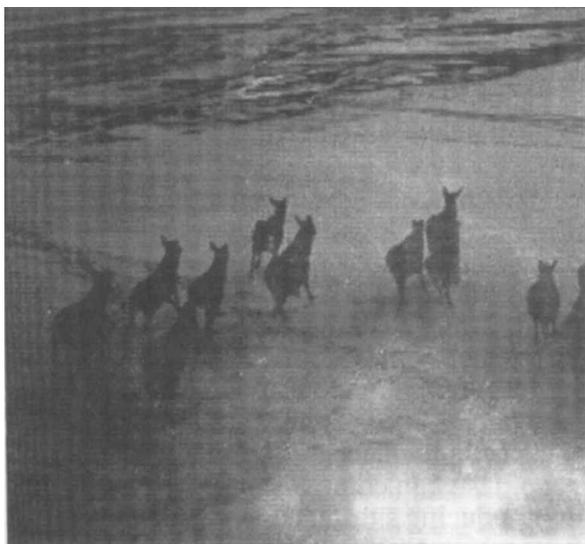
The emulsion of this engraver's dupe exhibits a few waterlines and some embedded fibers, some of which could probably still be removed today. They are clearly visible in a glancing light. However, in reproduction they are barely detectible.
