Source: *Objects Specialty Group Postprints, Volume Nine, 2002*

TEN YEARS OF SCULPTURE AND MONUMENT CONSERVATION ON THE MINNESOTA STATE CAPITOL MALL

Paul S. Storch

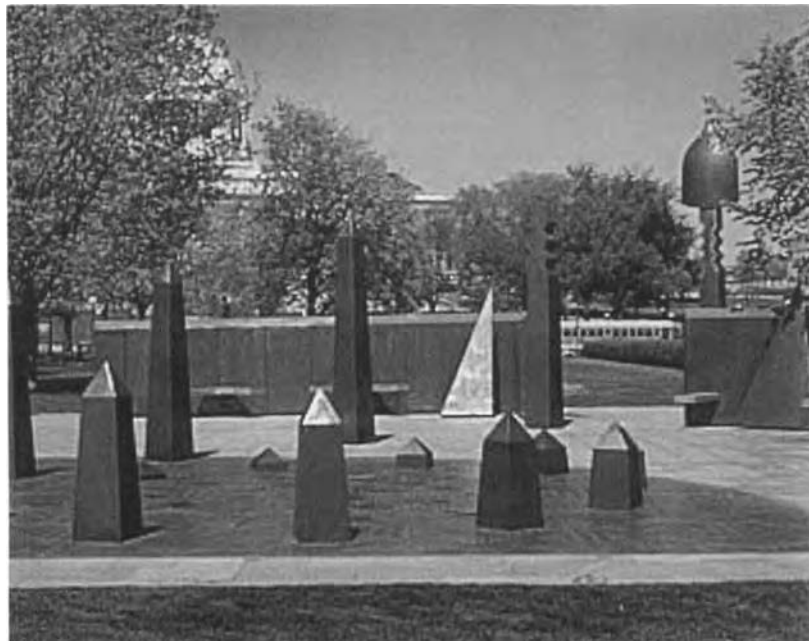
Figure 5. View of the Roy Wilkens memorial plaza, *Spiral for Justice*, in 2002, showing dark weathering surfaces.

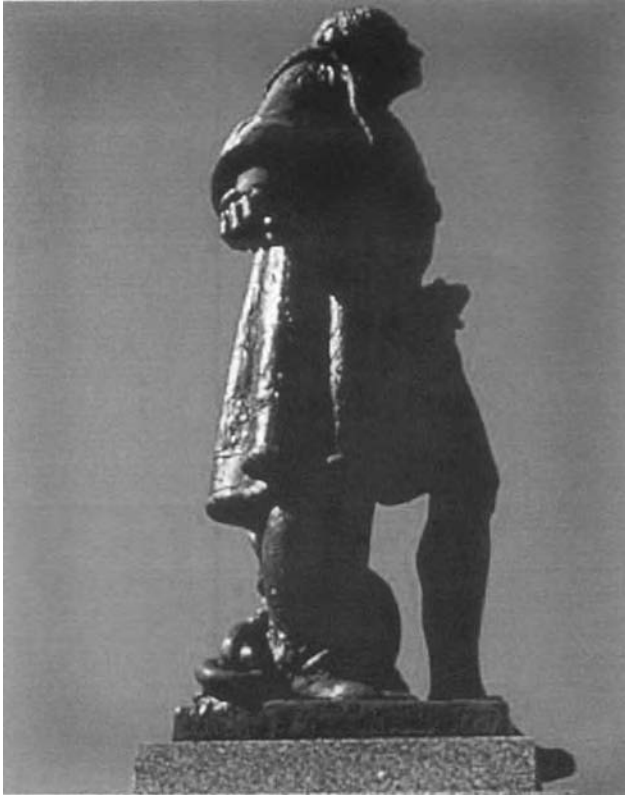
The first project of the State Capitol Mall Sculpture Conservation Program was in 1991 with the donation of money from the Italian-American Society to the MHS for the conservation and preservation of the Christopher Columbus statue located on the northeast side of the Mall (Fig. 6). Sculpted of bronze by Charles Brioschi and dedicated in 1932, the statue had never been

properly maintained. It had weathered and corroded from its original “Roman bronze” patination to a dull, mottled greenish-tan. The Italian-American Society requested that the treatment be completed in time for the 500th Columbus Day anniversary celebration in October 1992. The project was submitted for bids from contract conservation firms, and Fine Objects Conservation Inc. (FOC, Inc.) was awarded the bid. Based on her work on the Garfield Memorial at the US Capitol, Linda Merck-Gould, president of FOC, Inc., proposed that the bronze be cleaned with medium pressure water (1000-1400 psi), followed by an application of benzotriazole, chemical patination, and coating with Incralac and carnauba wax. Ms. Merck-Gould devised an on-site testing project that would take place prior to the actual treatment of the sculpture in order to finalize the treatment specifications. The exact details and results of the testing done on the Columbus sculpture in coordination with the MHS conservation department were published in a paper presented by Ms. Merck-Gould at the 1993 ICOM Committee for Conservation Conference (Merck-Gould 1993) (Fig. 7).

Figure 6. *Christopher Columbus* monument.

The rest of the treatment was carried out and was successful in restoring the bronze to the 1932 appearance of Roman Bronzework brown (Merck-Gould 1993). Unfortunately, in October 1992 just prior to Columbus Day, the statue was attacked in the middle of the night by vandals who doused it with an oil-based red paint. An emergency cleaning effort early the next morning by the State Department of Administration Plant Management Division used an outside non-conservation-trained local contractor. The contractor removed the paint in time for the holiday, but damaged the wax and Incralac layer to the extent that it had to be chemically stripped and replaced in the summer of 1993, and the statue re-treated in 1994 (Fig. 10). Since then, yearly maintenance has preserved the patina and surface coatings in a satisfactory manner (Fig. 11). This incident called out the need to create a useable monument and sculpture disaster response plan so that everyone necessary could be called in if something like this occurred again. A copy of that plan can be found at the end of this article (Appendix II).

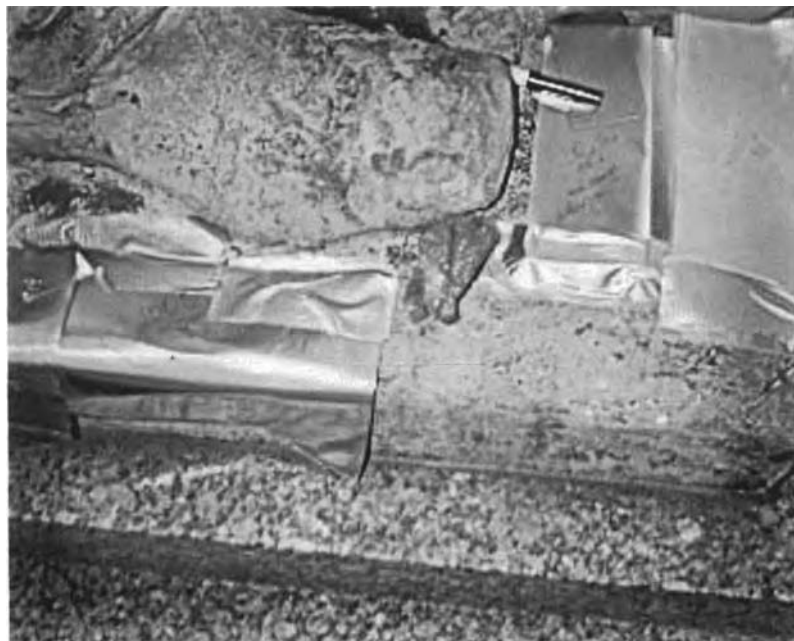
The detailed tests on the self-base of the Columbus statue to determine which pressures higher than 1000 psi could be used (Fig. 9) included the following objective: to remove the soluble corrosion products from the surface and the pits in the bronze without removing metal. The test methods included pressurized water at 1000, 2000, 3000 and 4000 psi, in comparison with 10.5 AD walnut shell powder at 35 psi. All cleaning method tests were reviewed at 37.5x

The technique that removed the soluble, active corrosion from the surface and pits of the bronze was 4000 psi using a 25 degree fan tip. The surface retained a light green corrosion layer and was not stripped to bright bronze.

Figure 9. Self-base of *Christopher Columbus* masked off for the cleaning tests, 1992.

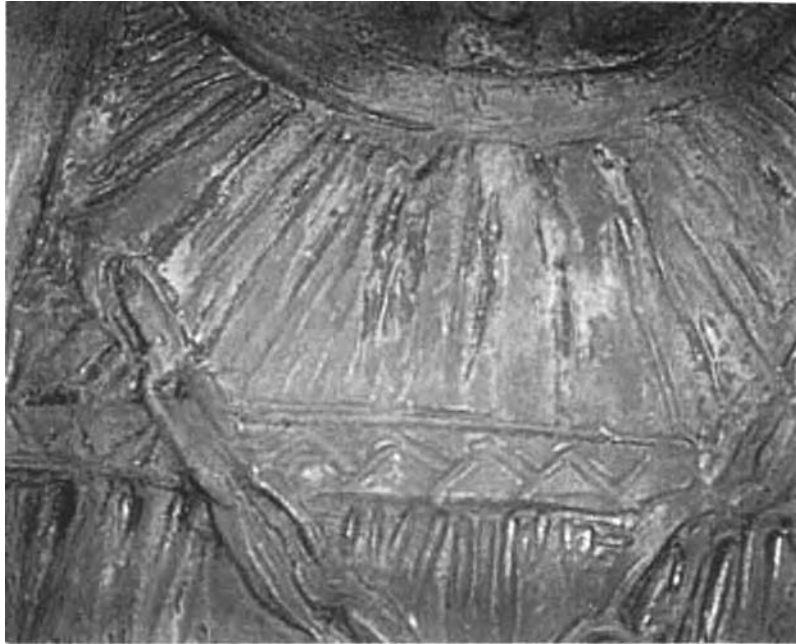
Figure 10. Chest area of *Christopher Columbus* showing metal surface after solvent stripping the layers of Incalac and wax for spot treatment to repair paint damage caused by vandalism, 1994.

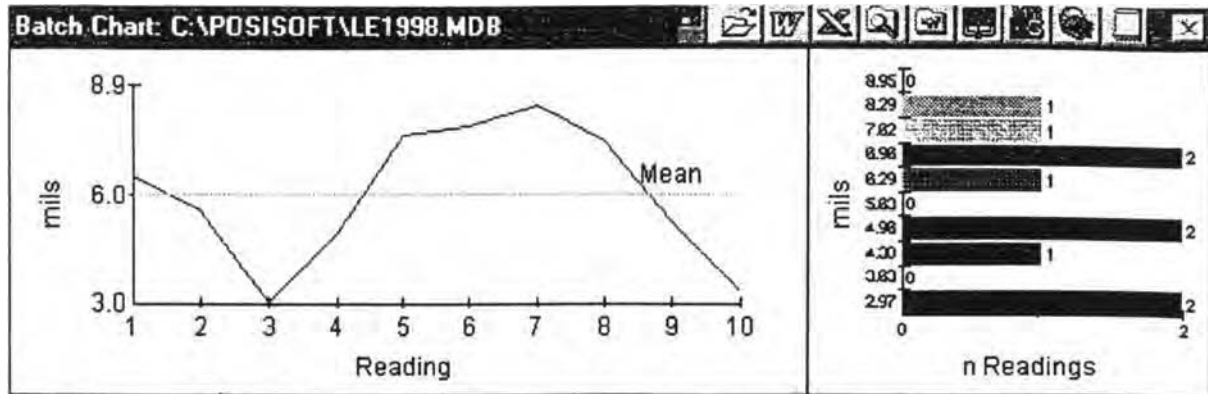
N: 10
Mean: 5.96 mils
Std Dev: 1.8898 mils
Max: 8.4 mils
Min: 3 mils
USL: ---
LSL: ---

Annotation:
PR Drapery by Bicep. The readings were taken by P. Storch and Chris, CTA, 9/16/98 as part of the 2nd year's CTA maintenance contract. The coating thickness varied from 1.5 to 2.0 mils.

Figure 16. Graph of Positest instrument thickness data, *Leif Erikson* sculpture.

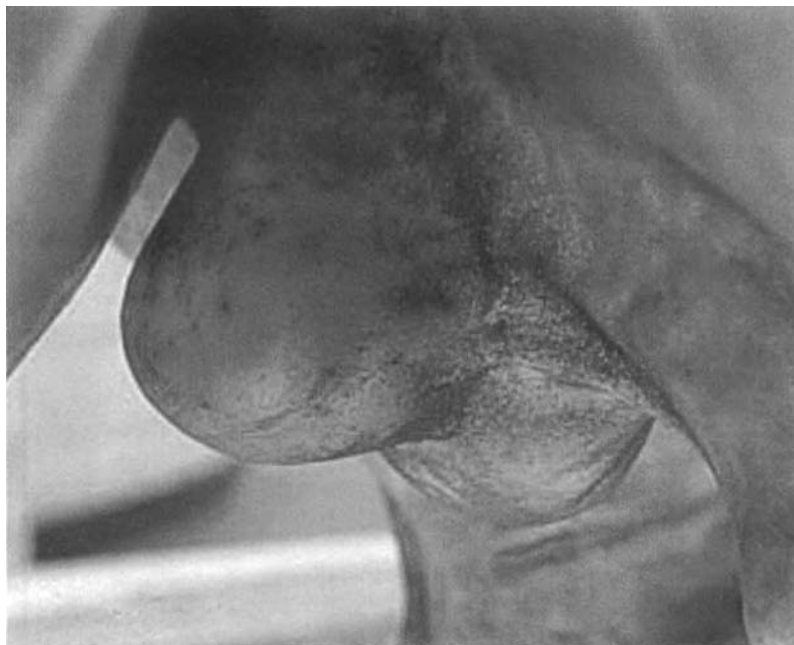
The sculpture was spot re-gilded under warranty during the summer of 1997, and routine maintenance was performed by the author and assistant. By 1999 it was noticed that spot corrosion was occurring on various areas of the chariot and on the undersides of the horses (Fig. 18). There was a concern that the most recent treatment had not properly removed all of the solvent used to soften the 1979 primer layer, which may have compromised the new gilding layers leading to water infiltration and corrosion formation. Another hypothesis was that the solvents in the wax were weakening the sizing and allowing for increased corrosion. In 2000 and 2001, after the required RFP process, a contract was awarded to Jensen Conservation Associates, Omaha, NE, to examine the problems and to propose a course of action. Two copper panels salvaged from the roof beneath the Quadriga were gilded and set up in a test rack in late 2001. Each panel was divided into quadrants. One quadrant was left uncoated as a control, and the other three were protected with various combinations of waxes, pigments, and lacquers (Fig. 19). By the Spring of 2002, the test panels indicated that the type of weathering and wear that was seen on the Quadriga is a natural result of the conditions to which the surface is exposed, rather than an effect of workmanship or material from a previous treatment. The waxes and lacquers did not enhance

Figure 18. Detail of spot corrosion on the gilded surface of the Quadriga, underside of a horse, 1999.

The normal life-span of a gilt sculpture in a temperate climate is approximately 20 years. The observations and research done as part of the sculpture conservation and maintenance program show that the failure of the gilt layers is progressive over that period and may proceed at different rates depending on the location of the surface in terms of environmental exposure and moisture condensation. From a fiscal management perspective, the decision was made to spot treat each of the corroded areas at this time and to continue the annual maintenance regime of washing and re-waxing (Fig. 20). Spot re-treatment, which includes removal of the corrosion (Fig. 21), and re-gilding (Figs. 22, 23) is a more efficient use of funds and will extend the life-span of the surface layers over the long term. Cleaning and re-waxing, while effective to an extent, will not prevent the need for re-gilding at some point. Incremental regilding, along with the stabilization and repair of failed joints, for example, will maintain both the structural and aesthetic aspects of the Quadriga.

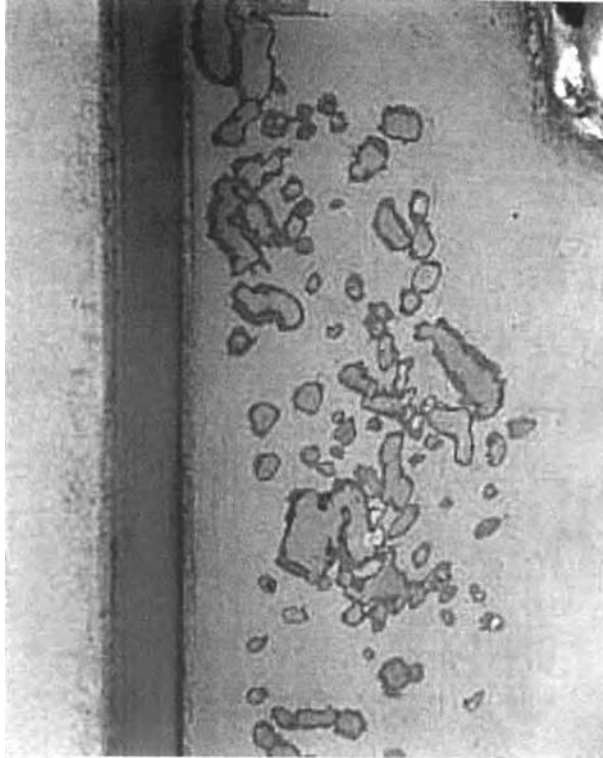
Figure 21. (upper left) Detail of the corroded surface on the rear of the chariot, 2001.

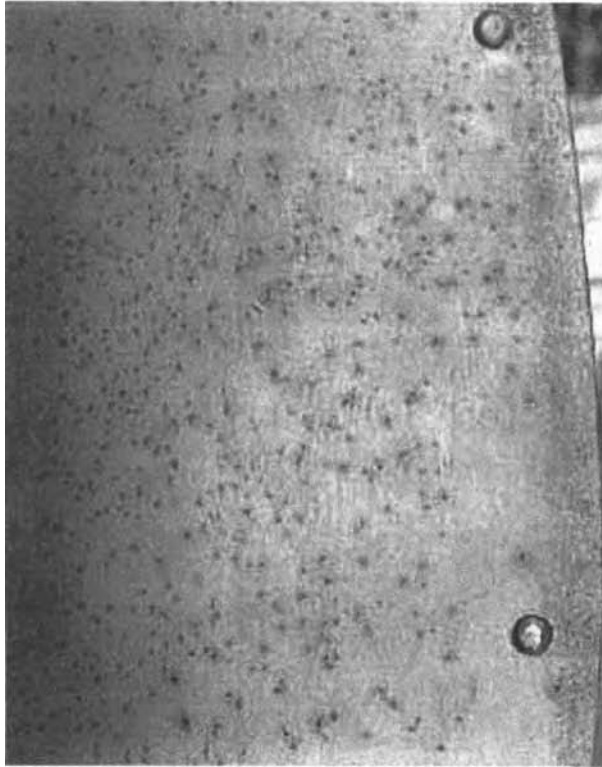
Figure 22. (upper right) Detail after mechanical removal of the spot corrosion down to the metal surface as part of the regilding tests, rear of the chariot, 2001.

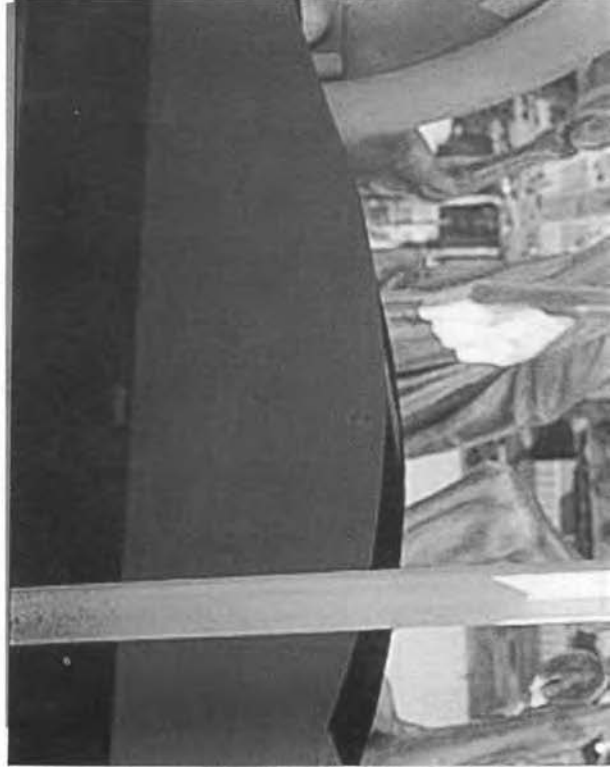
Figure 23. (lower left) Rear panel of the chariot after priming and regilding during regilding tests, 2001.
