Article: Three case studies of outdoor sculpture with problematic intent issues

Author(s): Michael Belman

Source: *Objects Specialty Group Postprints, Volume Nine, 2002*

THREE CASE STUDIES OF OUTDOOR SCULPTURE WITH PROBLEMATIC INTENT ISSUES

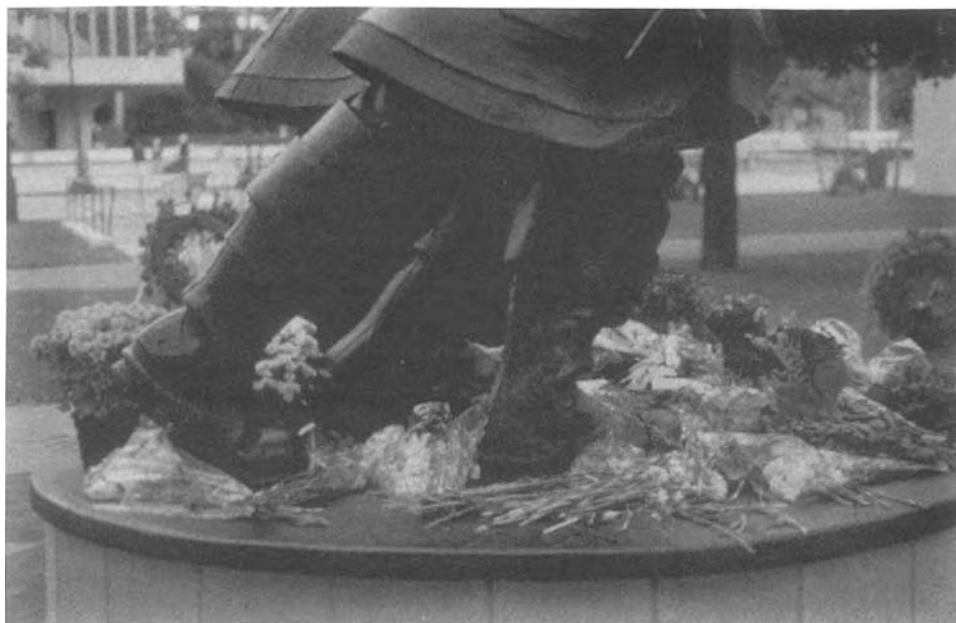
objects lab in Williamstown received a phone call from the offices of the Empire State Plaza Art Collection. In the outpouring of grief after the disaster, flowers, wreathes, figurines, clothing, candles, letters and bells were being heaped on the base of the firefighter sculpture causing new bright green corrosion (Figs. 2 and 3). The conservators inquired as to whose responsibility it was to remove the items, assuming that they were probably important to some specific groups, and they would want it done respectfully. It turned out that there was no set plan for collection.

Figure 2. *The New York State Fallen Firefighters Memorial.*
The base of the sculpture shows heaped memorial items following September 11th. Photo taken September 15th, 2001

Williamstown Art Conservation Center recommended that New York State develop a set procedure for sharing the monument, one that would involve sensitively collecting the memorial items in order to minimize the prolonged contact that causes such damage. A protective mat could be laid out on the base during ceremonies or other periods of remembrance. Another solution, although one that would significantly change the current use pattern, is to set a small sign into the base respectfully asking to please put flowers against the wall.

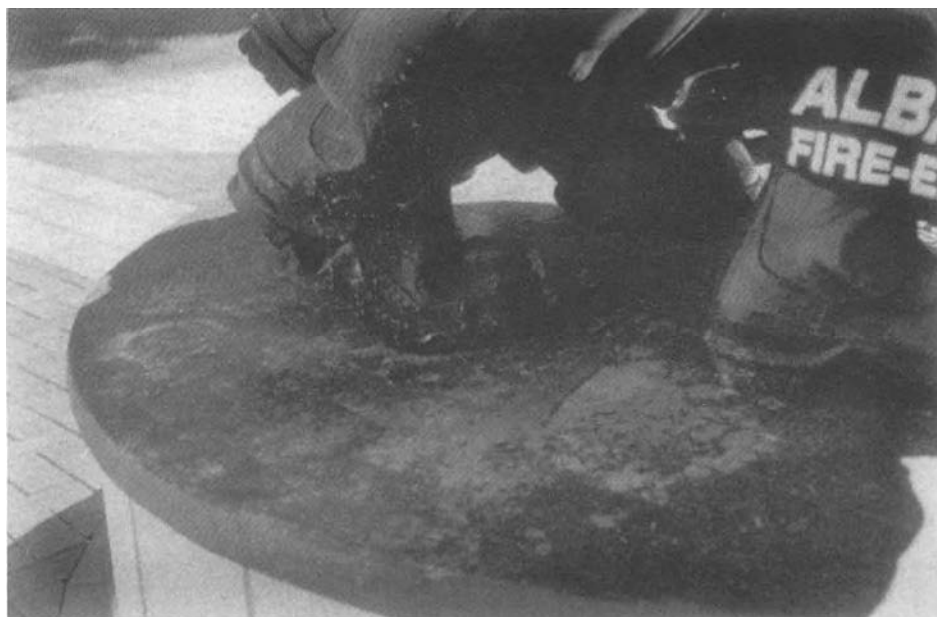
Figure 3. *The New York State Fallen Firefighters Memorial.*
Bright green corrosion from the post-September 11th memorial
items. October 5th, 2001 cleaning for the Rededication Ceremony.

The 911 memorial items were set aside and the corrosion was removed again (using the same technique as before), though this time there was some visible damage to the patina. The conservators felt it important to not interfere with the outpouring of emotion, and after the treatment, everything was carefully replaced.

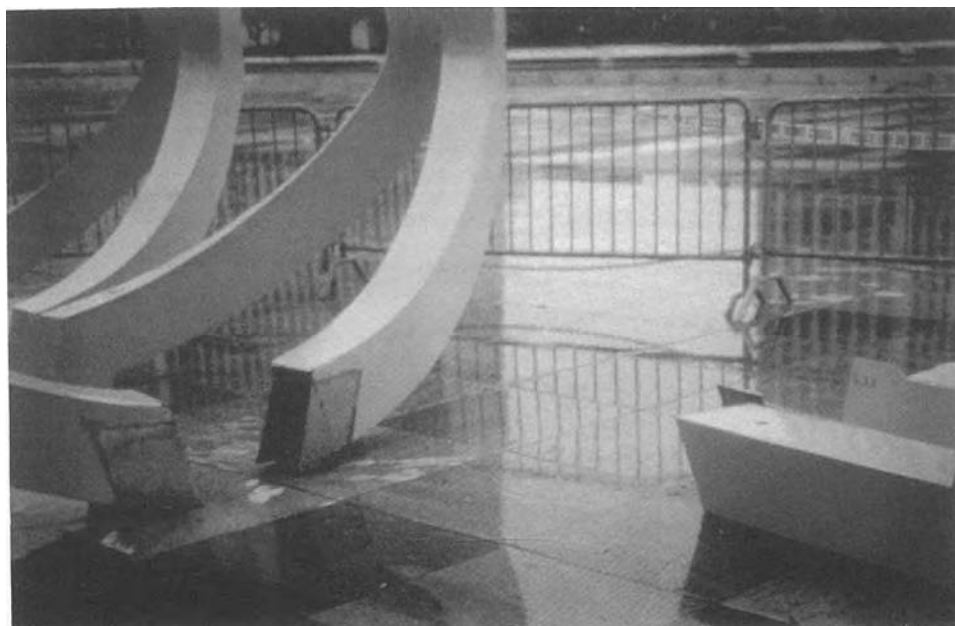
Fifteen years and numerous maintenance campaigns later, on March 25th 1993, between 4 and 5:30 am, *Trio* was rolled 25 feet into an empty reflecting pool nearby on the plaza. There was speculation that Grateful Dead fans may have damaged the sculpture, as the band was playing at the nearby Knickerbocker Arena, now called the Pepsi Arena, earlier that night. A spokesperson for the New York State Offices was quoted as saying “There were 60,000 Grateful Dead fans in the area, and we can’t rule out that possibility” (Quinn 1993, 11).

Figure 7. *Trio*, split in half following the catastrophic March 25th 1993 act of vandalism.

The Williamstown Art Conservation Center condition report after the incident described the sculpture as having broken in half with extensive paint loss overall (Fig. 7). The report mentions

that the work had never been bolted down because of the complexity of the plaza substructure. Conservation treatment ensued. The two halves were welded together and the entire sculpture was anchored into the plaza with four threaded stainless steel bolts. Dents and paint losses were filled and spot primed, and the object was completely repainted with three coats of a polyurethane enamel that was recommended by the artist (Williamstown Art Conservation Center 1993).

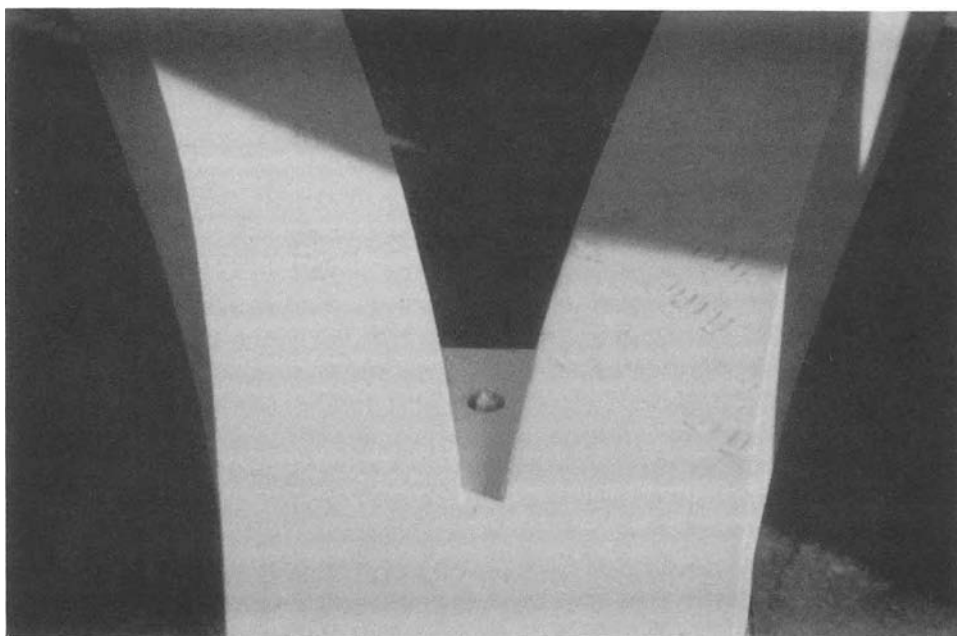
Only seven years later, in the summer of 2000, *Trio* needed another major restoration campaign to repair cracks and paint loss not only from climbing, but also from skateboarding and BMX riding. Immediately following the final paint application in this treatment, the sculpture was overrun with black footprints from vandals (Fig. 8). This occurred very quickly, within ½ hour of application, despite stanchions and wet paint signs. Paint was reapplied locally to cover the footprints (Holbrow 2002).

Figure 8. *Trio*. Footprints of a vandal in freshly applied polyurethane paint, following the Summer 2000 treatment.

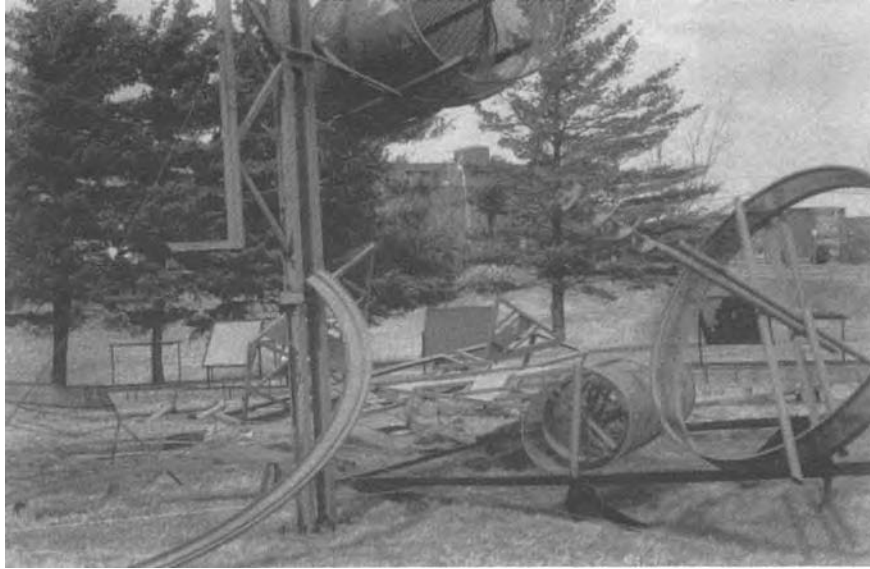
The Brainerd Gallery, now called the Roland Gibson Gallery, asked the Williamstown Art Conservation Center in August of 2001 to examine *Formula Compound #1* and draft a treatment proposal. The sculpture had fallen into a state of severe deterioration due to lack of maintenance. Numerous parts had tipped over, broken apart and were scattered about the field, lost and half buried in the grass (see Fig. 12). The mesh screens had badly rusted, as were many of the welded

Figure 12. *Formula Compound #1*. Detail of steel elements that have collapsed after 18 years without maintenance.

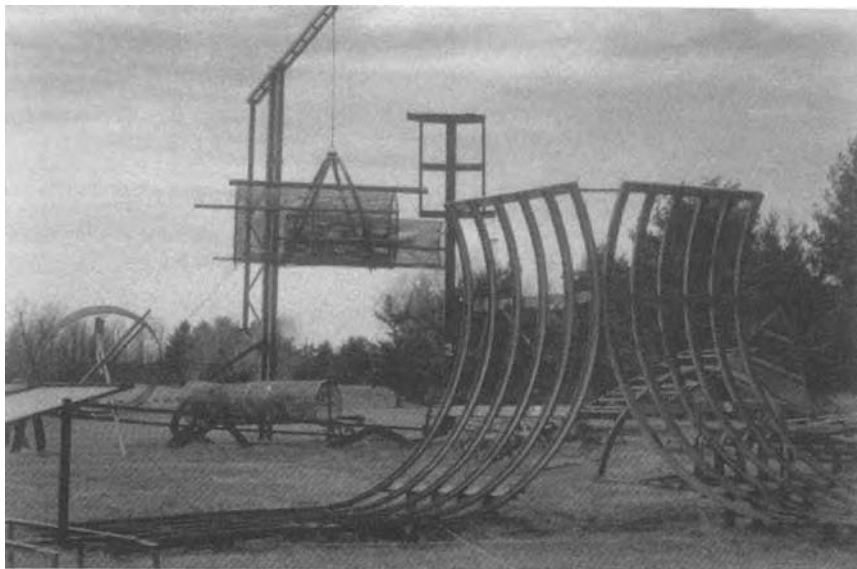
joints of the ribbed tracks and ramps. Particularly unnerving was the large dangling cylinder, which was suspended on a single rusted cable from the supporting tower (see Fig. 13).

Figure 13. *Formula Compound #1*. Detail of elements of the sculpture as they appeared in March 2002.

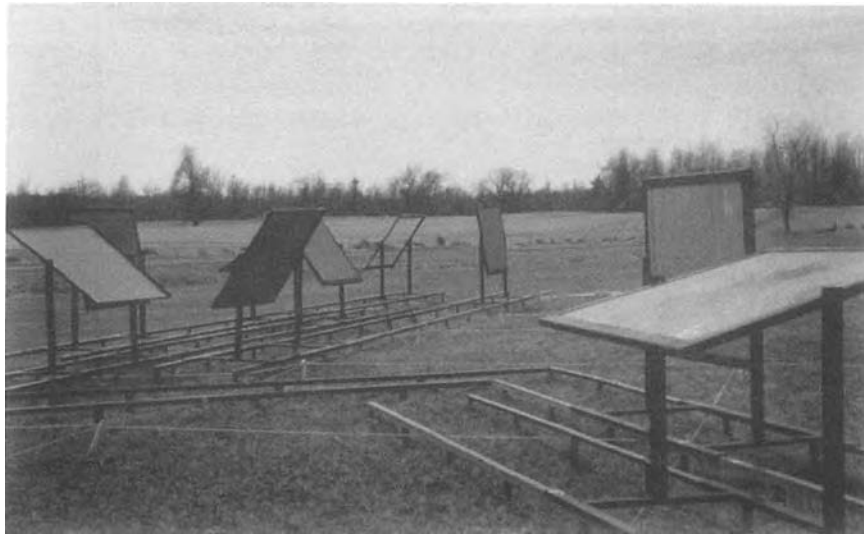
Whole sections of the reflector panels had been relocated and other elements visible in the original image, such as the towering pinwheels, now appeared to be missing entirely. Due to corrosion and weathering, much of the original paint was badly flaking or lost from the metal surfaces (see Fig. 14). Because no blueprints or other ground plans were available, the full extent of the damage was unclear. The size and weight of the steel elements, in particular the towers and dangling parts, made the sculpture a danger and a liability. The presence of empty beer bottles confirmed that the site had become a night time hangout spot for the Potsdam college students.

Figure 14. *Formula Compound #1*. The banks of panels showing corrosion, paint loss and missing pieces. March 2002

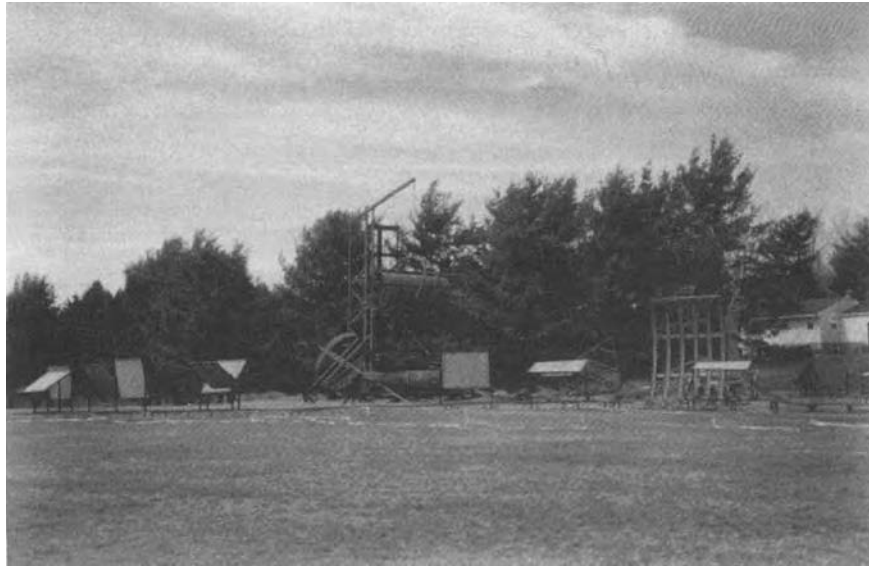
Figure 15. *Formula Compound #1*. Overall view as it appeared in March 2002 before demolition.
