Article: *Three Way Plug* three ways: Conservation treatments of three editions of Claes Oldenburg's COR-TEN steel and bronze *Giant Three Way Plug*

Author(s): Mark Erdmann, Adam Jenkins, Robert Marti, and Marianne Russell Marti

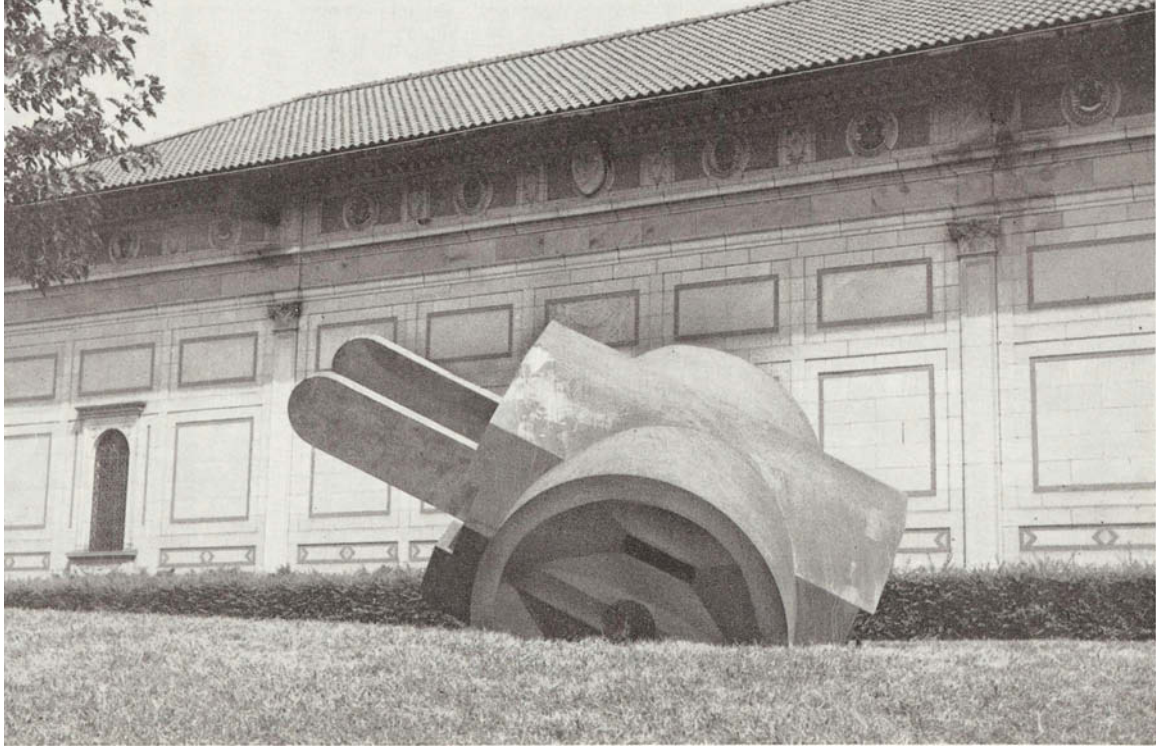
Fig. 1. Claes Oldenburg, *Giant Three-Way Plug, Scale A 1/3*, 1970, COR-TEN steel and bronze, 302 × 199 × 148 cm, Allen Memorial Art Museum, 70.38 (Courtesy of the Oldenburg van Bruggen Studio, © Claes Oldenburg 1970)

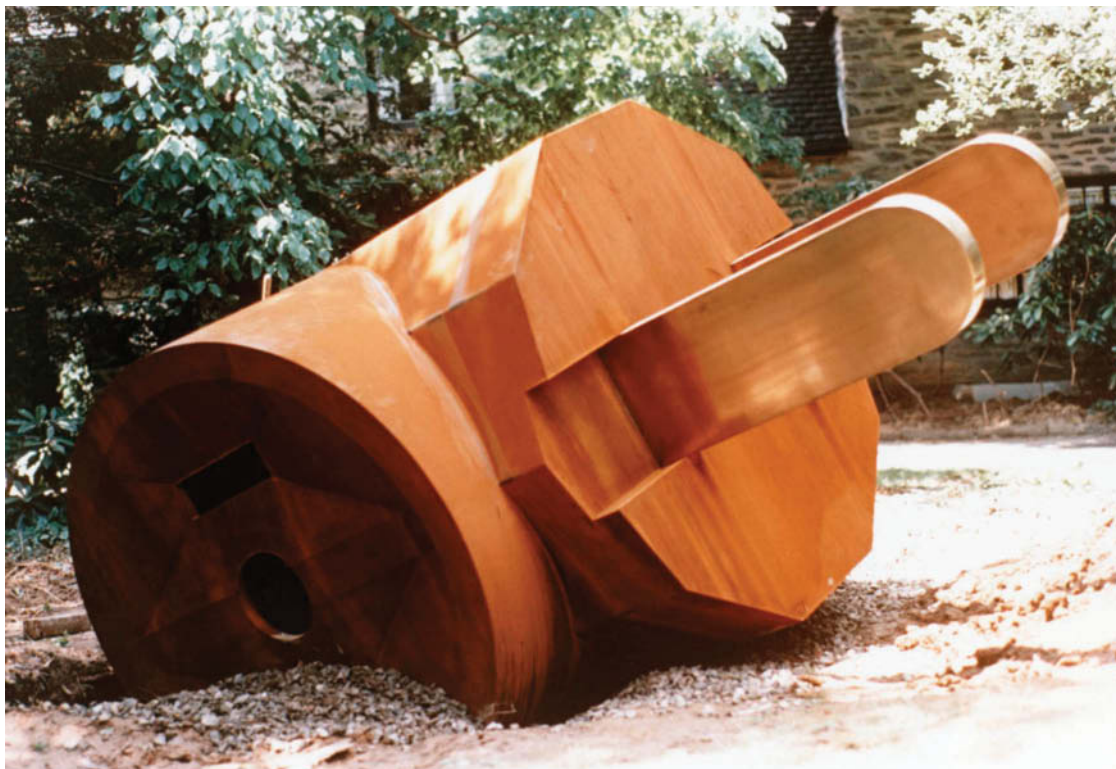
Fig. 3. Claes Oldenburg, *Giant Three-Way Plug, Scale A 3/3*, 1970, COR-TEN steel and bronze, 297 × 198 × 147 cm, Philadelphia Museum of Art, 2010-15-1 (Courtesy of the Oldenburg van Bruggen Studio, © Claes Oldenburg 1970)

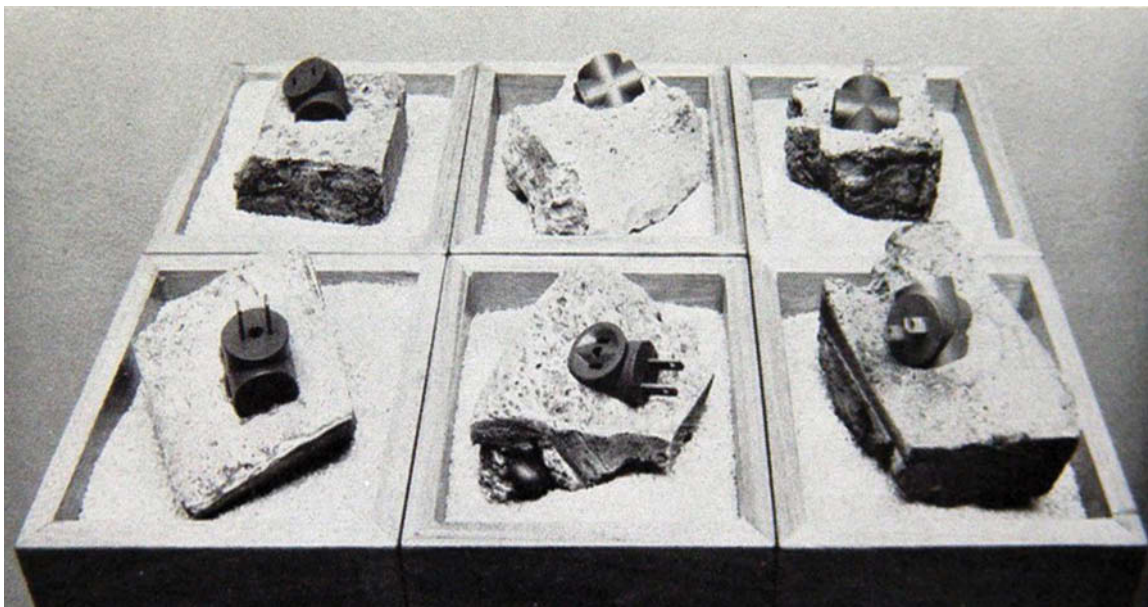
Fig. 8. Several small models made by Oldenburg exploring possible orientations for siting the Three-Way Plug (Courtesy of the Collection of Parks and Christie Campbell)

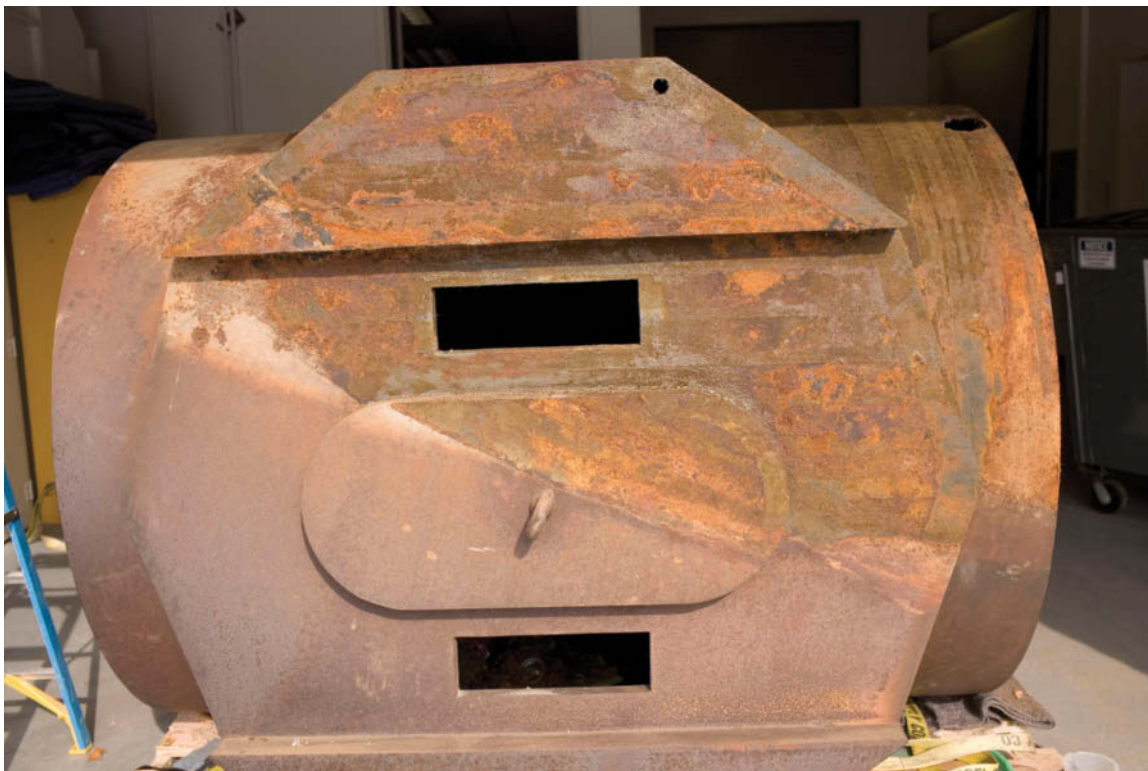
Fig. 9. The Allen Memorial Art Museum Plug (Oberlin) after removal of the Densyl tape from the previous conservation treatment (Courtesy of John T. Seyfried, ICA)

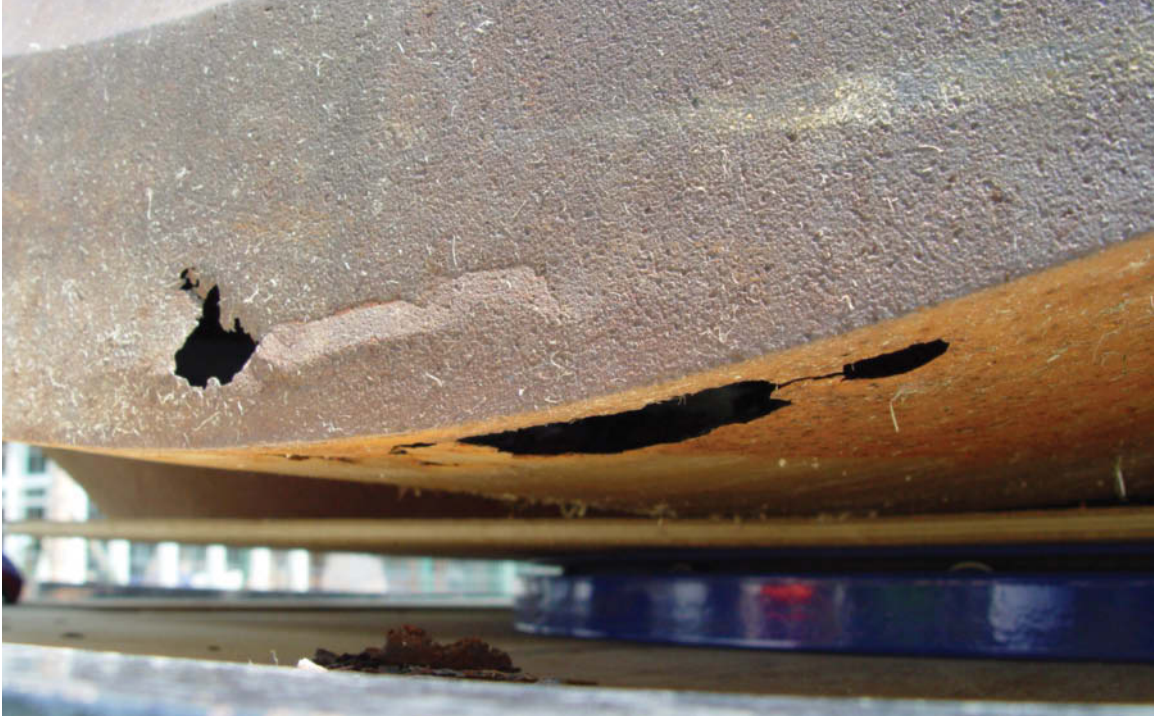
Fig. 10. Severe corrosion at interface between side chamber body and face of the Saint Louis Plug, due to humid micro-environment in the space created by the internal angle iron (Courtesy of Russell-Martí Conservation Services, Inc.)

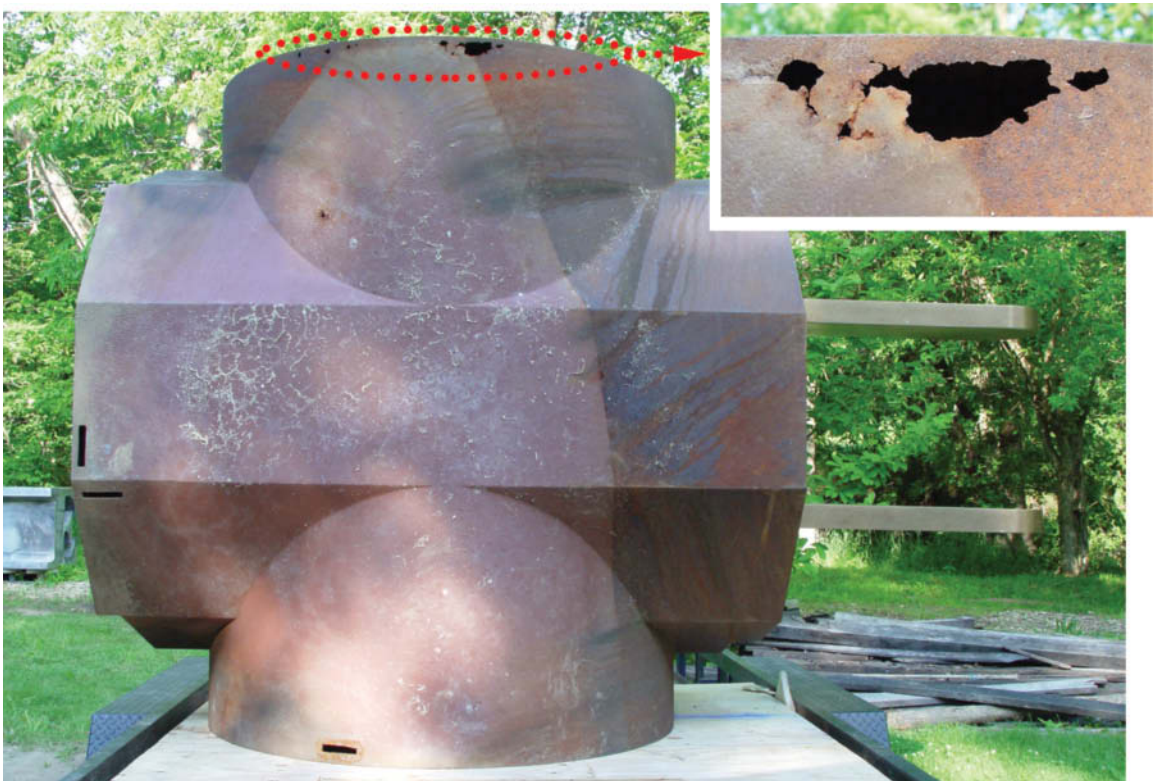
Fig. 11 (left) and Fig. 12 (inset). Severe corrosion along the bottom edge of proper right side chamber of the Saint Louis Plug. The extremely thin metal extended along a 180° arc along the edge of the chamber. (Courtesy of Russell-Martí Conservation Services, Inc.)

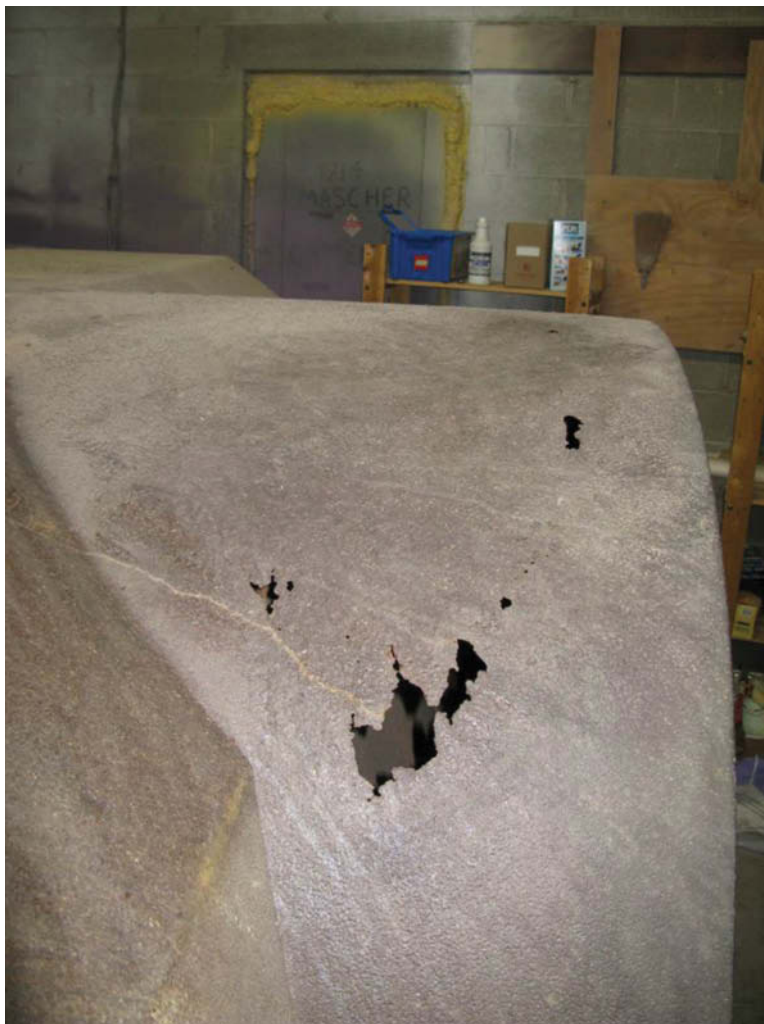
Fig. 13. The Philadelphia Plug showing severe corrosion of the proper left side chamber, due to moisture retention on interior (Courtesy of Materials Conservation, Philadelphia, PA)

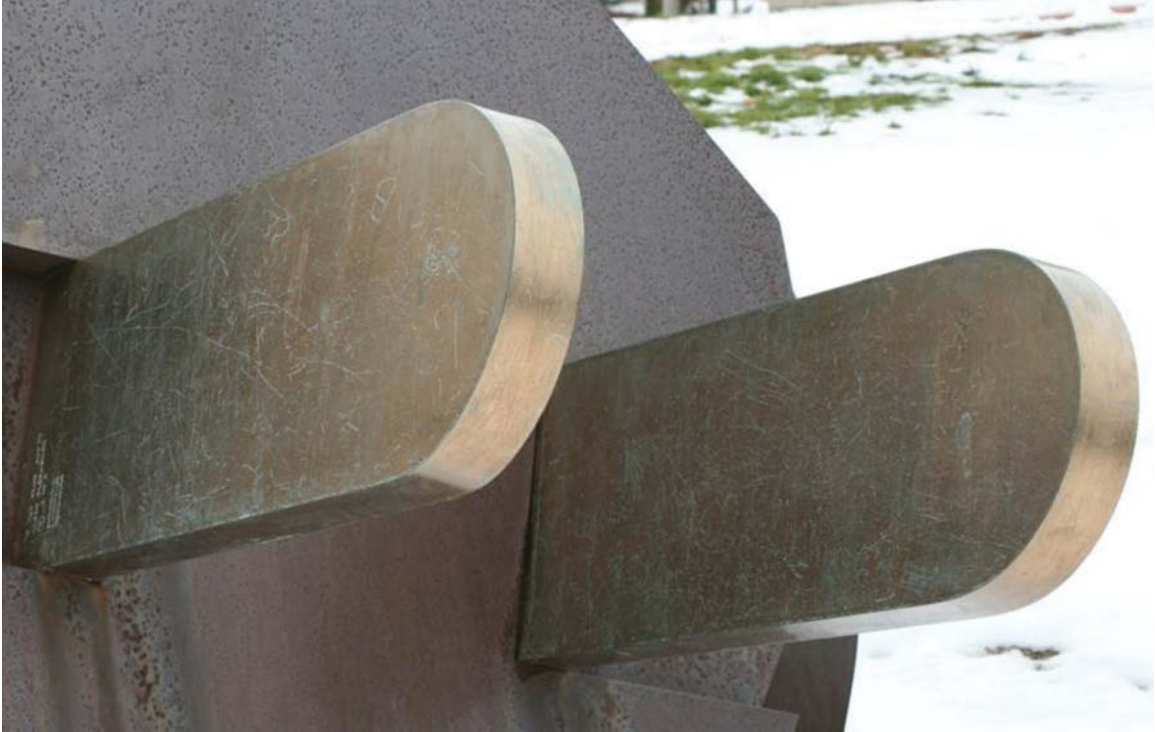
Fig. 14. The bronze prongs of the Oberlin Plug with corrosion in scratches and graffiti as well corrosion related to general weathering of the protective coating (Courtesy of John T. Seyfried, ICA)

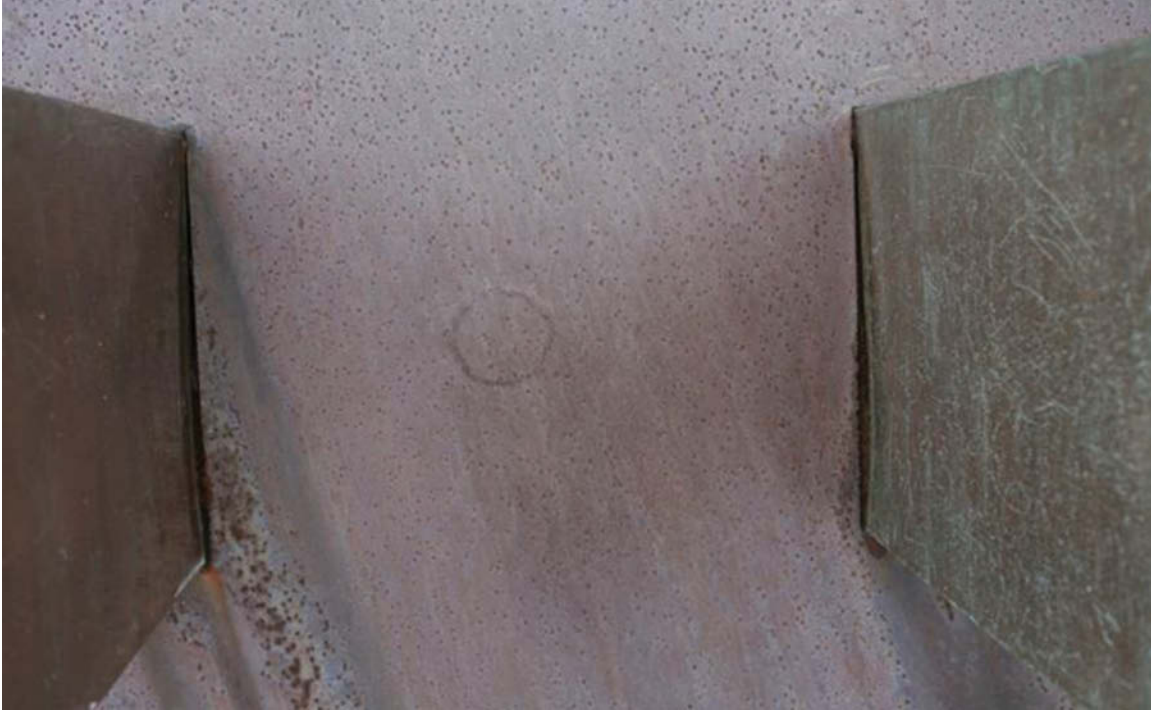
Fig. 15. Inward bowing of the bronze prongs on the Oberlin Plug due to expansion of iron corrosion products in the gap between the bronze and the COR-TEN steel (Courtesy of John T. Seyfried, ICA)

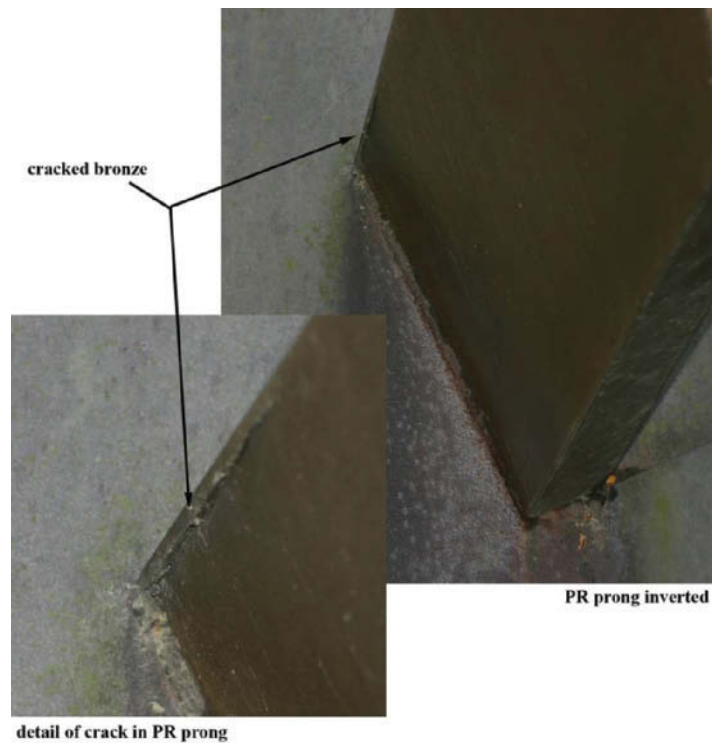
Fig. 16. Detail of expansive iron corrosion products in the gap between the bronze prongs and the COR-TEN body on the Philadelphia Plug. The pressure from the expanding rust in the gap between the bronze and the COR-TEN was so extensive that both prongs had deformed and one had cracked along its welded seams in two places. (Courtesy of Materials Conservation, Philadelphia, PA)

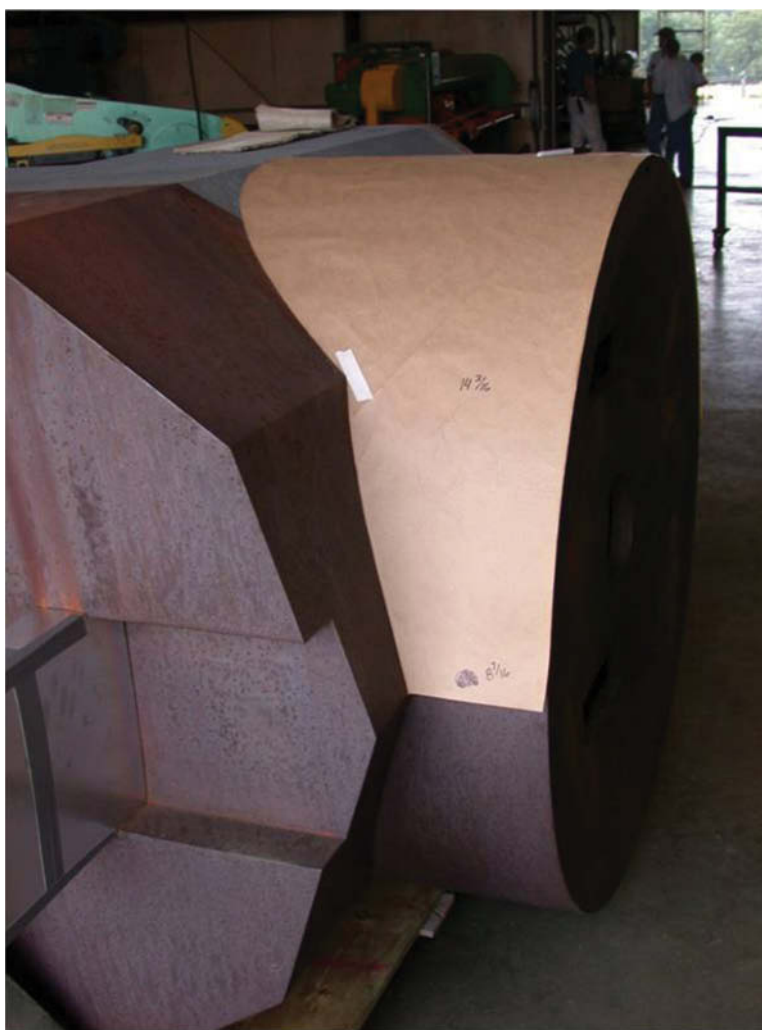
Fig. 17. The Saint Louis Plug, prior to reconstruction of the bottom half of the proper right side chamber, which had been severely compromised due to corrosion on the interior. A paper template is being made of the section to be replaced. (Courtesy of Russell-Marti Conservation Services, Inc.)

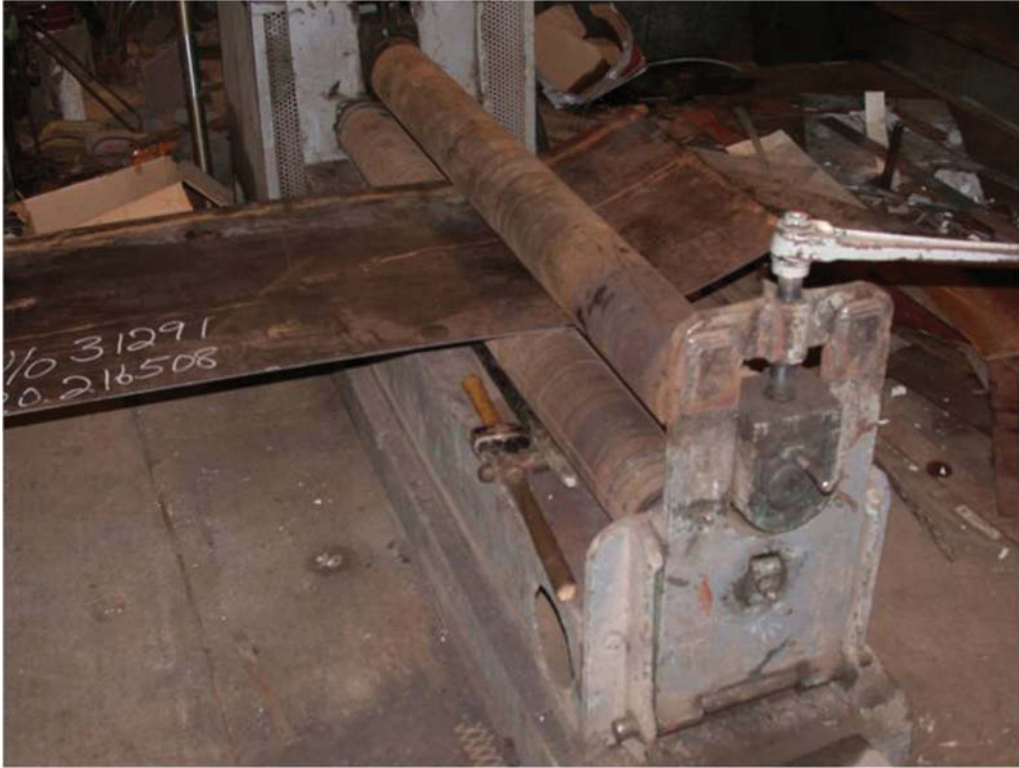
Fig. 18. Rolling the new section of COR-TEN steel to the exact curvature of the original (Courtesy of Russell-Marti Conservation Services, Inc.)

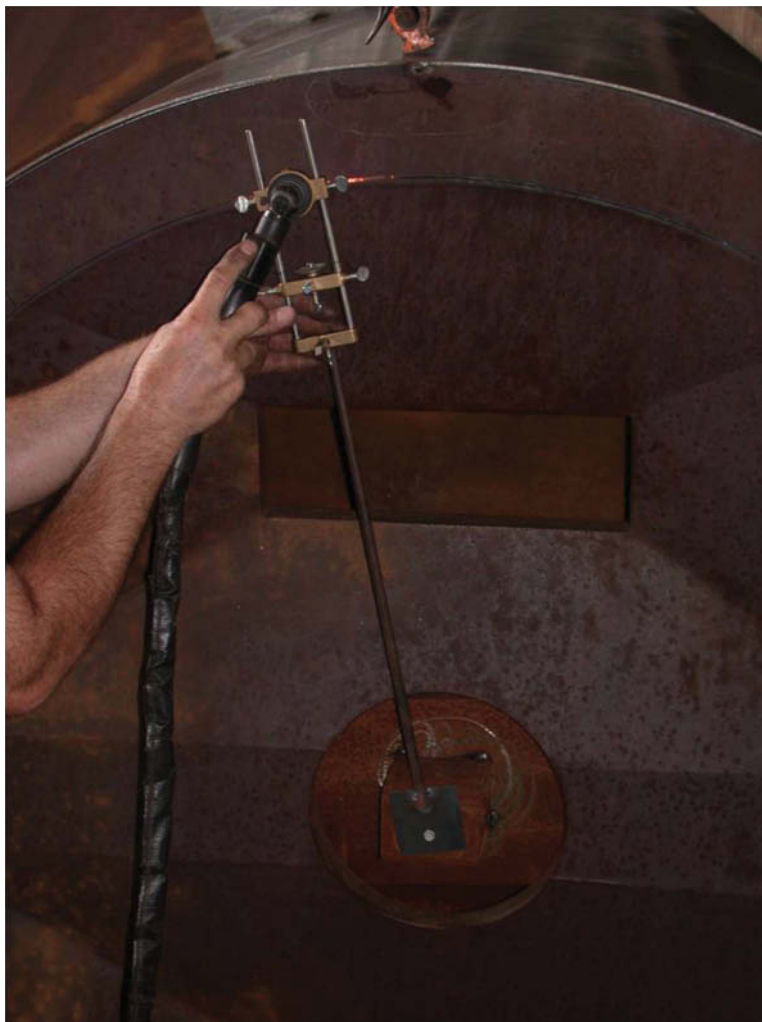
Fig. 20. Using a custom jig—a radius swing arm—to precisely cut away a degraded section of COR-TEN on the Saint Louis Plug (Courtesy of Russell-Martí Conservation Services, Inc.)

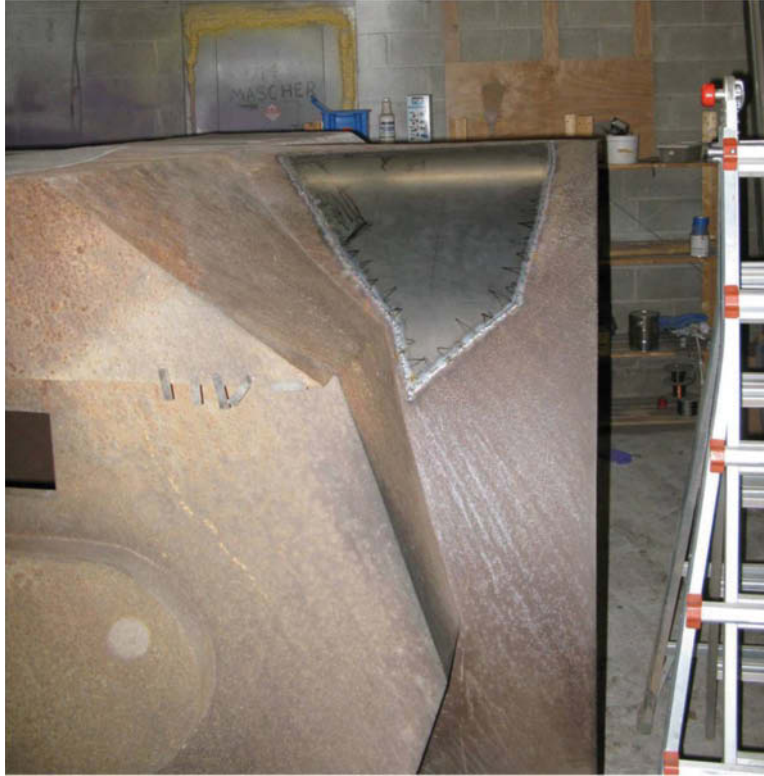
Fig. 21. The new COR-TEN patch on the Philadelphia Plug, prior to final texturing (Courtesy of Materials Conservation, Philadelphia, PA)

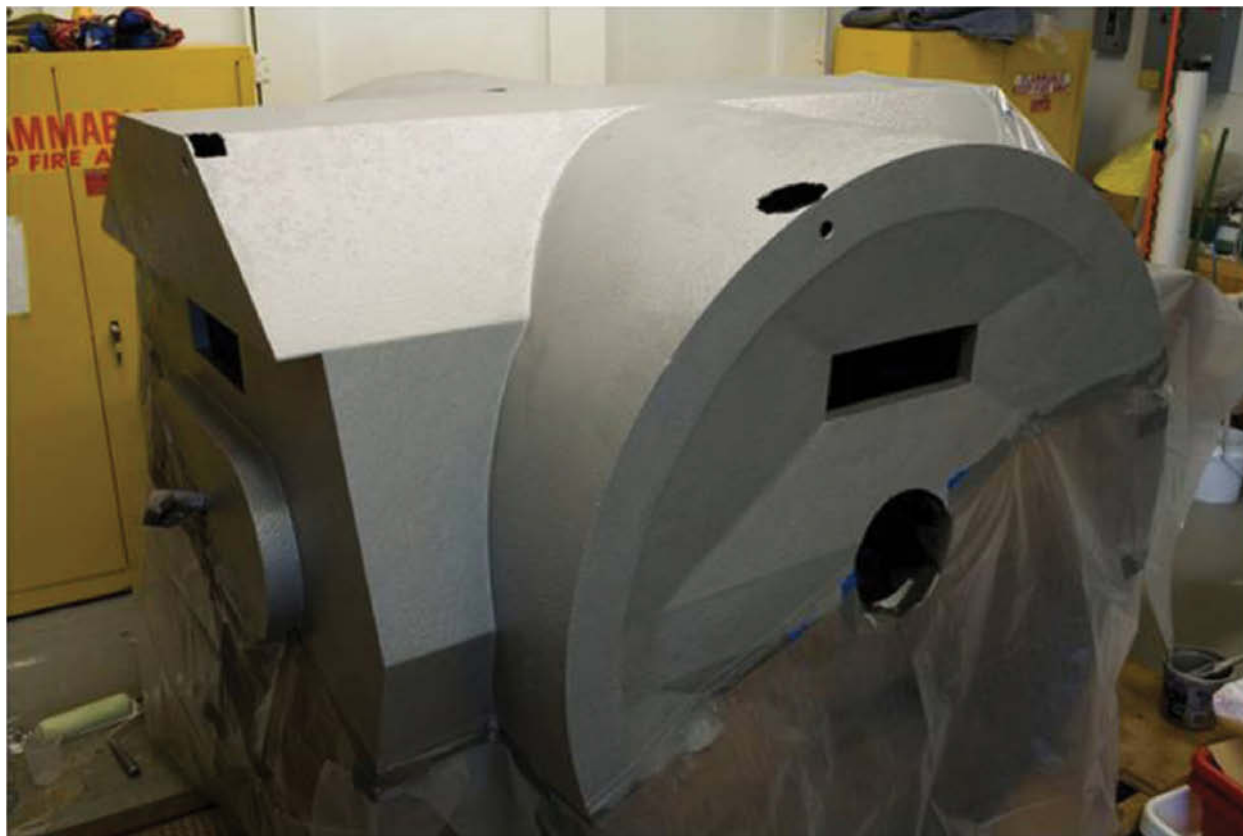
Fig. 22. The Oberlin Plug after application of the Carboline Carbomastic 15 aluminum-filled epoxy primer. The Plug is inverted in this image. (Courtesy of John T. Seyfried, ICA)

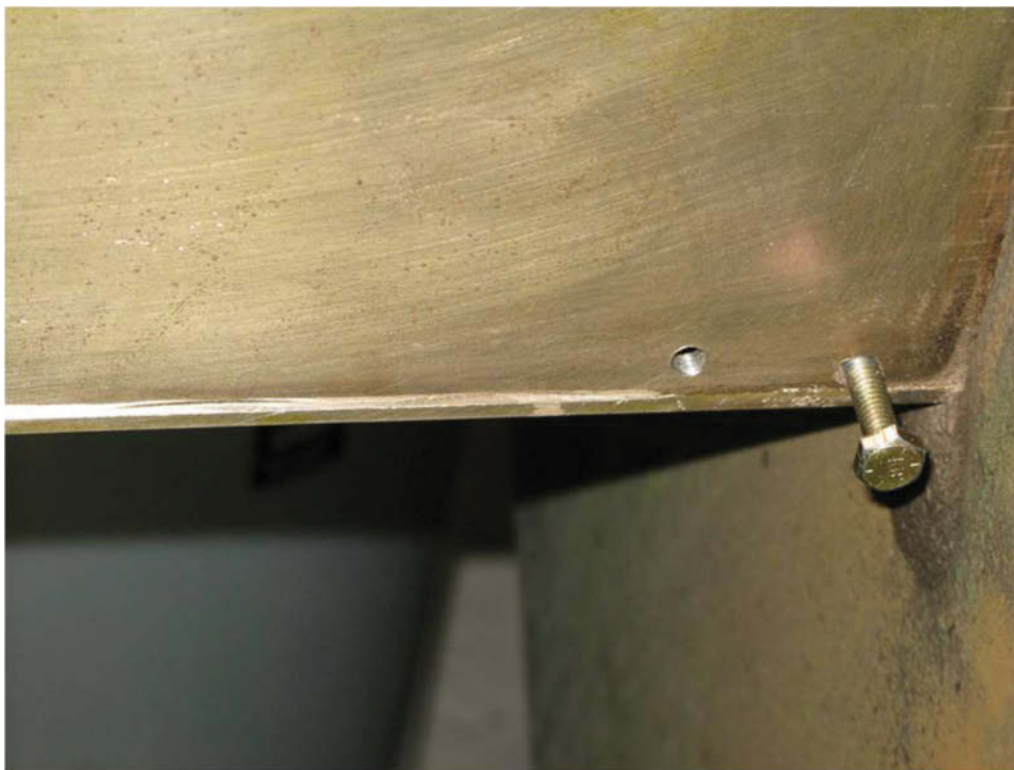
Fig. 24. Pushing the deflected side plane of the prong back into position using a threaded bolt inserted into temporary, tapped holes (Courtesy of Materials Conservation, Philadelphia, PA)

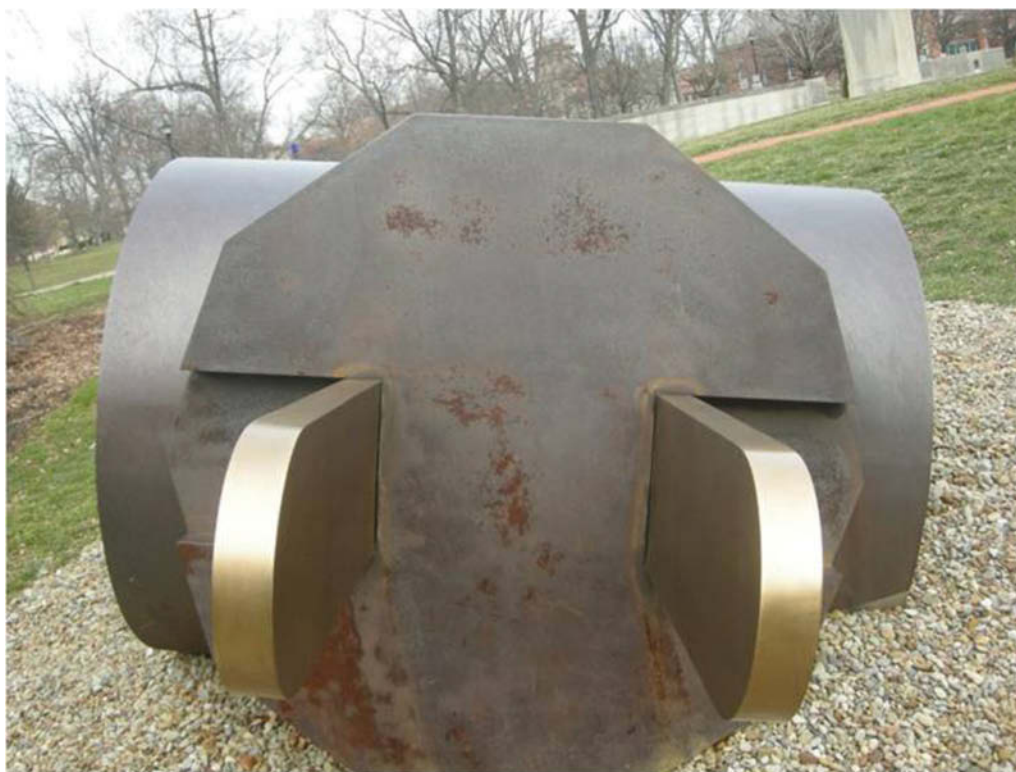
Fig. 26. The Oberlin Plug, in situ, during development of the patina on the front face of the Plug. The mottled surface is the result of contaminated blast media, which resulted in an irregular cleaning pattern. (Courtesy of Mark Erdmann, ICA)

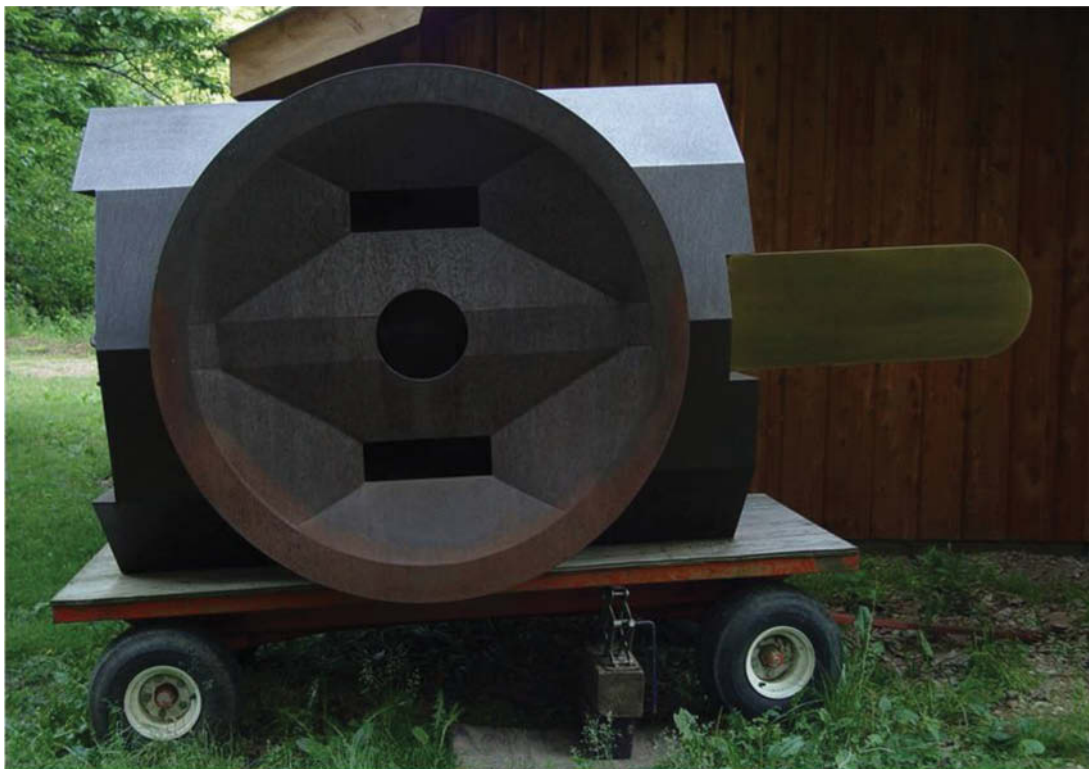
Fig. 28. The proper right face of the Saint Louis Plug, with development of the weathered patina in the areas of replaced metal and areas immediately adjacent (Courtesy of Russell-Marti Conservation Services, Inc.)

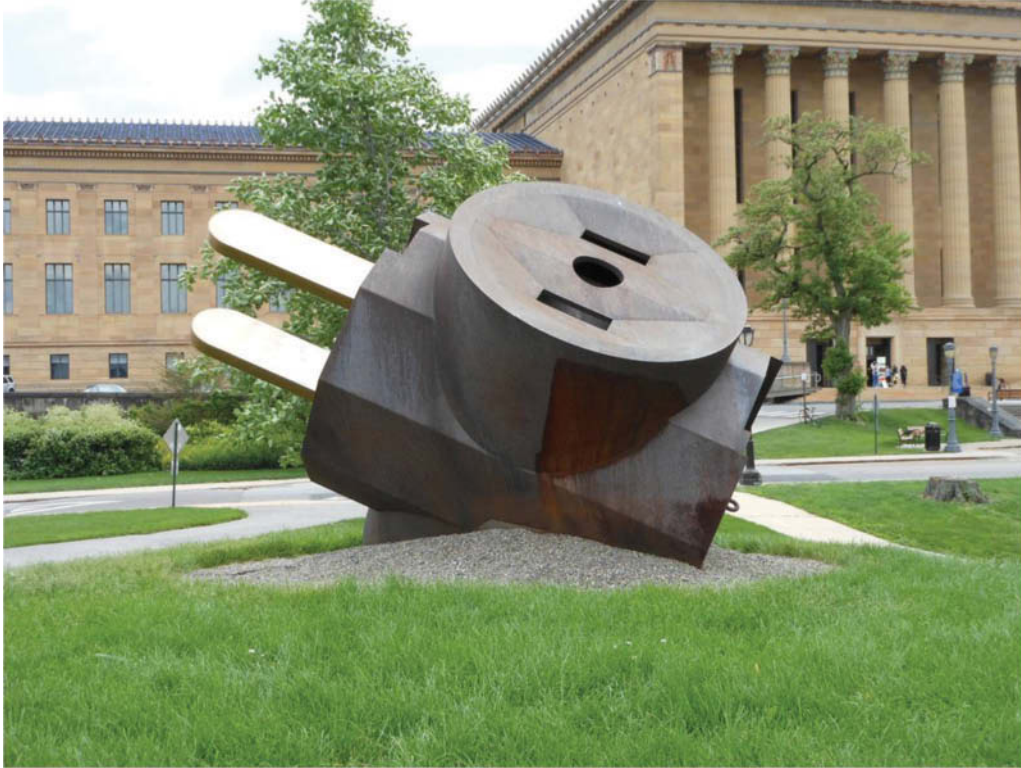
Fig. 29. Natural patina development on the new section of COR-TEN B on the Philadelphia Plug (Courtesy of Materials Conservation, Philadelphia, PA)

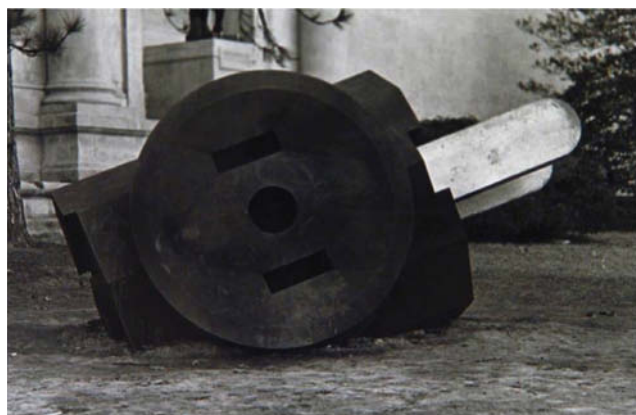
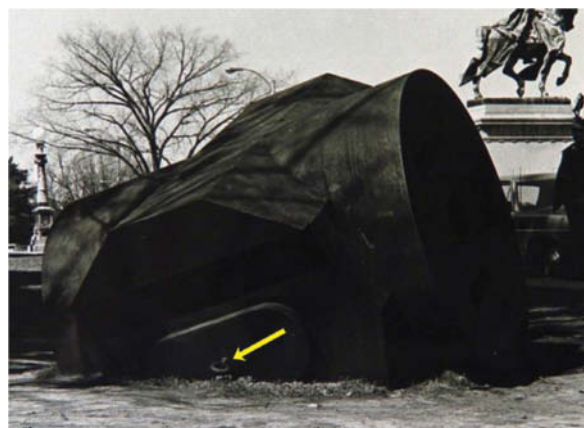
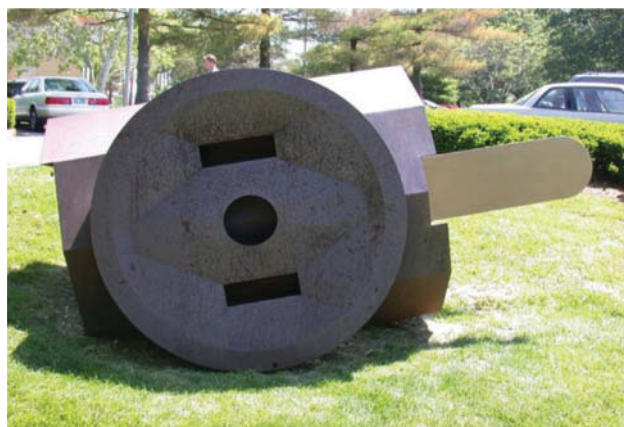
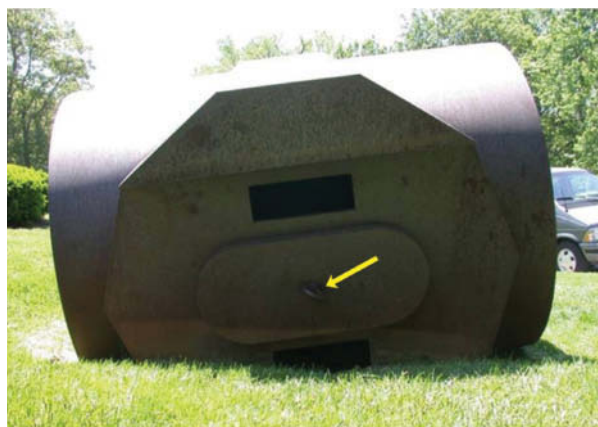
Figs. 31–34. Clockwise, from upper left: Fig. 31. Saint Louis Plug, original 1971 installation, proper right side; Fig. 32. 1971 installation, back and proper right sides; Fig. 33. Saint Louis Plug, 1982 installation, back; Fig. 34. 1982 installation, proper right side. Arrows in figs. 32 and 33 indicate eye bolt in back, as reference for comparing burial depth (Figs. 31 and 32 courtesy of the Saint Louis Art Museum, figs. 33 and 34 courtesy of Russell-Martí Conservation Services, Inc.)

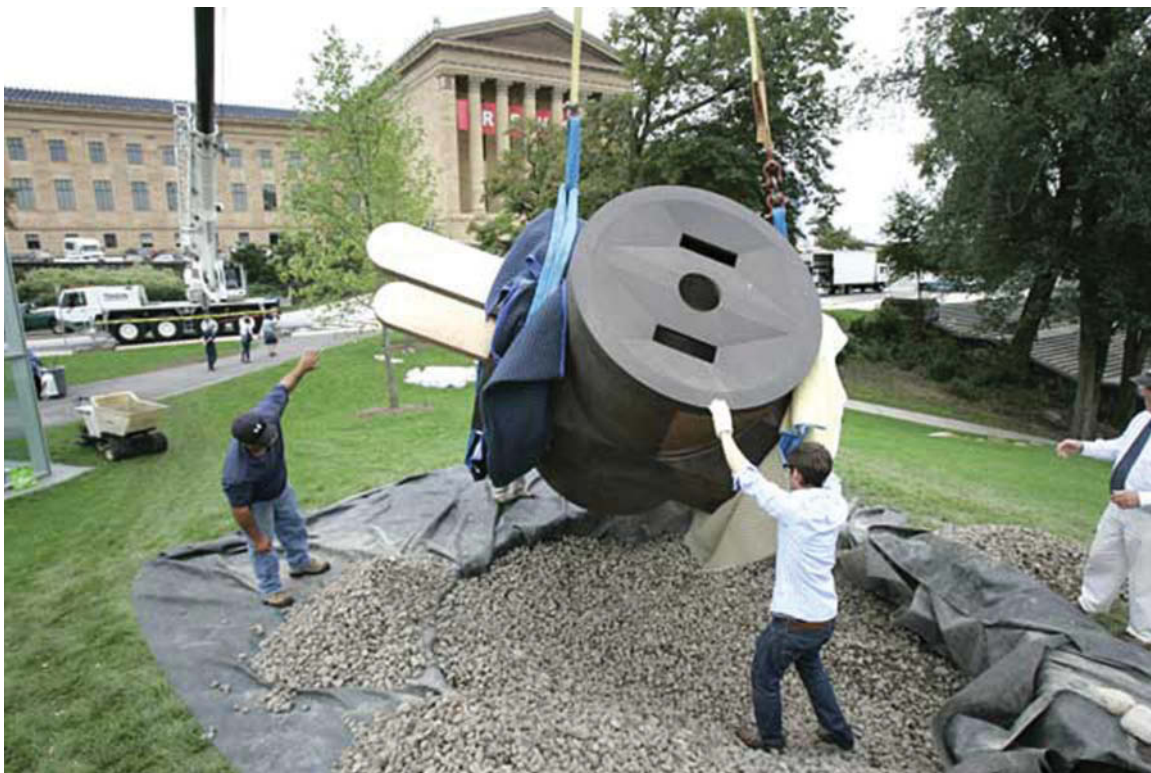
Fig. 35. Reinstallation of the Philadelphia Plug in the Anne d'Harnoncourt Memorial Sculpture Garden, Philadelphia Museum of Art (Courtesy of Materials Conservation, Philadelphia, PA)
