Source: *Objects Specialty Group Postprints, Volume Six, 1999*

AFTER THE FIRE AT THE CHURCH OF LA COMPAÑIA DE JESUS, QUITO, ECUADOR

Constance Stromberg

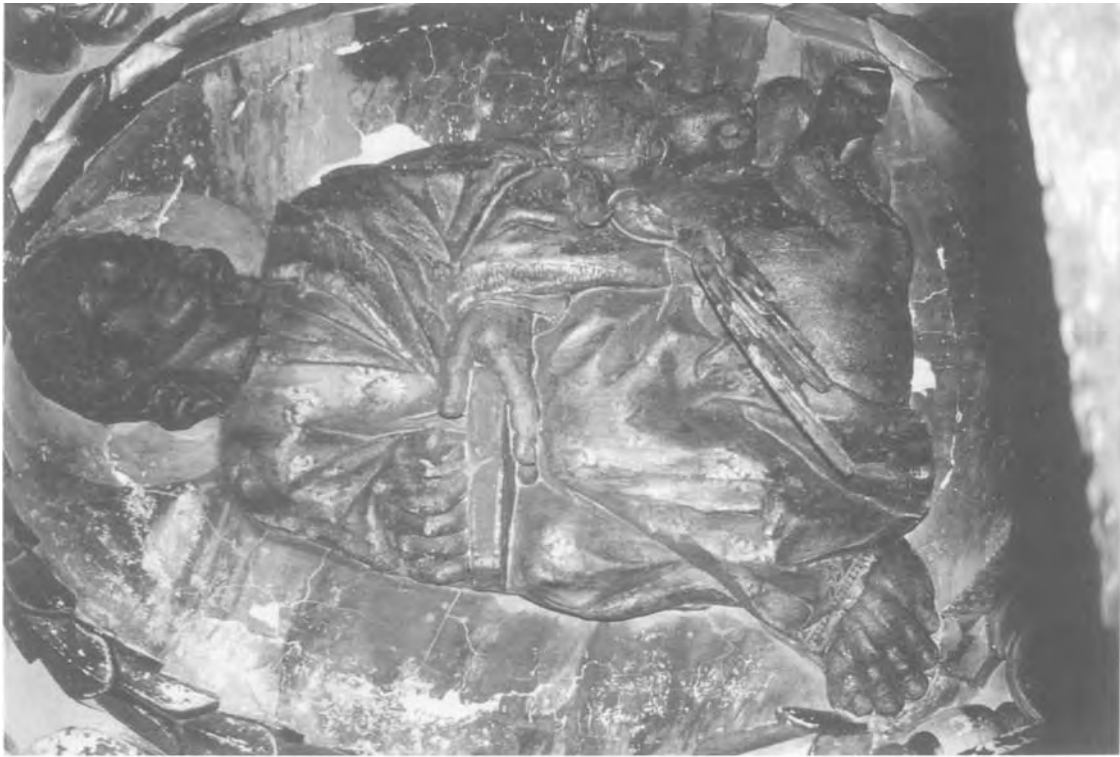
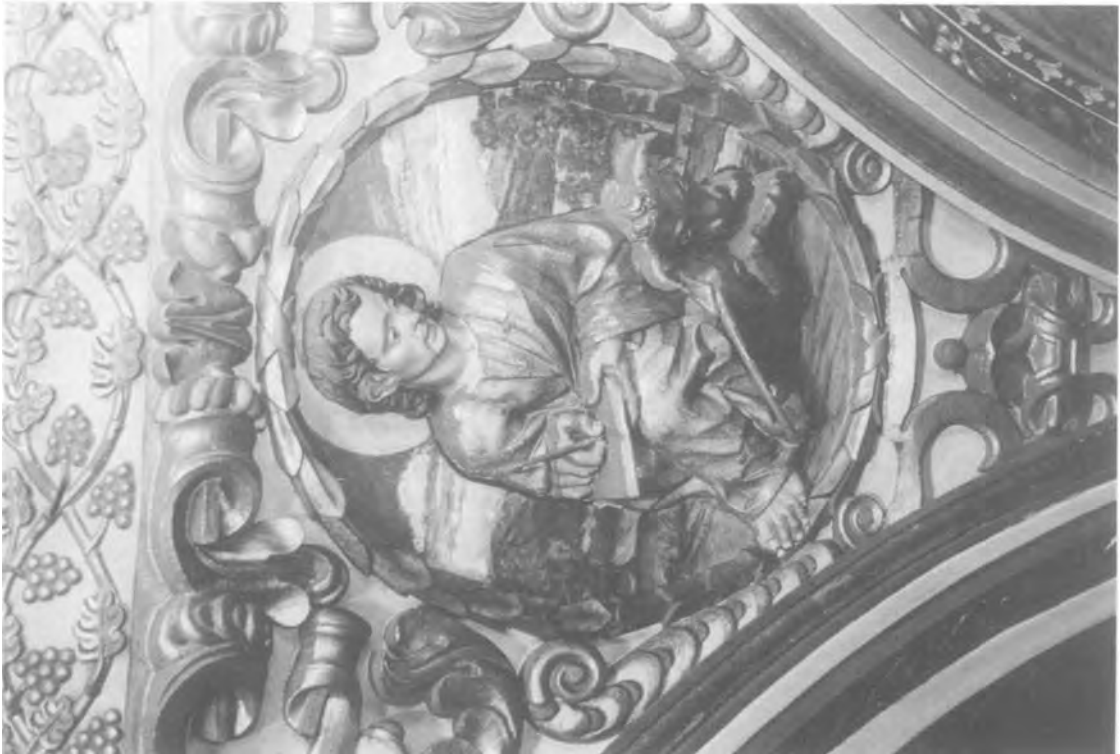
The fire was drawn into the cupola when the scaffolding boards under the four relief figures of the evangelists just below the cupola ignited. These figures were severely damaged by the intense heat given off by the burning boards. Paint and ground layers were burned away from the heads, hands and feet, and their wood surfaces were charred, but the sculptural form and the gold leafed and painted garments remained (fig. 6 and 7). Mural paintings on plaster in the cupola sustained fire and water damage. After the fire was extinguished, further problems with soluble salt crystallization occurred as the water soaked cupola dried out toward the interior of the church. Two of the archangel oil paintings on linen were lost (fig 9). The cherubs and other wooden elements burned in varying degrees of severity depending on the path of the fire as it swept through the cupola towards the windows at the top (fig. 12).

Figures 6 and 7. High relief life-size figure of the Evangelist San Lucas, before the fire on the left and after the fire on the right.

In April 1998 I was able to return and review some of the work done on the burned wood since I had left. Consolidation, cleaning and some fills were completed on the cherubs. The evangelists were surface cleaned, partially consolidated, faced, and dismantled, as was done with the cherubs. This time the challenge was greater due to their size, acute angle and attachment height. Also, the fragile estofado gold and painted layer on the garments was barely supported by the burned wood beneath. Enormous spikes holding the figures to wooden anchors embedded in the wall were cut from the back to dismantle them (fig. 16).

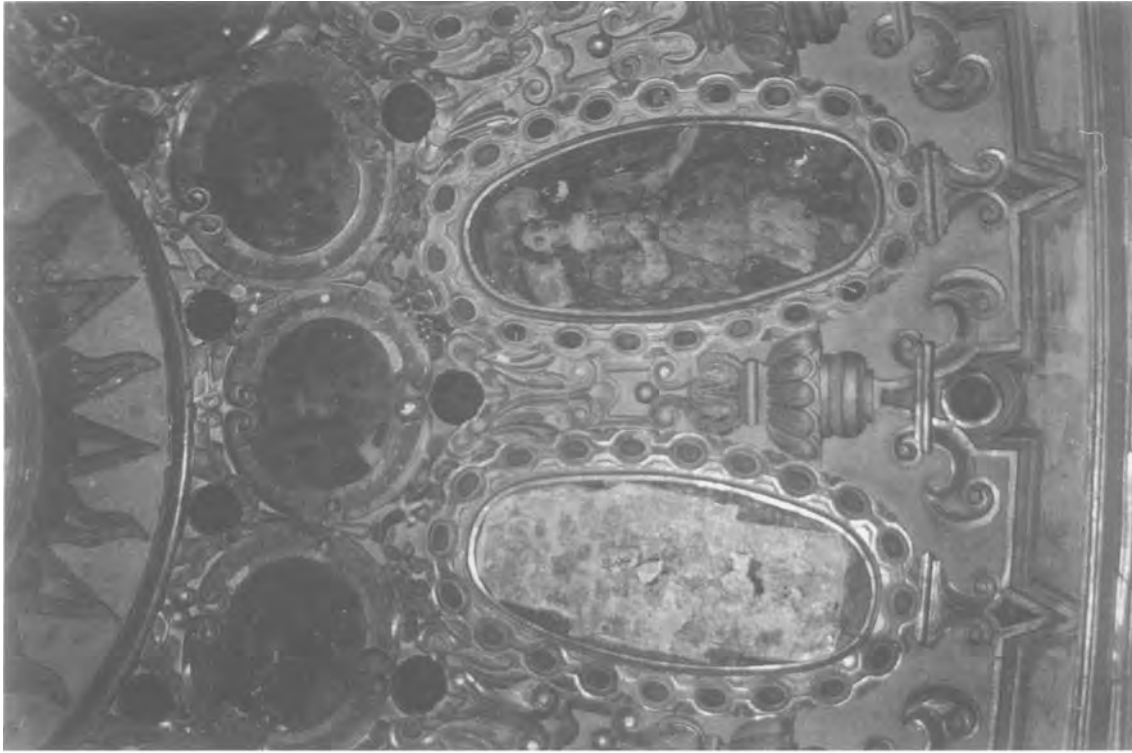
Figure 9. Burned cherub heads and lost painting on linen in the central cupola, after the fire.

We began the first phase of the conservation of the burned wood with the removal and consolidation of 37 cherub heads from the cupola. Due to the rapidly deteriorating condition of the cupola, it was not possible to do a complete technical study of the cherubs before treatment. After removal of loose carbonized material, the cherubs were faced with tissue and gauze applied with dilute polyvinyl alcohol, then dismounted by cutting the four nails holding them to the cupola wall.

The facing was mechanically removed from the cherubs in the workshop, after dampening with cotton poultices. Loose charred surfaces were removed mechanically, down to the gesso layer. Discolored but un-carbonized paint was not removed. Cherubs were consolidated with nine to 18 applications of 3% Butvar in isopropanol or ethanol (depending on availability), applied by brush and syringe. Between applications of consolidant the cherubs were kept in sealed containers, to improve penetration by slowing evaporation of the solvent. After consolidation, 10% Butvar in alcohol was injected into cracks and large fissures were filled with Grilonit epoxy bulked with glass microballoons. Chunks of carbonized wood from points of hair or noses, which had detached due to shrinkage during evaporation of the alcohol, were readhered with Acryloid B72 adhesive.

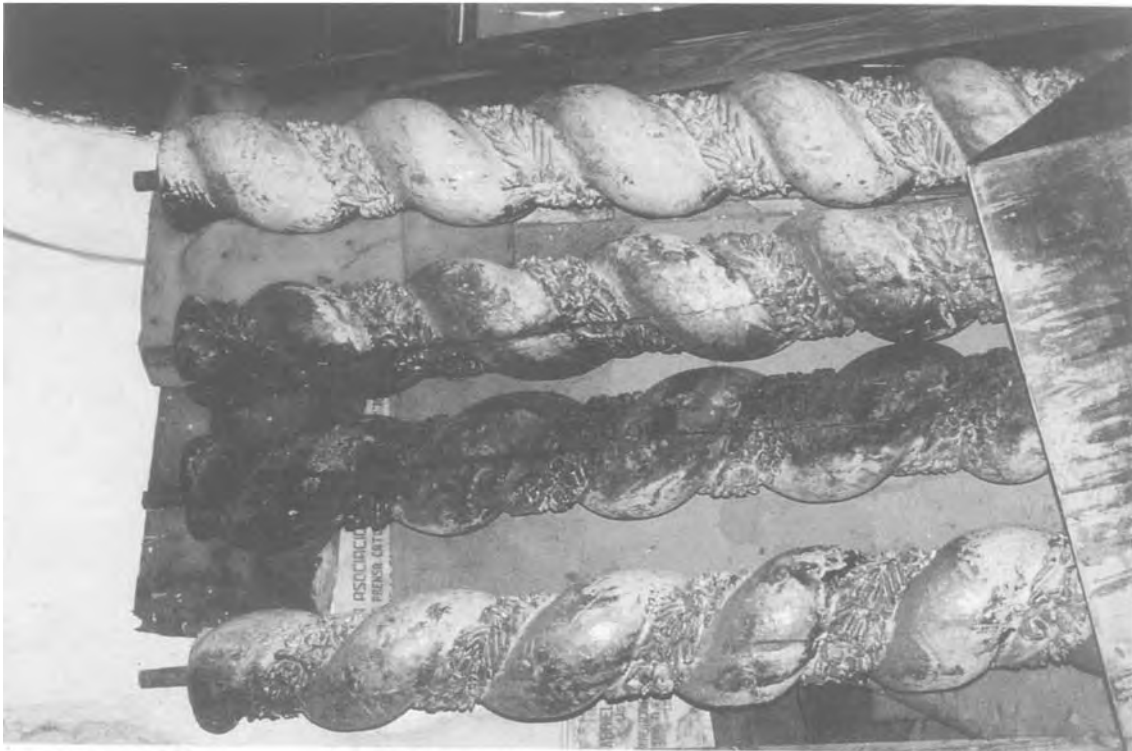
In January 1996, as the conservation of the San Francisco Xavier altarpiece neared completion, solvent fumes caught fire when an overloaded electrical outlet exploded. Fire swept up from the altarpiece into the cupola, also damaging the main altar and the arch of the transept. The fire department responded rapidly, so that only approximately 10% of the entire church was affected. Fortunately, many of the sculptures from the San Francisco Xavier *retablo* had not been reinstalled. Only one of its four columns was severely burned, but they all suffered water damage and loss of water gilding and gesso layers when the fire was extinguished (fig. 8). More than 50% of the altar sustained damage, including about 35% that was irretrievably lost. The *encarne* layers on several images in the main altar became blistered and distorted.

Figure 8. The four columns from the San Francisco Xavier altarpiece, removed after the fire.

Conservation of the San Francisco Xavier altarpiece was also completed. The infrastructure of the heavily burned midsection was rebuilt to support conserved and re-carved panels, which were remounted after treatment. Soot was removed from gold leafed carved panels with turpentine. Butvar B98 in alcohol was used to consolidate salvageable burned sections, with the addition of pinholes made down to normal substrate. This facilitated penetration and insured a stronger bond between the carbonized and undamaged wood beneath. For gap filling and gesso materials, PVA emulsion mixed with glass microballoons was used, and epoxy bulked with microballoons was used to fill large losses.

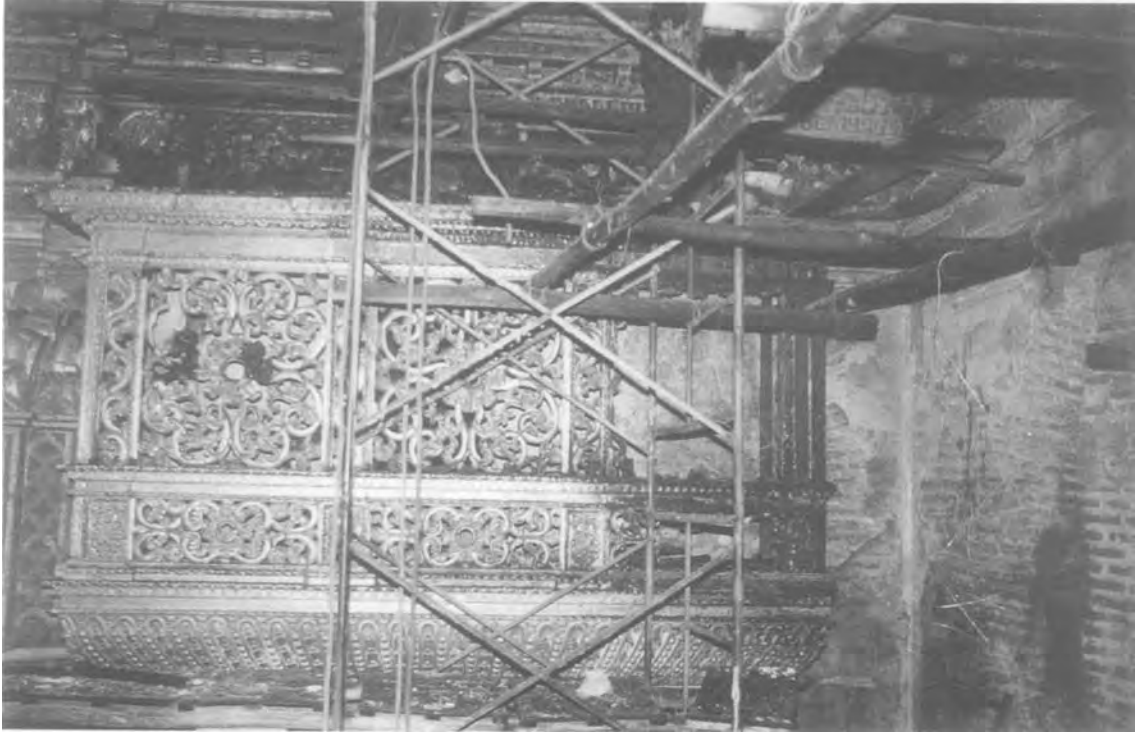
Figure 10. Partially burned gilded panels in the San Francisco Xavier altarpiece.

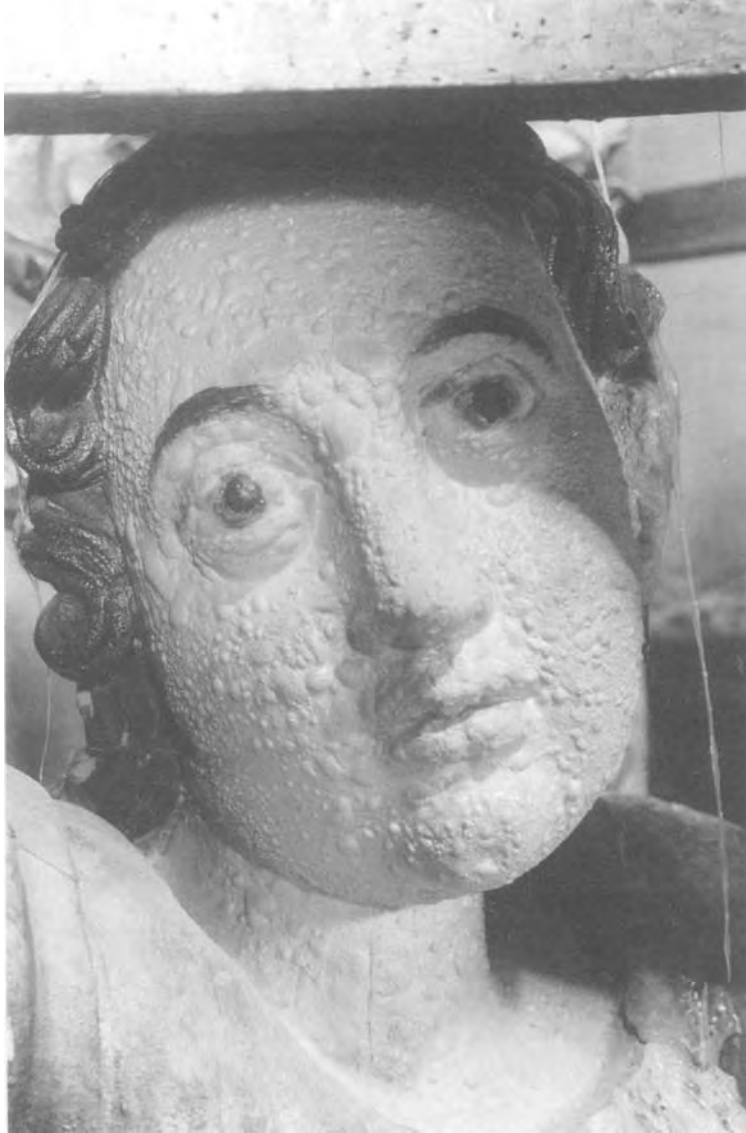
Figure 11. Blistered encarna on polychromed figure of an angel in the main altar.

Bubbled paint was treated on some of the main altar images soon after the fire (fig. 11). Blisters were poulticed with cotton soaked in dilute animal glue, which was also injected under the bubbles. A heated spatula was used to reform blisters after facing with tissue.

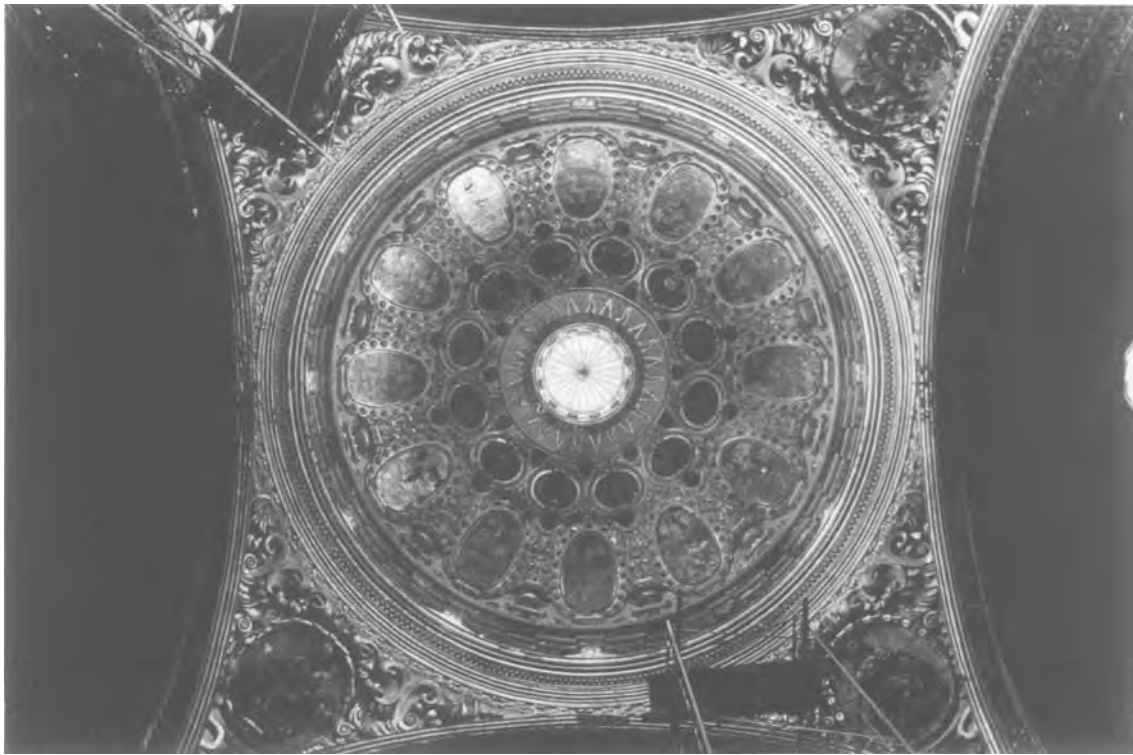
Figure 12. Central cupola, evangelist figures and scaffolding, seen from the ground after the fire.

Conservation of the interior of the cupola after the fire began with the rebuilding of the huge work platform at its base. From the platform we could see and feel tiny particles of spalling paint and plaster raining down on us, as the crystallizing salts pushed off surfaces of the mural paintings and painted plaster. These exfoliating surfaces had to be immediately stabilized. Conservation of the mural paintings and plaster moldings in the cupola are outside the scope of this article (see Rogers 1980 and Schwartzbaum 1985). It is important to note here that the crystallizing salt problem had to be mitigated by facing and consolidating the spalling mural paintings before soot removal, making it much more difficult to remove soot after consolidation. Other problems included: removal of degraded PVA consolidant (Borden Polico 2153) used on murals and painted decoration before the fire; removal of soot and burned Acryloid B72 surface coating; drying and stabilization of the cupola walls; and treatment of burned polychrome sculptures (fig. 12).

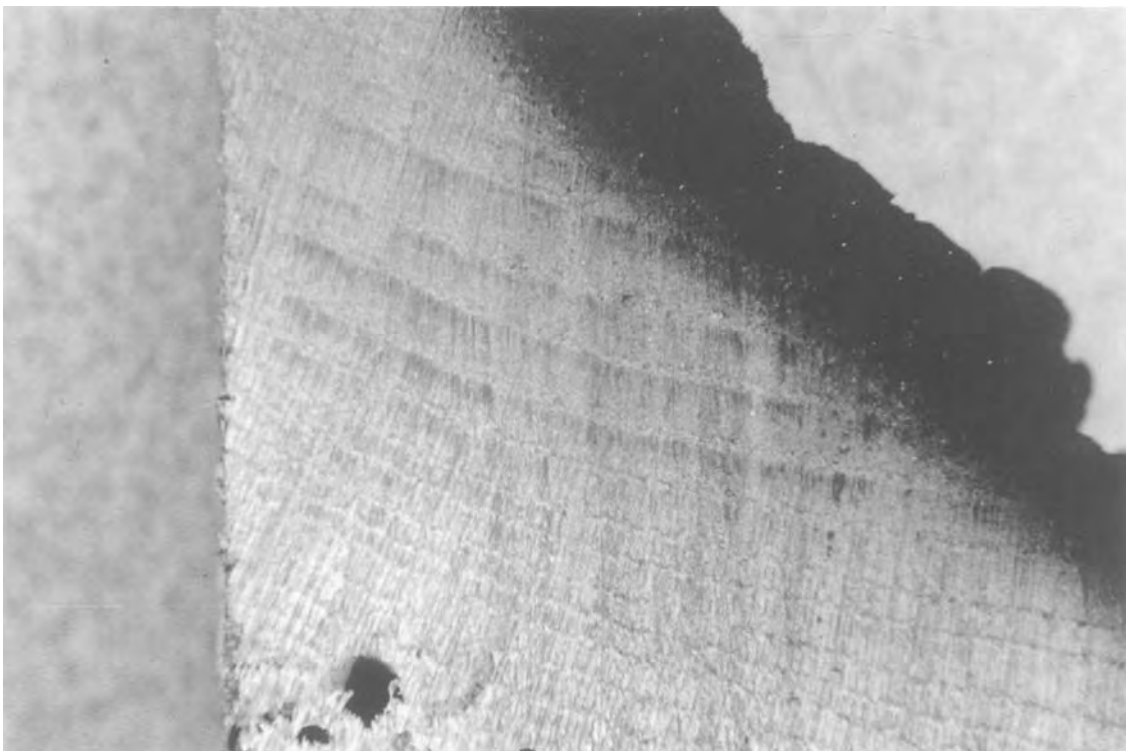
Consolidant penetration through fragile char layers, down to the interface with sound wood was necessary. Figure 13 shows a cross-section of one of the burned red cedar samples, illustrating the thin boundary between burned and sound wood as well as cross-grain fissures that commonly form in the weak char layer (Zicherman 1981). Worm-eaten red cedar samples were included to observe resin penetration more readily and to look for treatment alternatives for the ongoing problem of insect damage in the church.

Figure 13. Cross section of a cedar sample showing the border between the char and sound wood.

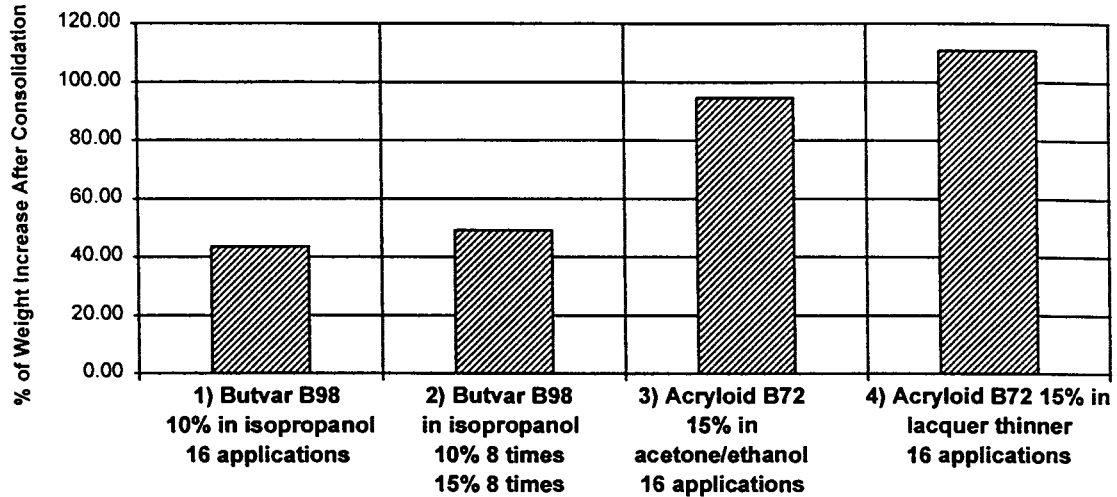
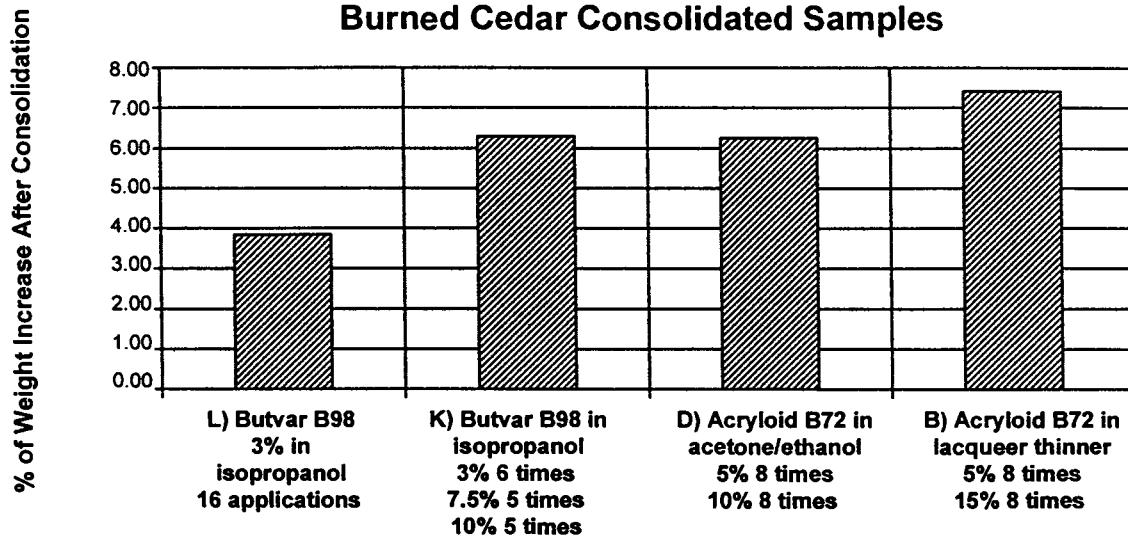
Charts 1 and 2 show the different resin concentrations and the weight gains of samples consolidated with Butvar B98 and Acryloid B72 in burned and worm-eaten cedar (fig 14). Samples with Acryloid B72 in thinner gained more weight in both cases, partly because of better resin penetration, due to lower viscosity and slower solvent evaporation. The worm-eaten samples gained between 40 and 110% of their weight due to their tunneled structures. Burned samples became from 3.3 to 7.4% heavier, since the carbonization only penetrates about 3-6 millimeters and there is nonporous, sound wood beneath.

Figure 14. Charts 1 and 2 show the difference in weight gain between samples consolidated with Acryloid B72 and Butvar B98.

Consolidation with both resins in different solvent combinations appeared to have penetrated through the char layer in the samples, to the interface with sound wood, when each piece was sliced through to assess depth of penetration. However, results were inconclusive in the burned samples, due to the presence of Acryloid B72 consolidant applied just before the fire. In our empirical strength measurements the Butvar B98 samples were harder and more resistant to thumbnail scratches than the Acryloid B72 samples. After seeing the higher strength and lighter weight of the Butvar B98, best illustrated by handling the sponge-like worm-eaten samples, the team was convinced it was the better option for treatment of sculptures mounted at acute angles in the church. However, Acryloid B72 appears to achieve better penetration than Butvar B98 and may be suitable for burned wood consolidation in other situations.

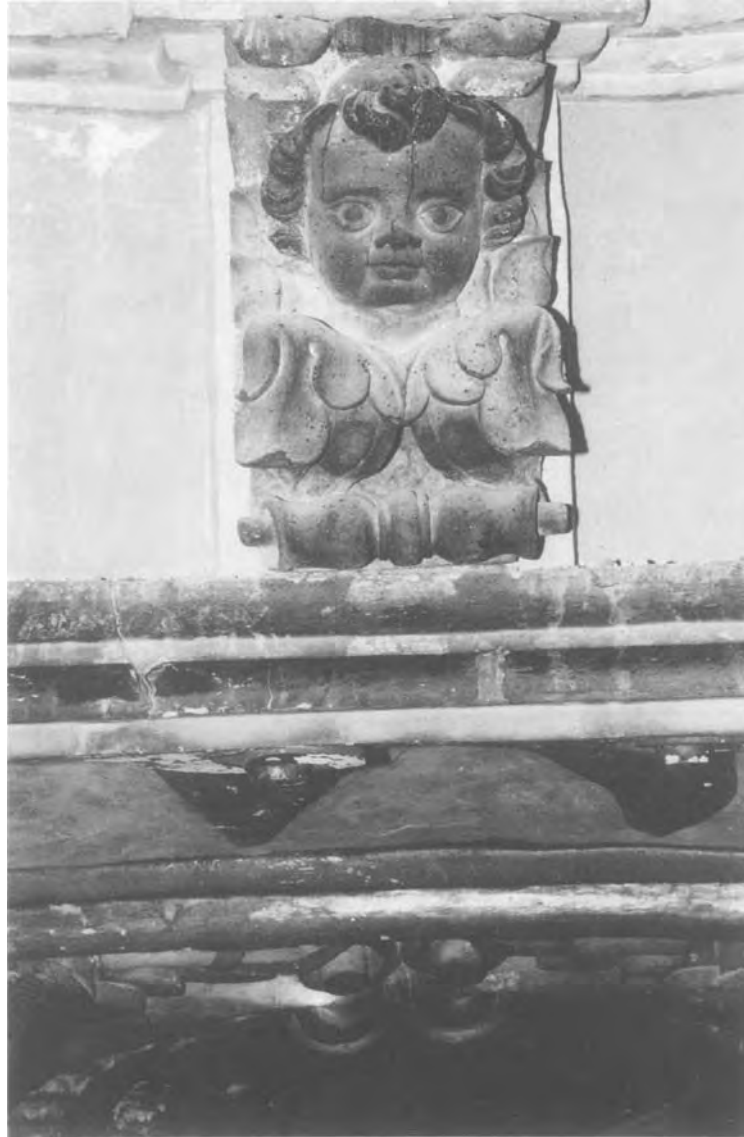
The highest row of 12 cherubs, called *estipites*, were more badly damaged due to previous insect attack (fig. 15). Fire penetrated these figures more easily, through the network of exit holes left by the borers. Since they were vertically attached, we could partially consolidate them in situ, with eight to ten applications of 3% Butvar B98 in alcohol, before their removal. They were consolidated further in the workshop with approximately ten applications of 10% Butvar B98 in alcohol. Overpaint was mechanically removed from the wings, revealing gilded scrollwork. Unfortunately, I had to leave Ecuador in June 1997, before the project was completed.

Figure 15. One of the estipites at the highest level, in the linterna above the cupola after the fire.

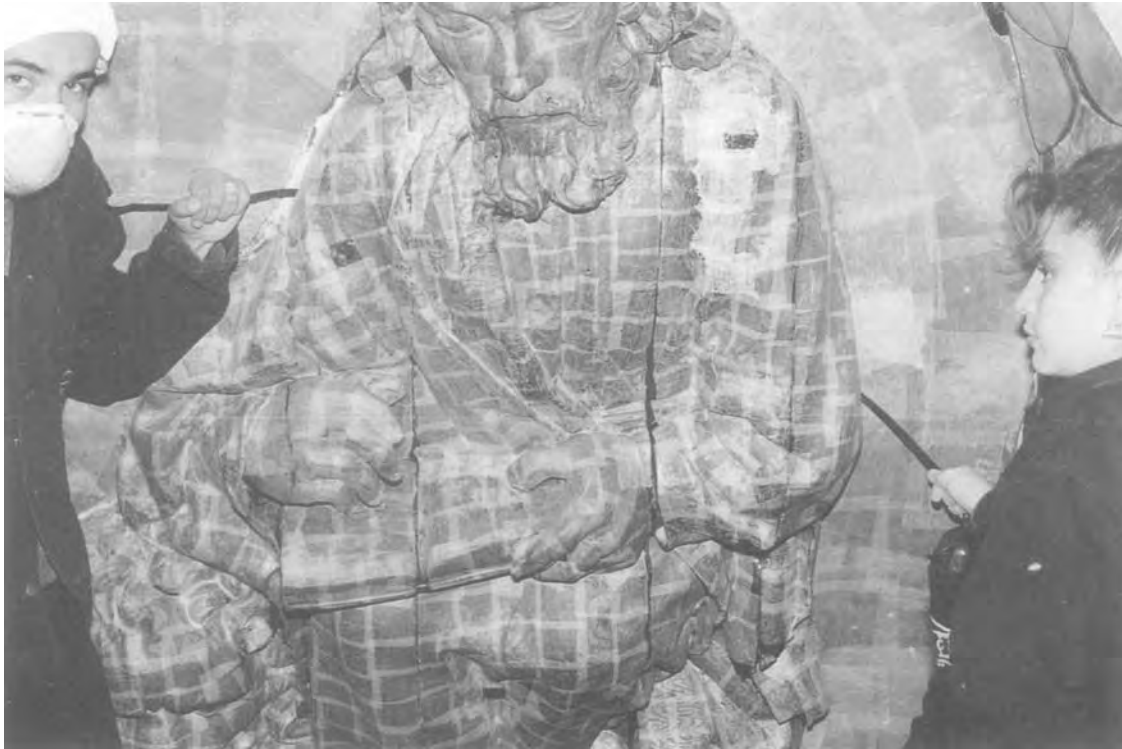
Figure 16. Dismounting of an Evangelist figure after partial cleaning, consolidation and facing.
