Article: Restoring the M.R. 1750 public clock: History, analysis, experimentation, and re-creation

Author(s): Steven W. Dykstra, Donald Saff, and Lee W. Badger Source: *Objects Specialty Group Postprints, Volume Thirteen, 2006*

# RESTORING THE M.R. 1750 PUBLIC CLOCK: HISTORY, ANALYSIS, EXPERIMENTAION AND RE-CREATION

Steven W. Dykstra, Donald Saff and Lee W. Badger

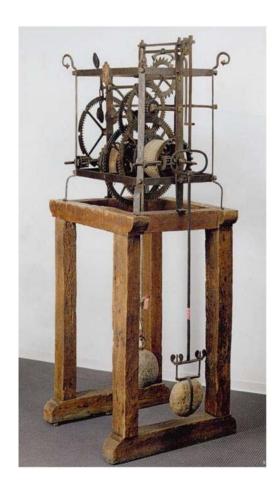
Figure 3. The *M.R.* 1750 clock before treatment, as it appeared at the time of its acquisition.

After the acquisition of the *M.R.* 1750 clock, it became obvious that crucial parts were either missing or altered, and experimental test operation of the clock revealed gross time-keeping dysfunction. Missing parts included an hour strike release arm, the entire quarter-hour strike assembly, a weight to drive the strike train and several less functionally critical fittings; a winding crank, a frame brace and several spacers and washers. Horological analysis of the clock's operation included direct observation of its mechanical operation and the introduction of

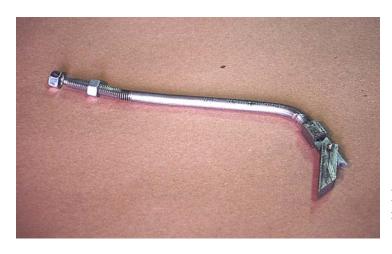
The hour strike release arm was missing from the existing hour strike release arbor. In full operation, this arm would be lifted each hour, rotating the arbor to release the hour counting and striking portion of the clock. A hole in this arbor indicated the location of this arm whose alignment demonstrated that it should be lifted by a pin on the time barrel great wheel.

The absence of a separate warning strike and hour count release system in the *M.R.* 1750 clock required an hour strike release arm that would not dwell on the down (waning) side of the hour lift pin after reaching its apogee. If the arm remained elevated in the release position, the hour count wheel would continue to allow the counting of subsequent hours beyond the one marked at the apogee of the hour lift pin. To obviate this problem, the hour strike release arm would need an articulated foot. This drop-foot device is occasionally found in Dutch striking clocks and is called a "goat's foot," or "nag's head." Once the lever reaches the highpoint of the pin, the goat's foot drops and the lever immediately falls rather than remaining elevated in the release position while riding down the backside of the pin. All lengths and angles of the missing arm were determined by extensive prototyping and testing, resulting in the development of a precisely functional prototype hour strike release arm (Fig.4).

Figure 4. The prototype hour strike release arm.

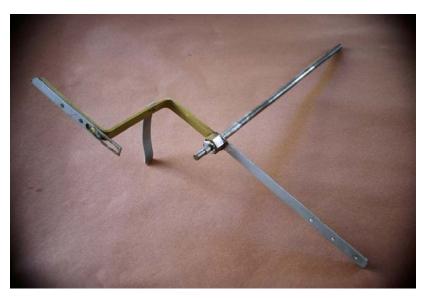
The quarter-hour strike lever was the most complicated piece missing from the clock. It needed to be lifted by a pin on the great wheel in the time train portion of the clock, rotate on an arbor mounted above the hour strike assembly on the strike train portion of the clock and incorporate a quarter-strike hammer pull. In addition, it would need a feature to prevent it from falling too far into the time train where it could miss being lifted by pins on the great wheel on their upward arc.

Furthermore, the combined quarter-strike and hour warning function would require the lift-arm portion of the lever to be released from the lift pin precisely for accurately timed striking by the hammer pull. This would be accomplished by the traditional method of forming the ends of lift arms with reverse bevels, providing a sharp and sharpenable point at its critical tip. Again, the lengths, bends, shapes and angles of the missing arm were determined by extensive prototyping and testing, resulting in the development of a precisely functional prototype quarter-hour strike release arm (Fig. 5).

Figure 5. The prototype quarter-hour strike lever.

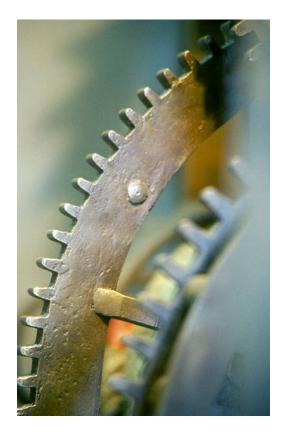
Close inspection of the great wheel and its four pins revealed that the back of one pin, where it was peened over its point of insertion through wheel, was somewhat larger and rounder than the others, and more significantly, marked with a small dimpled punch mark (Fig. 6). These differences in this pin were taken to identify it as the original hour lift pin to be extended to functional length.

Figure 6. The back of one of four pins on the hour wheel showing a punch mark indicating it as the likely hour lift pin.

The first step in restoring the *M.R.* 1750 clock was to add the length to the hour-lift pin that was removed in the past, as described in section 2.1.3, above. The length and diameter of the pin extension was determined by measurements taken in-situ from the prototype lever arms and the existing pin, and a piece of mild steel was cut and ground to the appropriate dimensions. The extension piece was welded to the existing pin using a MIG welder.

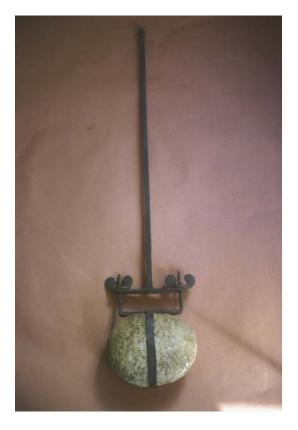
Observation of the mechanical features, configuration and operation of the clock's time train indicated that the time barrel and great wheel needed to travel one revolution per hour. On test, it traveled at a rate of almost two revolutions per hour. The error proved to be the product of a

pendulum that had been significantly reduced in length. Although some similar clocks may have been casually displayed without their awkwardly long pendulums, the *M.R.* 1750 clock has a stone pendulum weight, unique and unusual in its shape, support and method of attachment to the pendulum rod (Fig. 7). When the clock was removed from service, it was likely placed in a

Figure 7. Detail of the weight end of the existing shortened pendulum showing the unique weight stone and wing nut assembly for fine adjustment of pendulum length.

A contemporary weld in the pendulum rod was readily discernable, indicating the location where a length of original rod was removed and the pieces rejoined in a convenient shortening. The operationally functional pendulum length was calculated by multiplying the wheel teeth and dividing by the number of pinion trundles using the principles and the mathematical formula relating the period of a pendulum to its length and the acceleration of gravity, as applied by Huygens in the 17<sup>th</sup> c (Rawlings 1948). The amount of time it takes for a pendulum to go back and forth once, its period, is related only to the length of the pendulum and the acceleration of gravity. Since gravity is considered to be constant at any given spot on the planet, the length of the pendulum is the only thing that affects its period. Neither the weight of the pendulum nor the length of its arc of swing have any consequence in this calculation. The re-computed pendulum length was tested by attaching temporary improvised extensions to the pendulum rod. After the clock was made to keep accurate time by these provisional methods, a clear specification could be made for correcting the length of the shortened pendulum rod.

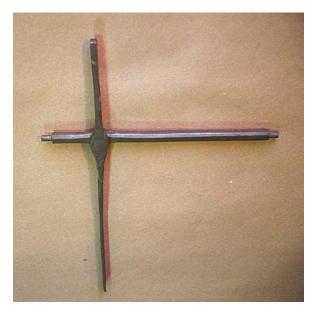
Figure 9. The existing hour strike lever showing characteristics of form and manufacture to be matched in a re-created quarter-hour strike lever.

Restoration treatment required re-creation of the entire quarter hour strike assembly including bearing brackets for attachment to the clock frame, an arbor bar and lever arms. The prototype quarter hour strike assembly provided a model for dimensions and configuration while the existing hour strike assembly (Fig. 9) served as an example to illustrate the characteristics of materials and manufacture necessary to avoid a mismatched or anachronistic appearance.

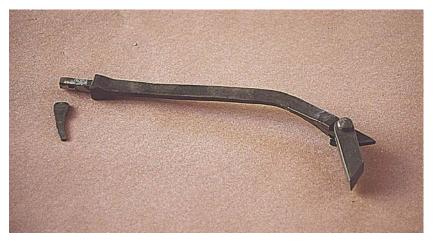
Figure 11. The re-created hour strike release arm.

The dimensions and configuration of the prototype hour strike release arm permitted little speculation on the original characteristics of its manufacture. The individual features of the mortised wedge attachment to the existing arbor bar were also easily apparent in wear patterns at the attachment point. The resulting re-created arm was also easy to fit and adjust by simple methods (Fig. 11).

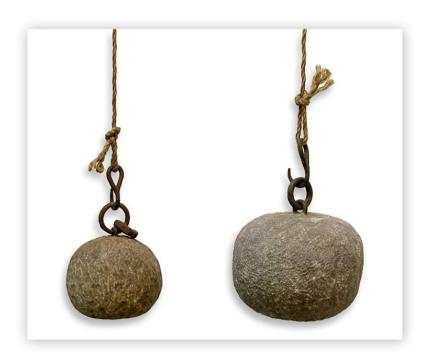
Figure 12. The existing granite time train weight (right), and the re-created strike train weight (left), sculpted from limestone, textured and colored to match.

The absence of a weight to drive the strike train posed a separate set of problems for restoration treatment. For clocks in this category, stone weights were not uncommon, and matching granite spheres or cylinders were the normal types. However, the force required to drive a strike train commonly differs from the force required by a time train. In the *M.R. 1750* clock the existing time train weight is a granite sphere, and it is likely that the strike train would also have a matching weight of a different size. Horological experimentation described in section 2.3 above indicated the mass necessary to drive the strike train, and the established treatment goals required a re-created weight of the proper mass and appearance. Practical problems in identifying the particular type and source of granite used for the existing weight led to consideration of alternative types of stone. Limestone was chosen to re-create the missing weight because it is easily worked and accepts a wide variety of color and texture finishes. Additionally, an artificially colored and textured limestone weight is in keeping with the treatment goals to avoid falsification or confusion between original and re-created parts. The resulting strike train

weight accurately suggests the appearance of an original weight without deceptive imitation (Fig. 12).

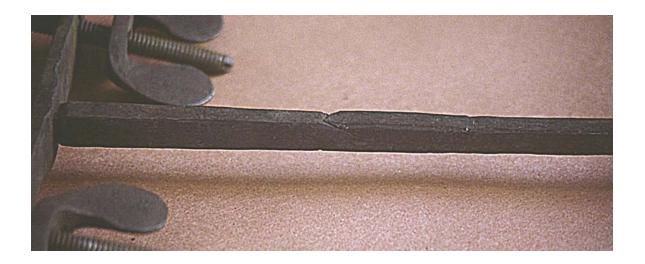
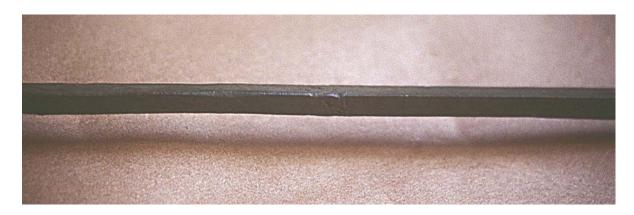
After determination of the correct pendulum length, described in section 2.2 above, inspection of the pendulum rod showed one forge weld consistent with 17<sup>th</sup> or 18<sup>th</sup> century manufacture and one electric arc weld (Fig. 13). Electric arc welding came into practical industrial use in about 1920 and became widely available for common metal fabrication purposes in the 1950's. Therefore, the newer weld marked the location where a section of the original pendulum rod was removed and the cut ends re-joined, sometime in the 20th c.

Figure 13. Existing welds on the pendulum rod: An older forge weld (top) and a 20<sup>th</sup> Century electric arc weld (bottom).

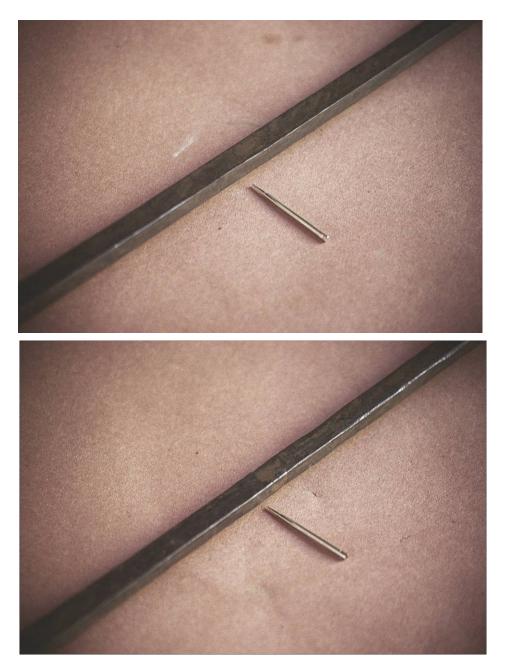
Figure 14. Locations of new welds showing the points where a section of re-created pendulum bar was inserted to restore the pendulum to proper operating length.

In order to lengthen the rod, a matching extension piece was created and the rod was cut at the newer welded point. The extension piece was inserted at the cut with two new welds. Again, the welds were accomplished using Stargon CS and .035" (0.9mm) diameter MIG welding wire conforming to ASME SFA-5.18, with welder settings adjusted to achieve a small quick weld of minimum size and heat. To create the appearance of a continuous original pendulum rod, the new MIG welds were heated with a propane torch and hammered on an anvil to alter their surface texture and to form them more closely to the dimensions of the existing and replacement sections of the pendulum rod. Additional draw filing by hand was necessary for final adjustment of surface texture before patination. The finishing and patination treatment of the extension welds yielded excellent results, unnoticeable to the casual observer (Fig.14).

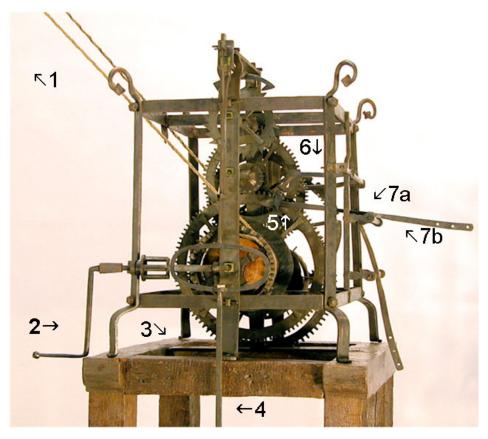
Figure 15. The *M.R.* 1750 clock after treatment. Arrows indicate locations of: 1. Re-created strike train weight; 2. Re-created winding crank; 3. Re-created stand brace and center support; 4. Restored pendulum; 5. Restored hour lift pin; 6. Re-created hour strike release arm; 7a. Recreated quarter hour release assembly - brackets and arbor bar; 7b. Recreated quarter hour release assembly - quarter strike lift arm and hammer pull.

Because the *M.R.* 1750 clock could be installed in a Saff Collection space allowing the pendulum to swing freely over the edge of a split-level floor, the existing stand was modified for re-use by disassembling it and re-fitting its pieces with dowels and lag screws for additional strength and stabilization. The project blacksmith provided a horizontal forged steel cross brace

for the stand, fabricated and patinated to match the clock frame's center support and support foot. The Saff Collection space also allowed for overhead pulleys and adequate lengths of rope to be wound on the time and strike barrels providing the necessary drop length for functional operation of the clock's weights. The project blacksmith also designed and fabricated a compatible crank to fit both barrel's rewinding shafts. The terminus of the crank handle was forged to match finials on the clock's frame indicating the dedicated function of the crank as a necessary accessory particular to this specific clock. The functionally restored clock has historically correct operation consistent with its likely configuration in 1750, and its operation is the subject of continued demonstration, adjustment and testing within the representational and research purposes of the Saff Collection (Fig. 15). In periods of operation during the first year of its demonstration in the Saff Collection, *M.R. 1750* has proved to be a reliable and dependable, easily adjusted and maintained clock, never stopping due to friction or design deficiencies, striking accurately without missed or miscounted, premature or delayed strikes, and demonstrating timekeeping accuracy within the 2 min./week expectation for well-functioning clocks of its historical period and type.
