Article: WORK IN PROGRESS: AN ANALYSIS OF THE EFFECT OF WATER ON  
THE CRACKING OF ALBUMEN PHOTOGRAPHS

Author(s): Paul Messier

*Topics in Photographic Preservation, Volume 4.*

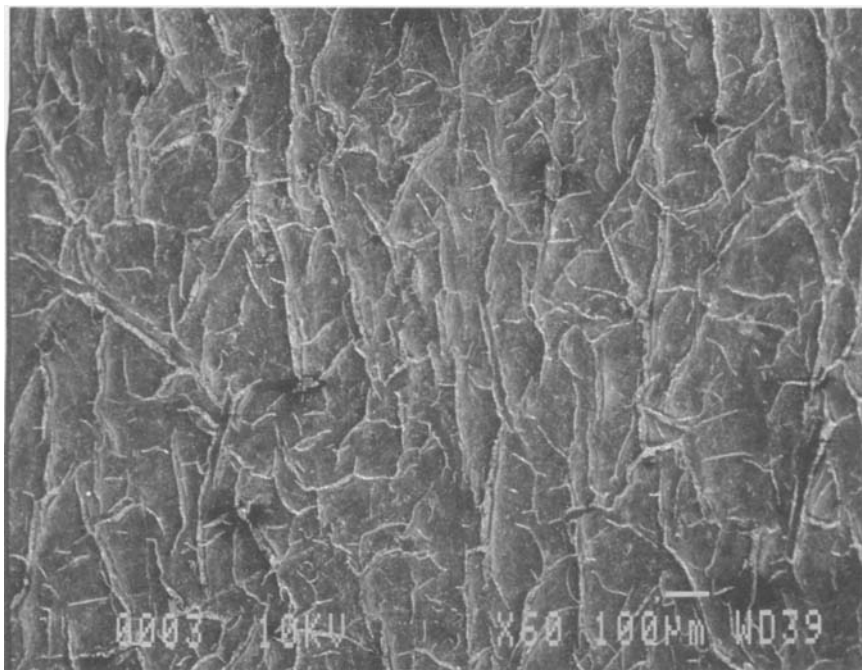
**Fig.1 ALBUMEN PRINT, C.1870, CONTROL, 60X**

Untreated albumen print from circa 1870. The white pattern visible in the scanning electron microphotograph is the existing crack network.

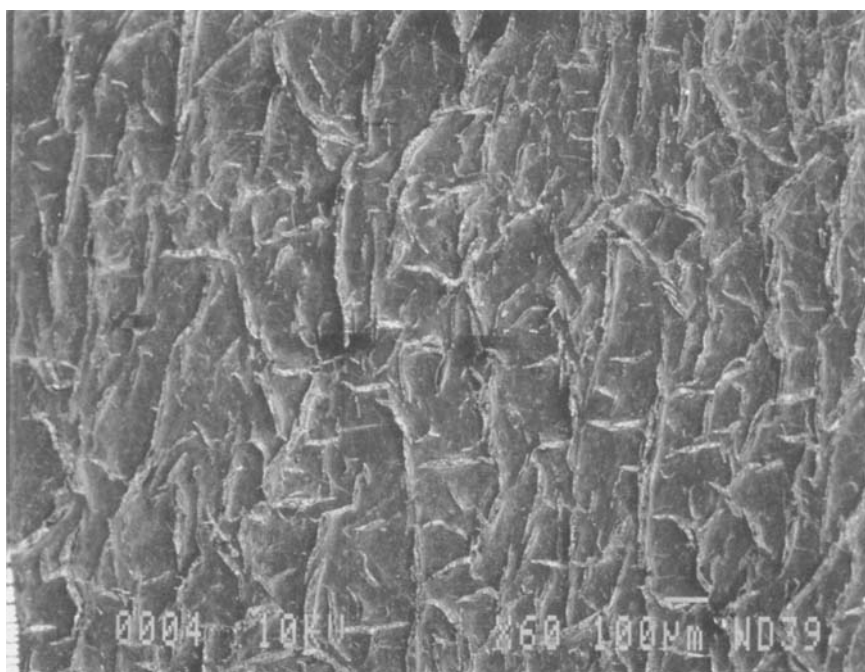
**Fig.2 ALBUMEN PRINT, C.1870, WASHED, 60X**

Another sample from the same circa 1870 albumen print. This sample has been immersed in water for one hour and then dried. Compared to the control sample at the top of the page, the cracks appear longer and wider.

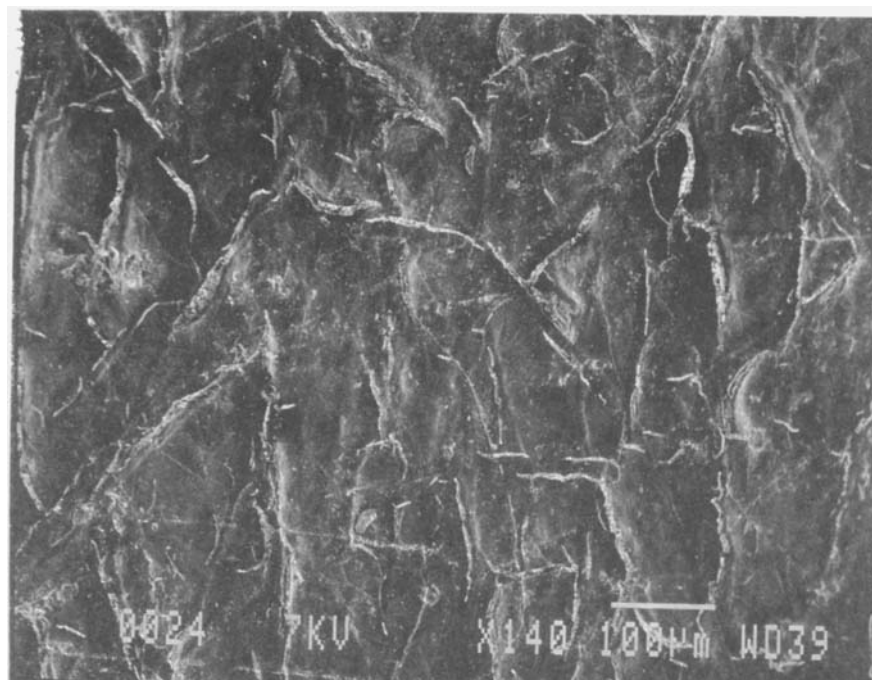
**Fig.3 ALBUMEN PRINT, C.1870, CONTROL, 140X**

A different albumen print with a pre-existing crack network. Before treatment.

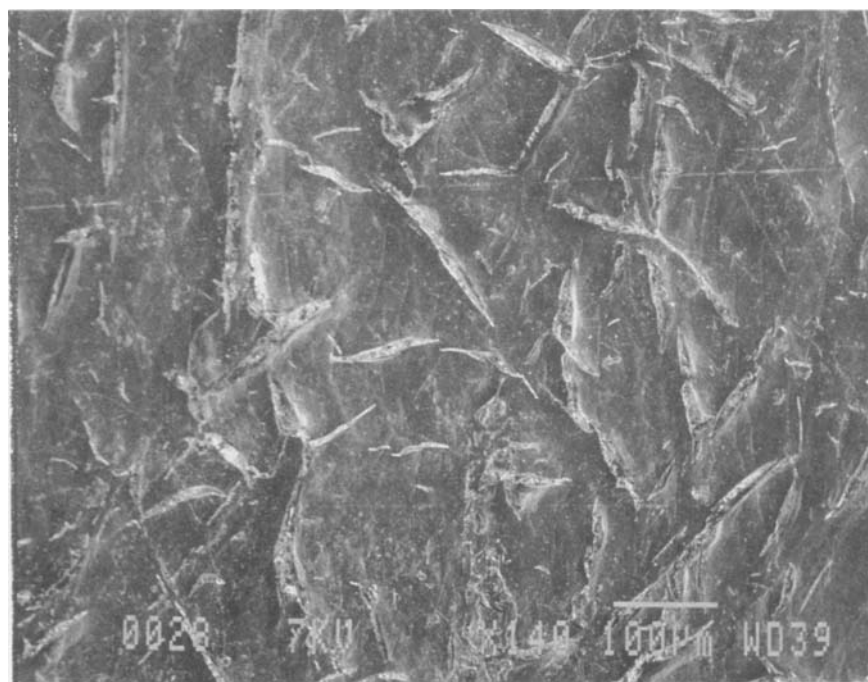
**Fig.4 ALBUMEN PRINT, C.1870, WASHED, 140X**

A sample from the albumen print shown at the top of the page. Again, the existing crack network has opened after washing.

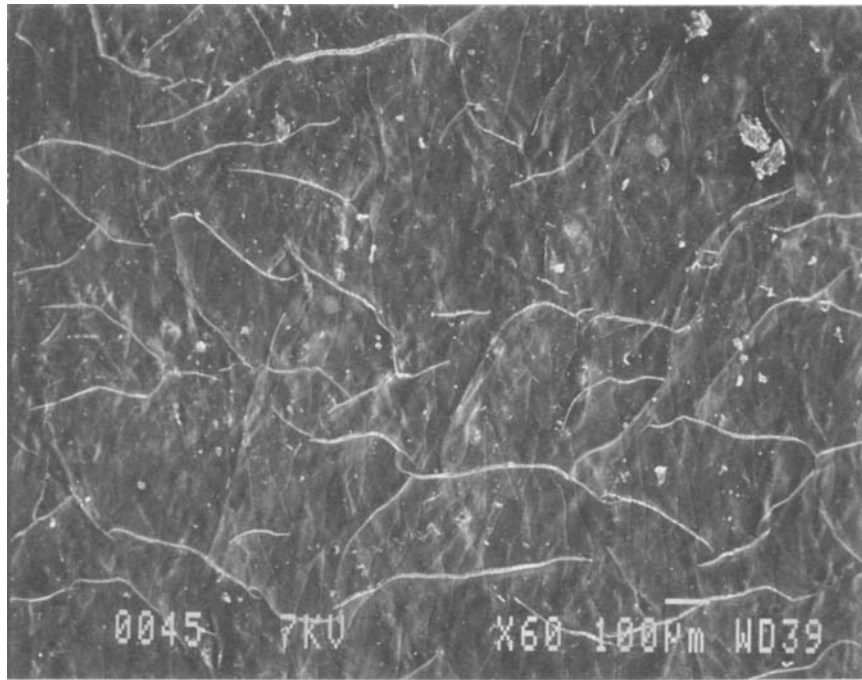
**Fig.5 ALBUMEN PRINT, 1989, CONTROL, 60X**

This modern albumen print already has a fine network of cracks.

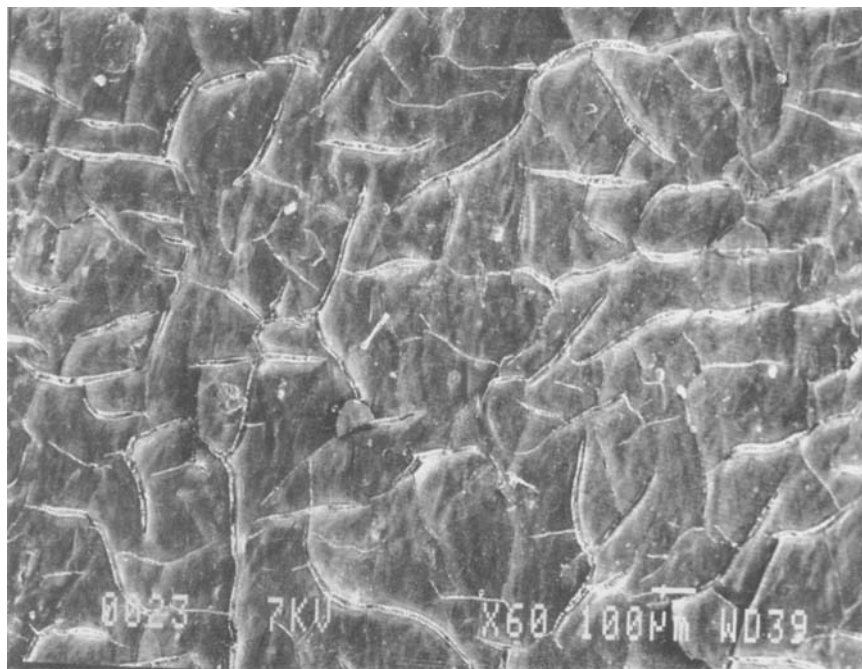
**Fig.6 ALBUMEN PRINT, 1989, WASHED, 60X**

A sample from the same modern albumen print at the top of the page. After washing, the fine crack network is significantly altered. New cracks are formed. Pre-existing cracks are wider and longer.

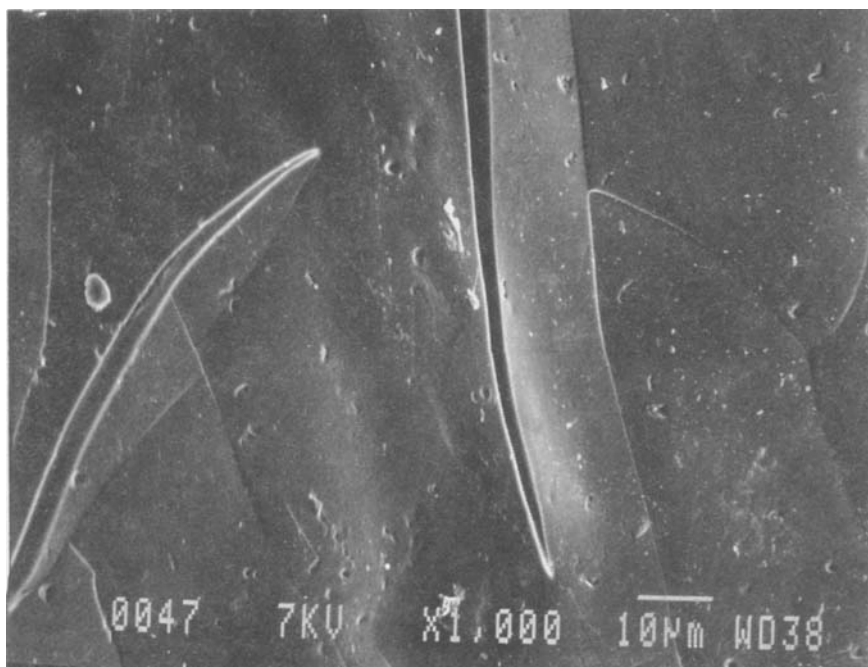
**Fig.7 ALBUMEN PRINT, 1989, CONTROL, 1,000X**

An example of the fine cracks present in this modern albumen print before treatment. The cracks are narrow and sharp. The surface of the albumen is relatively smooth and in plane.

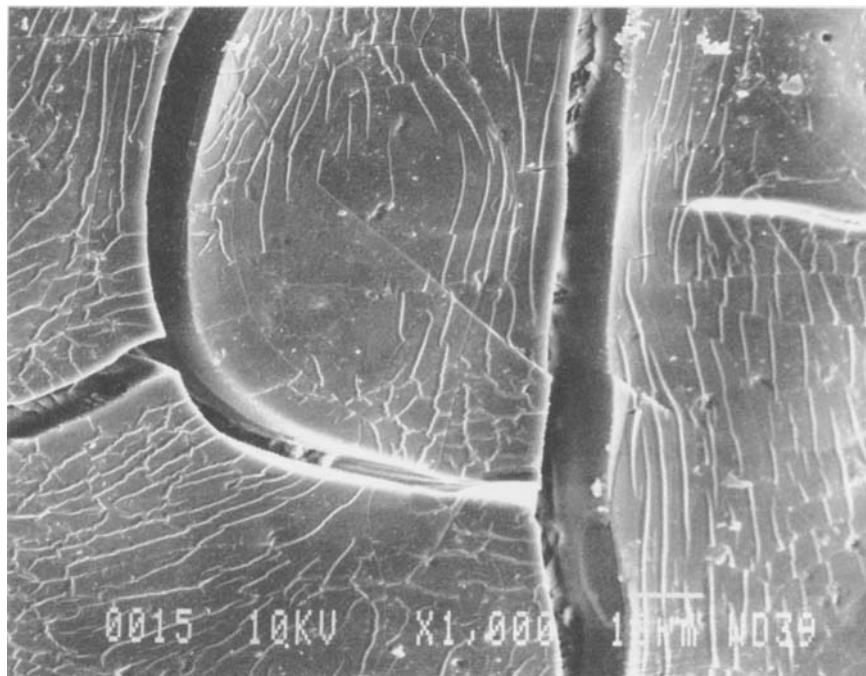
**Fig.8 ALBUMEN PRINT, 1989, WASHED, 1,000X**

After washing, the cracks have a wider aperture. The surface of the albumen is more disturbed and appears to be cupping. A fine craze pattern has developed which surrounds the major cracks.

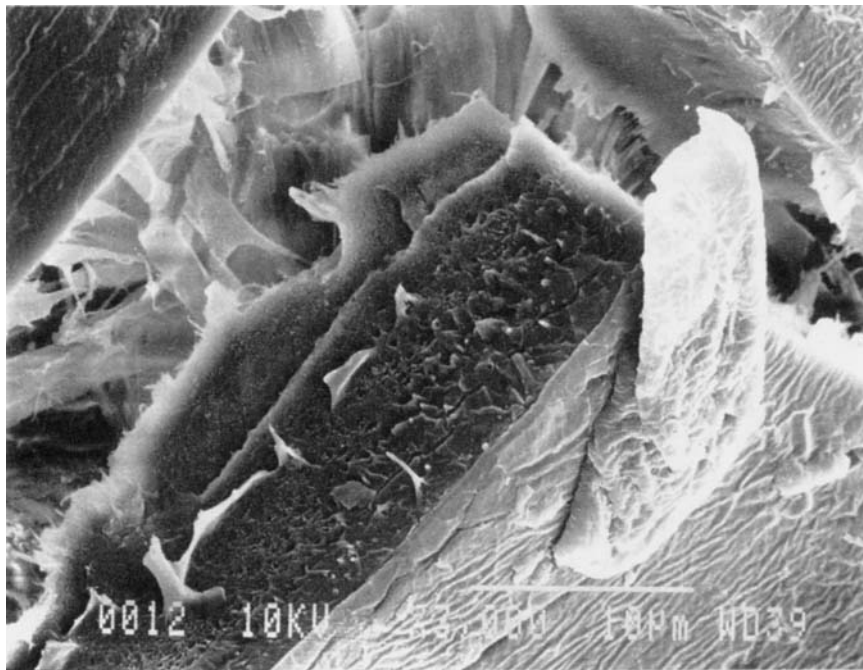
**Fig.10 ALBUMEN PRINT, 1989, WASHED, 3,000X**

After washing the crack walls exhibit an irregular, "taffy-like" appearance. Note how the crazed surface of the albumen compares to the sample shown at the top of the page.

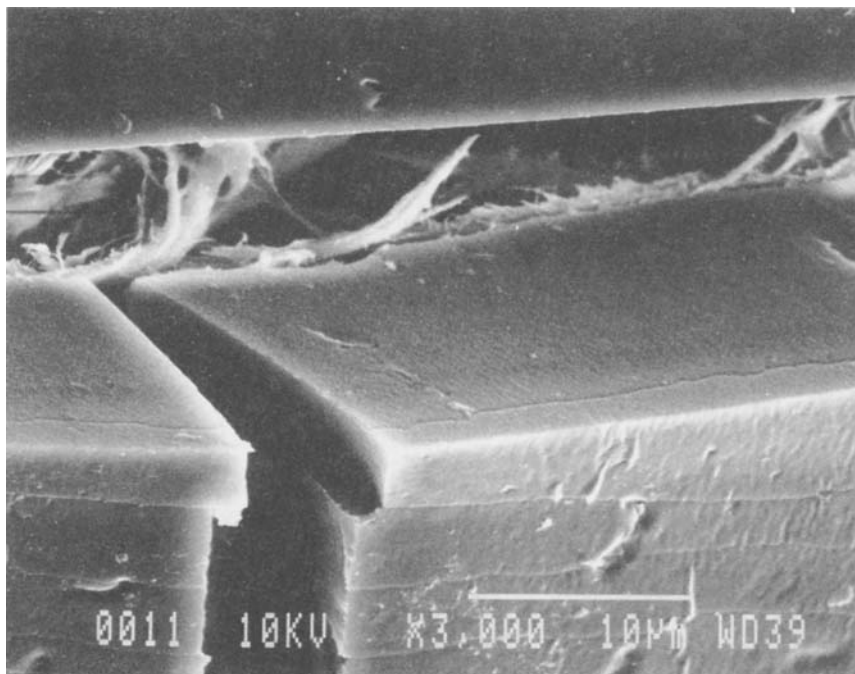
**Fig.11 ALBUMEN PRINT, 1989, CONTROL, 3,000X**

At close to 10 microns, the thickness of this albumen layer is nearly twice the thickness commonly found in prints from the 19th century. This additional thickness may explain the greater reactivity of the modern albumen prints relative to 19th century examples when exposed to water.

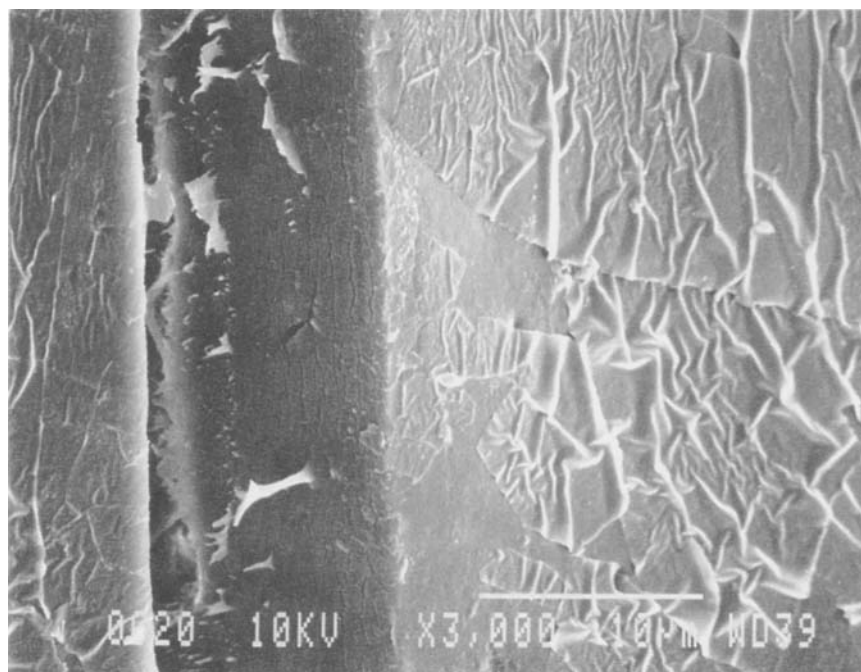
**Fig.12 ALBUMEN PRINT, 1989, WASHED, 3,000X**

The crazed surface of the albumen has partially flaked off. This type of crazed surface is not present in the samples observed before washing. The crack wall appears fractured and has an irregular surface.
