Article: DETERIORATION OF SOME CONTEMPORARY PRINTS Author(s): Bertrand Lavedrine *Topics in Photographic Preservation, Volume 6.* Pages: 106-110 Compiler: Robin E. Siegel © 1995, Photographic Materials Group of the American Institute for Conservation of Historic & Artistic Works. 1156 15th St. NW, Suite 320, Washington, DC 20005. (202) 452-9545, www.aic-faic.org. Under a licensing agreement, individual authors retain copyright to their work and extend publication rights to the American Institute for Conservation.

DETERIORATION OF SOME CONTEMPORARY PRINTS

Bertrand Lavédrine

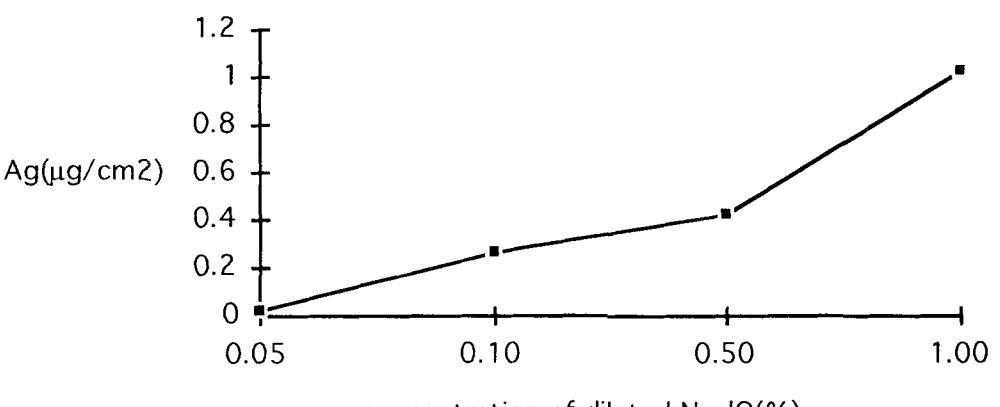
- use of water or hypo eliminator that contain chlorine (such an elimination procedure is mentioned in the literature). Small quantities of sodium hypochlorite in the rinsing water do lead to the formation of photosensitive silver chloride (detectable through XRD), and the process is hastened if the bath is acid or acidified by traces of fixing solution. We experimented along these lines with the same type of paper. Photographic prints were immersed in the solution for 30 minutes and then refixed ; the amount of silver made soluble by the fixing solution was measured by atomic absorption. Graph A represents the quantity of silver (Ag in micrograms per square centimeters) that turns into silver chloride when the photograph is immersed in a hypochlorite solution at different concentration. These samples, when analyzed by SEM, show the presence of chlorine, silver and also calcium (which is present in the commercial hypochlorite we used).
