**Irene Matteini**

**University of Pennsylvania**

**An assessment and evaluation on the effects of acidic cleaning methods on unglazed terra cotta  
using accelerated weathering test protocols**

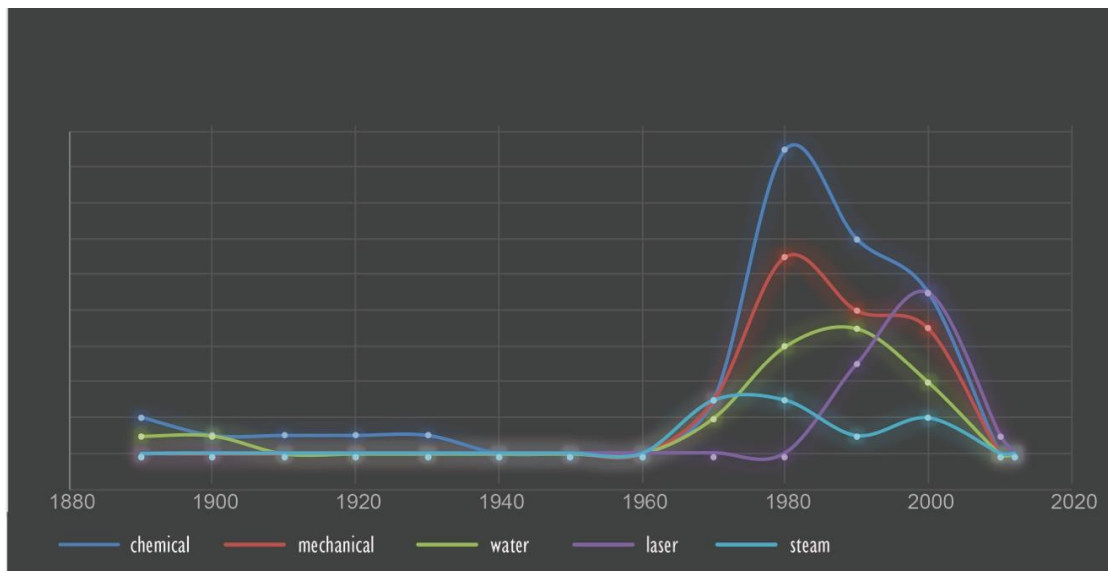
Fig. 3: Cleaning Techniques Overtime

By looking at different cleaning techniques overtime, chemical, followed by mechanical methods have remained the most popular according to the literature review, and also confirmed by the survey. (Matteini, 2014) (Fig. 3) Beginning in the early 1980's, we start to see the introduction of more sophisticated micro-abrasive techniques such as Thoman-Hanry Gommage (Slaton et al., 1994), Jos, Rotec Quintex (Varalli, 2014), and Sponge-Jet (Valoria, 2014), together with the rise of laser cleaning with its first application on terra cotta in 1994 at the Victoria Albert Hall. (Larson, 1996)

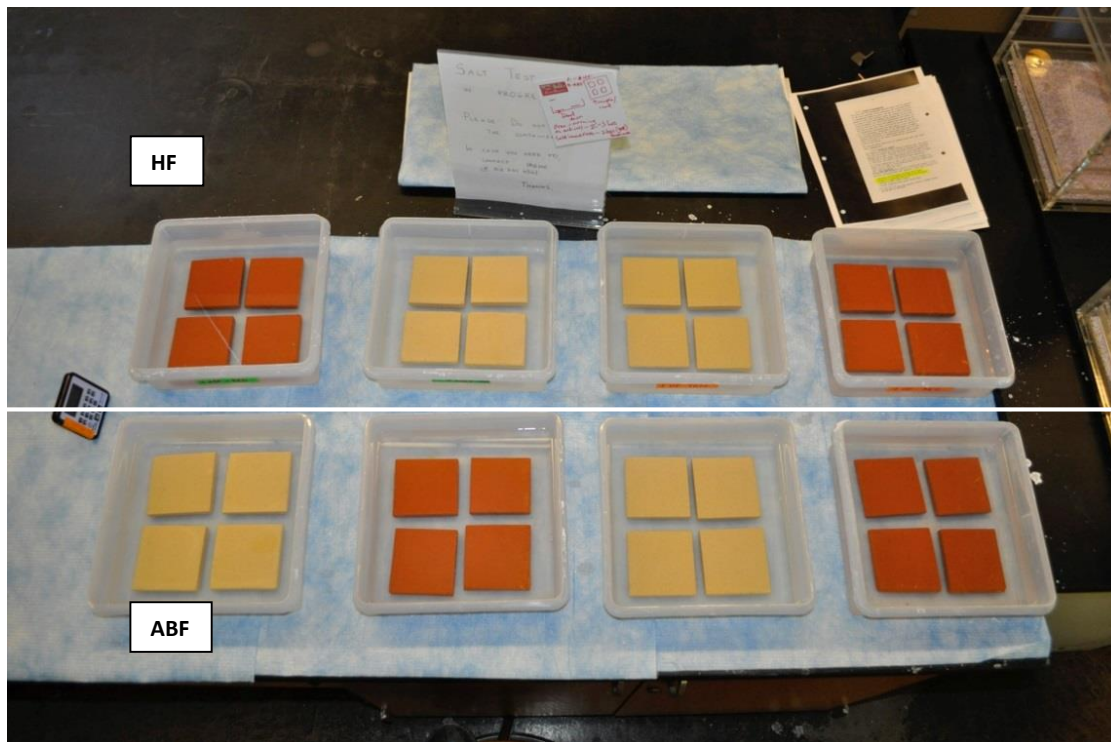
- **RILEM VB SALT TEST:** This test consisted of 15 cycles of 2 hour immersion in a 10% solution of sodium sulfate. For fifteen days, a daily cycle was completed which included: two hours of immersion, followed by 19 hours oven-dried at 60 degree Celsius and then cooling within 3 hours. The test was run on 32 samples: one representative set of 6 cohorts for each product and application. (Fig. 4)
- **QV-LAB WEATHEROMETER ASTM G154-12:** A QV-Lab apparatus was used to complete this test. Samples were alternatively exposed to ultraviolet cycles of 8 hours at 60 degrees Celsius, followed by a condensation cycle of 4 hours at 50 degrees Celsius which included a 25 minute water spray cycle at the beginning of each condensation cycle. This protocol was completed for a total of 1008 hours. (Fig.5)

Figure 4: Picture taken during the two hours immersion of the samples while performing the salt test.

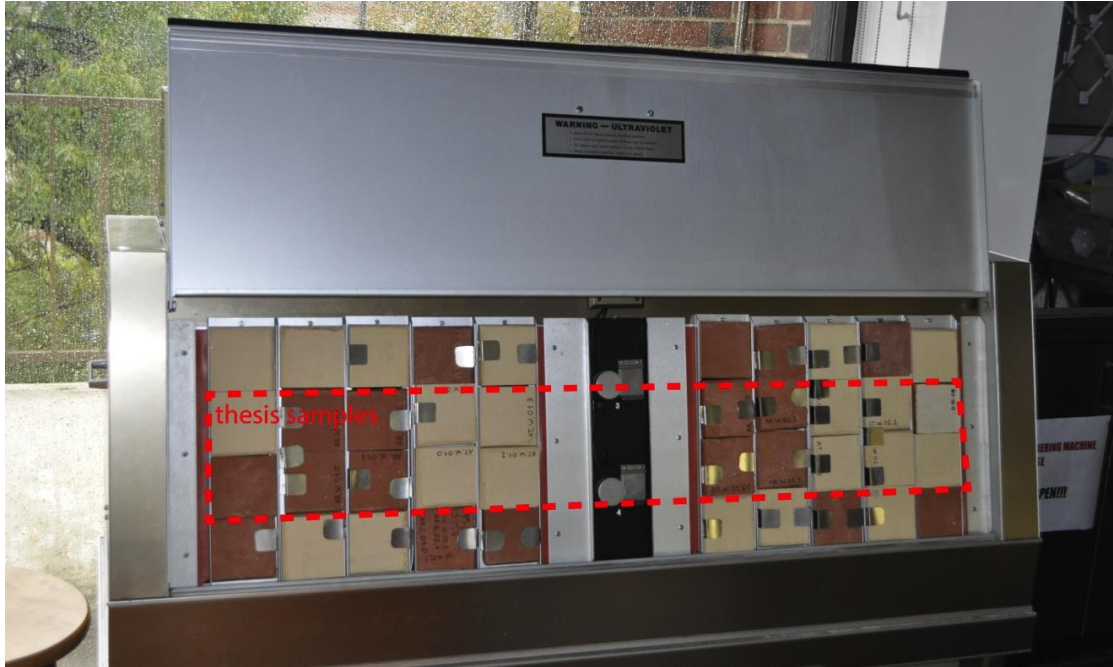
Figure 5: Pictures showing the samples in the weatherometer

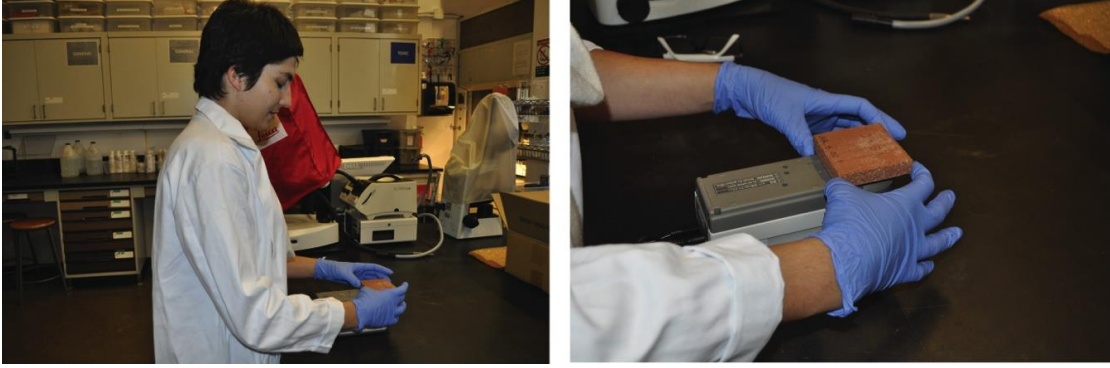
A CM2500D Konica Minolta Spectrophotometer was used to assess any changes in color in all of the 96 tiles before and after running accelerated testing. The reading for each tile was taken in the center of the sample. For each set, the control was used as a target and the cohorts as samples. The data were elaborated by using the C18 Minolta Software before and after accelerated weathering. (Fig. 9)

Figure 9: Irene completing a reading on a red tile with the Minolta Spectrophotometer

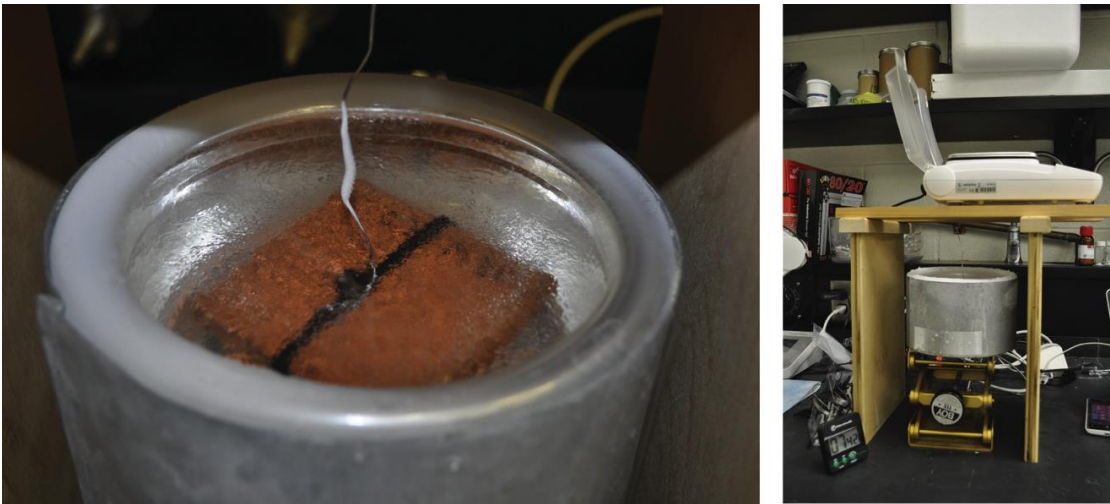
The equipment used included: a Sartorius electronic balance with an under-hook, metal wire for hanging the tile, and a Dewar flask for the liquid nitrogen. (Fig. 10)

Fig. 10: Completing the Liquid Nitrogen Test at the Chemistry Department

The liquid nitrogen technique follows under the liquid impregnation method, where open pore volume is determined by calculating the amount of liquid nitrogen adsorbed by the open pores. Several are the advantages of using liquid nitrogen for porosity measurements: it is very affordable, easy and quick to use as well as being more accurate than water based measurements and less toxic than mercury porosimetry. It evacuates on its own, so there is no need to physically remove it from the tile as in the case of mercury, or a need for a vacuum. (Matteini, 2014)

One of the critical aspects of using liquid nitrogen is that it evaporates very rapidly, requiring immediate measurement of the wet weight (W) after removing the tile from the liquid.

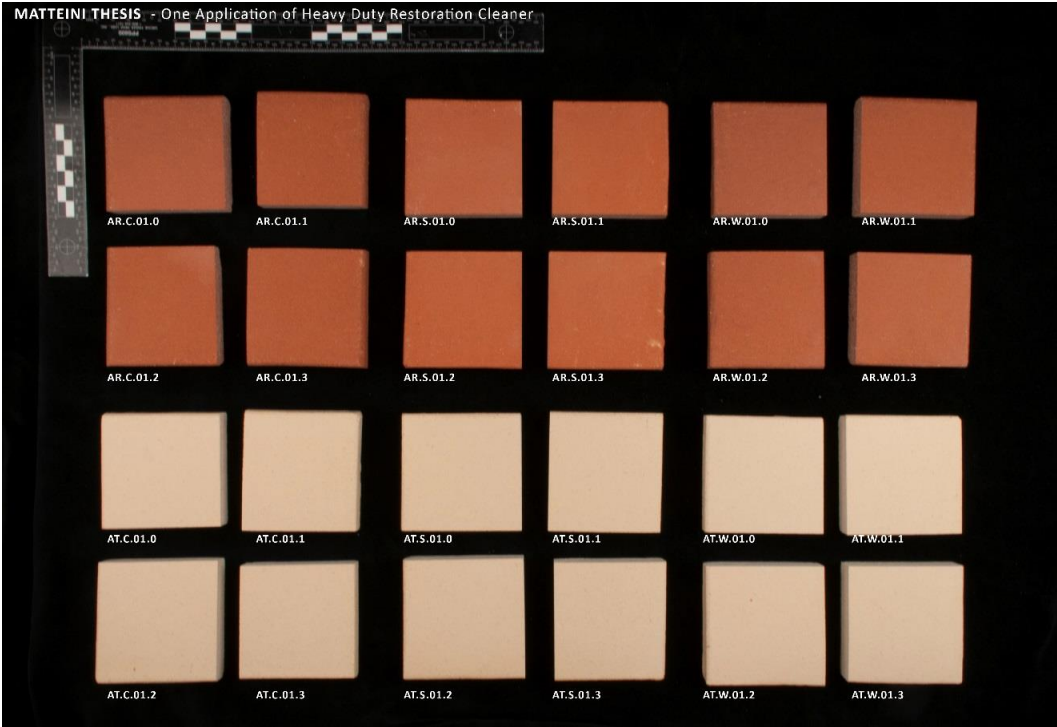
Figure 12: Sample set treated with one application of ProSoCo Heavy Duty Restoration Cleaner.

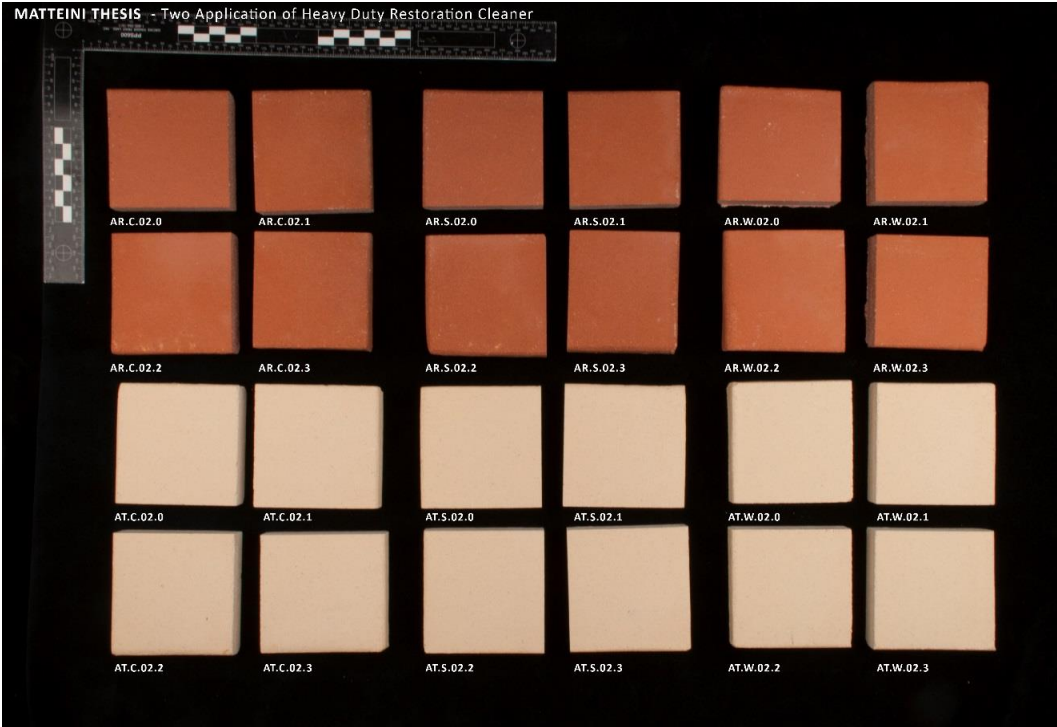
Figure 13: Sample set treated with two applications of ProSoCo Heavy Duty Restoration Cleaner.

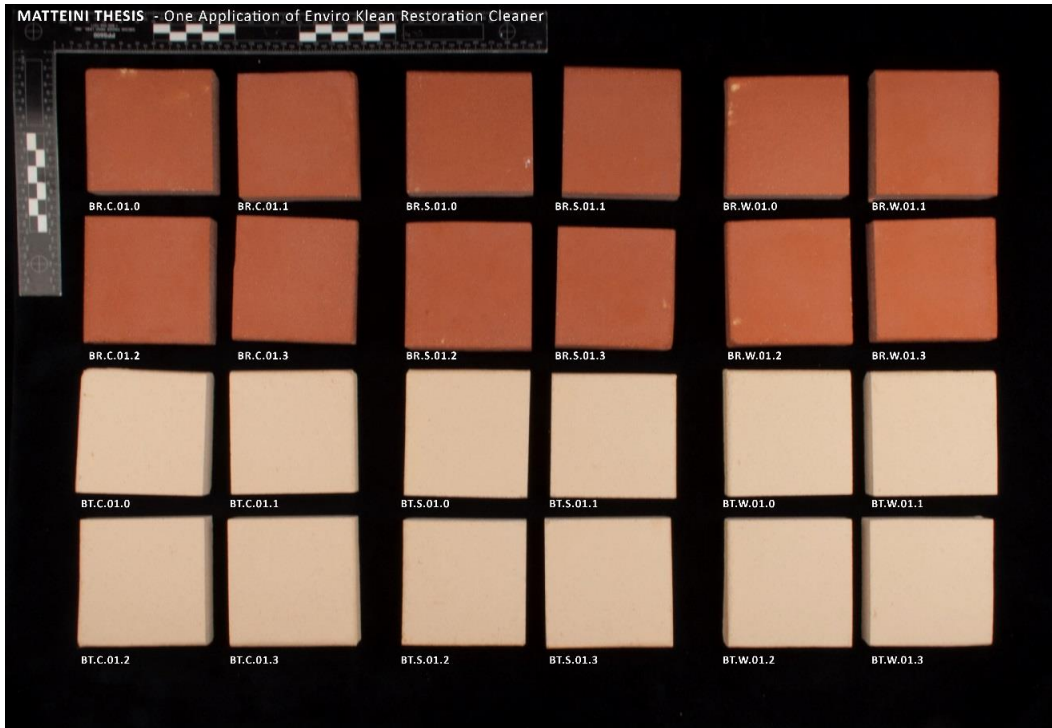
Figure 14: Sample set treated with one application of ProSoCo Enviro Klean Restoration Cleaner

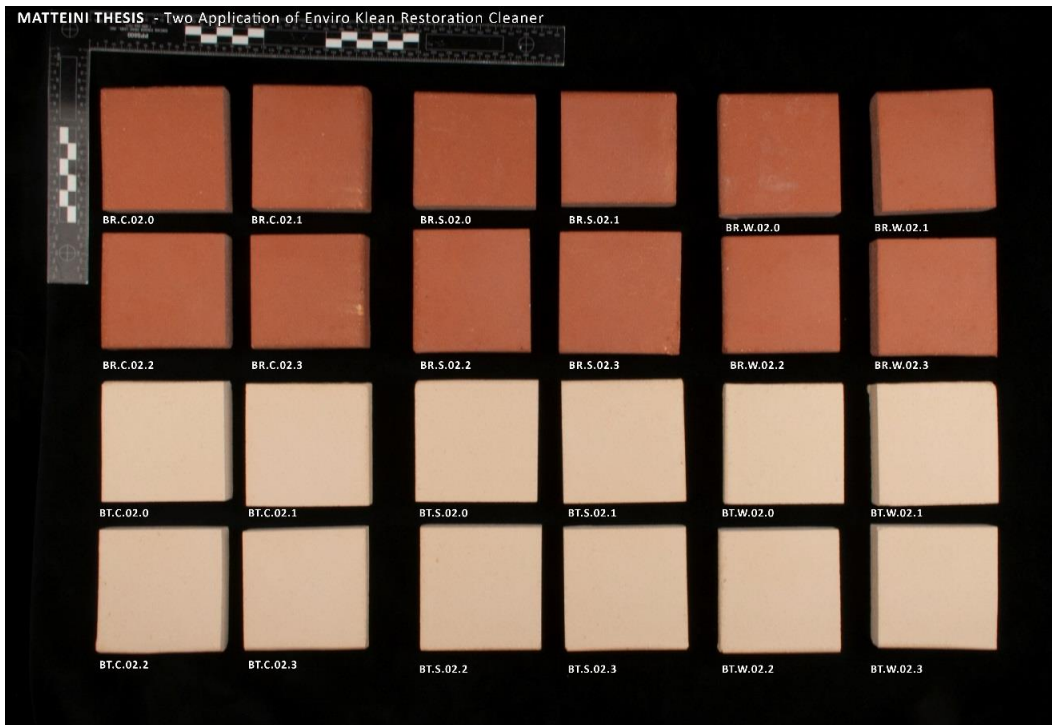
Figure 15: Sample set treated with two applications of ProSoCo Enviro Klean Restoration Cleaner
