Courtney Magill

University of Pennsylvania

**Performance Assessment and Evaluation of Hydrophobic and Ultraviolet Protective
Treatments for Historic Log Structures**

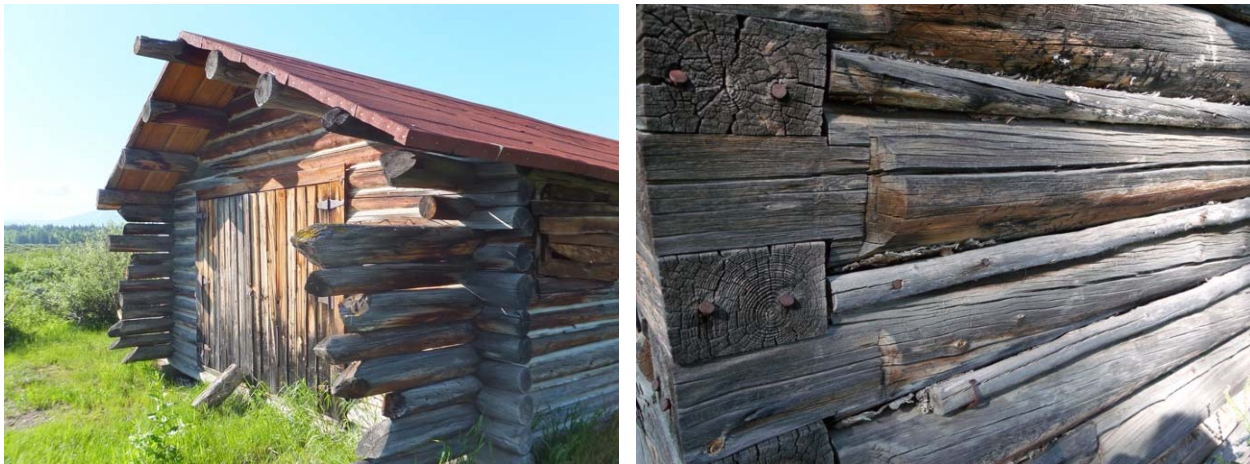
Figure 2. Cabin 1368 (left) and 1369 (right) on the Bar BC Dude Ranch, Bar BC Condition Assessment and Report conducted by the Architectural Conservation Laboratory of the University of Pennsylvania.

One such site, the Bar BC Dude Ranch, located on the banks of the Snake River in Grand Teton National Park, is a focal point for conservation and site restoration. The ranch was founded in 1912 by Struthers Burt and Horace Carncross, both prominent Philadelphians, and catered to western fantasies of elite guests from the east coast. The cabins and other log buildings on site were built in the so-called “cowboy style,” a rustic form of construction that was both economical for the owners and exactly what guests expected to encounter on their long vacations to the Wild West. The romanticized ideal was forwarded by Burt and his wife Katherine, both prominent authors; the ranch was even featured in the early Hollywood movie, “Snowblind,” from a screenplay adapted from one of Katherine’s Western romance novels. The logs at the many ranches like the Bar BC were usually left undressed or treated with linseed oil, allowing the wood to weather and aesthetically become part of the landscape.

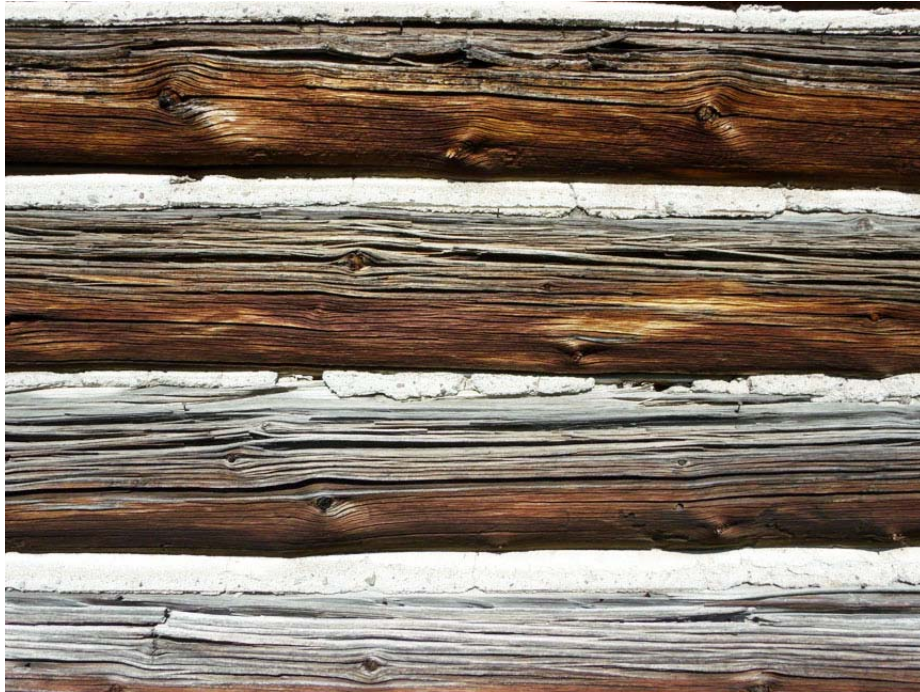
Figure 3. Degradation by UV Radiation on Cabin 1379 at the Bar BC Dude Ranch, Bar BC Condition Assessment and Report conducted by the Architectural Conservation Laboratory of the University of Pennsylvania.

Ultraviolet light can also damage the physical fabric of wooden members through degradation of lignin in the material. This photo-oxidation leads to colored decomposition

products that results in the lightening or darkening of the wood surface, depending on the species. This process can happen rather quickly, affecting the exposed wooden member in a matter of days. Due to a small depth of penetration however, this damage is restricted to surface areas. However, when combined with the shrinkage and swelling of water sorption or abrasion from weathering, surface material can begin to delaminate, exposing untreated surfaces for further delignification.

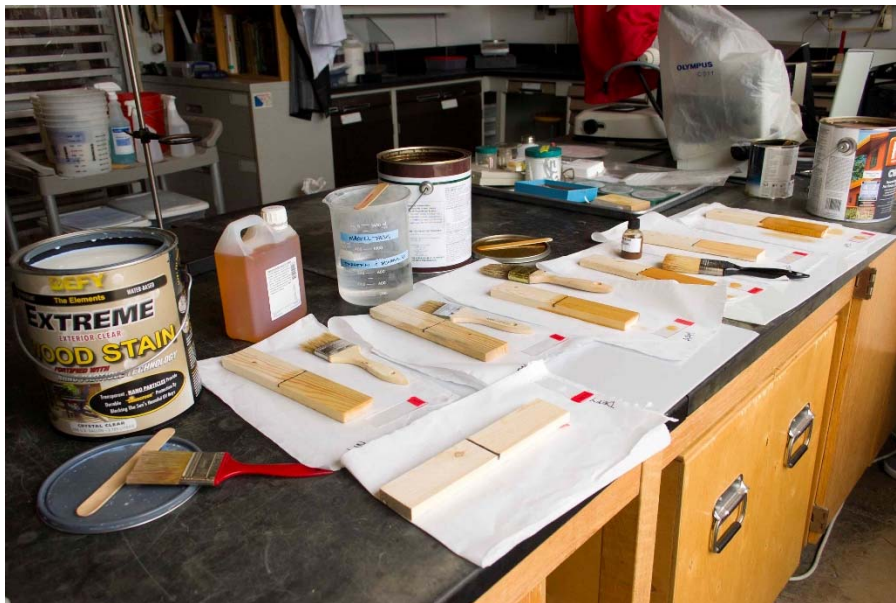
Figure 4. Preparation of Samples on the Lab Bench.

weathering, Willmore sent scrap material that was cut off of logs while making dimensional lumber using a technique called plain or cant sawing; the rounded edge is cut off to produce a cant that is further cut to produce boards. This edge material consists of the outer 1-2 inches of the lodgepole pine logs roughly the same size as those used at the Bar BC, comprising of the bark and cambium along with sapwood. Samples were cut from this material in the Fabrication Laboratory at the University of Pennsylvania to standardized sizes measuring 9 ¼” long, 1 ¾” wide, and ½” deep, removing the outer bark and creating a flat surface in order to fit into the stainless steel sample brackets of the weathering apparatus. Additionally, each long sample was separated into two smaller samples with the insertion of a neoprene strip coated in epoxy.

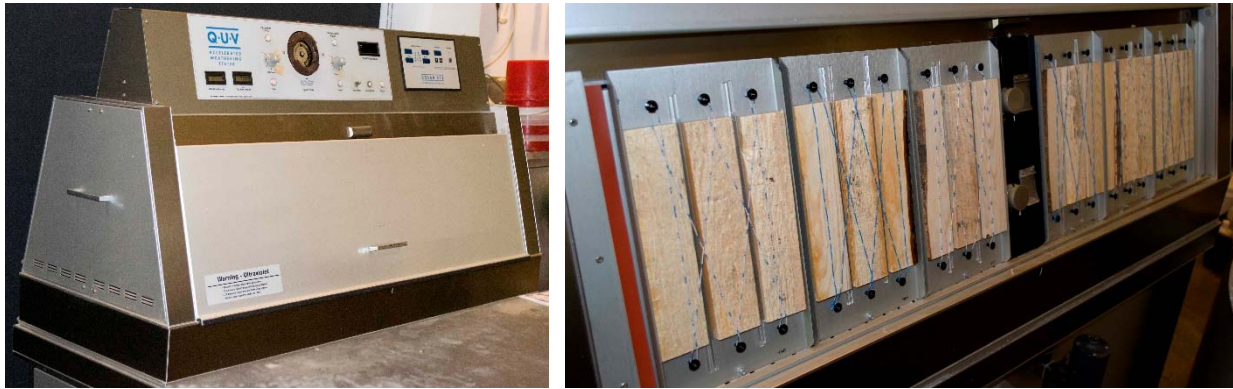
Figure 6. The QUV Weatherometer in the Architectural Conservation Laboratory both closed (left) and opened with specimen brackets inserted (right).

The experiment was carried out over an 800 hour period in a QUV Weatherometer to come as close to industry standards for testing as possible with the limited amount of time

available.¹ UV-B-313 lights were used instead of UV-A to further accelerate the process. Though they are more intense and project some wavelengths that are not seen in nature, the purpose of the experiment was to push the treatments to their limits to see how they might break down under extreme circumstances. Accelerated weathering by nature is an extreme process because of the small cycles of wetting and drying along with the radiation, so natural weathering testing is always recommended in the field to evaluate results.

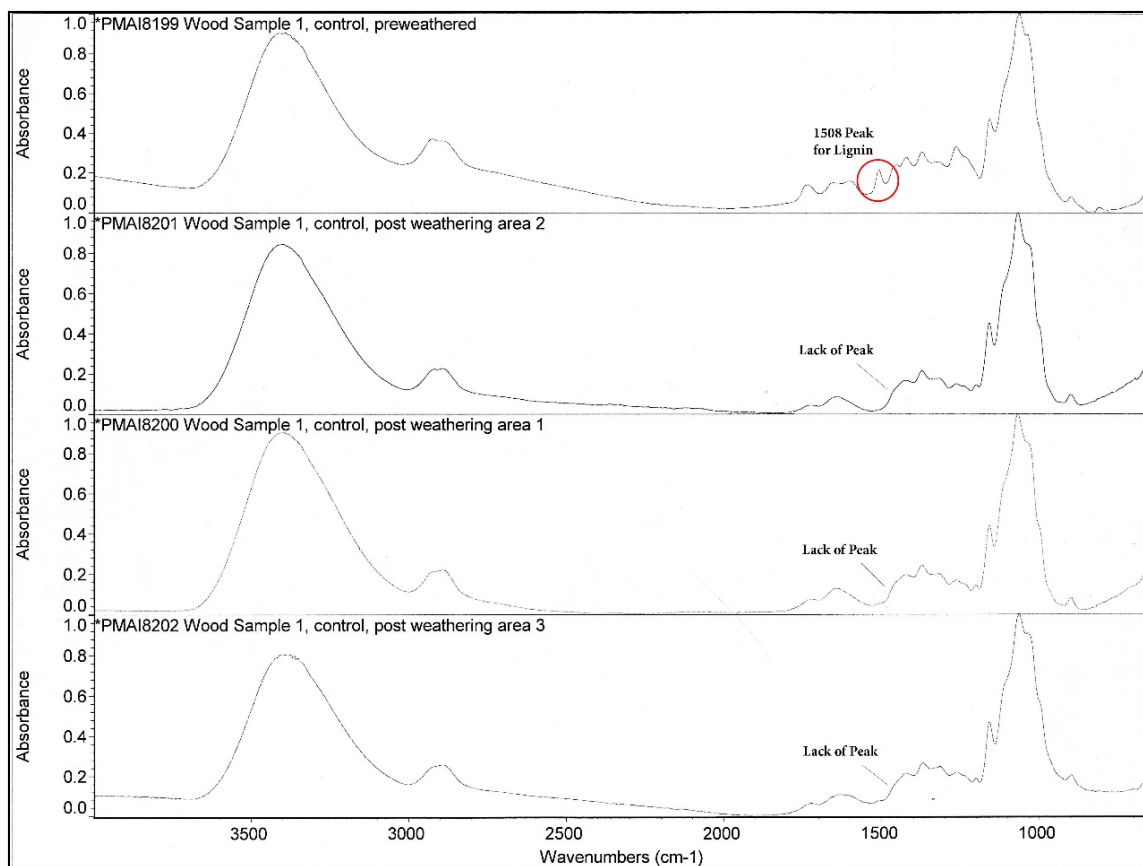
Figure 10. Spectra for Control Sample 1 before and after weathering confirmed that the peak for lignin at 1508 wavenumbers was a good indicator for weathering and subsequent loss of lignin. Spectra generated at the Philadelphia Museum of Art.

Once an acceptable sample was found with initial readings, the spectra was generated 200 times to form the resulting graphs. The spectra for un-weathered and weathered lodgepole pine was first inspected in order to confirm peaks listed in previous papers that used infrared spectroscopy to monitor wood and paper degradation (Lionetto et al., 2012; Proniewicz et al., 2002; Schmalzl and Evans, 2003). Each of these papers listed a variety of peaks for wood components, but all listed the small peak at about 1508 wavenumbers (cm^{-1}) as an indicator for lignin that can be monitored to detect wood fabric degradation. Spectra of the un-weathered surface and several areas of the weathered surfaces confirmed the presence of the peak from the fabric before weathering and its subsequent absence in the three sampling locations of weathered fabric.

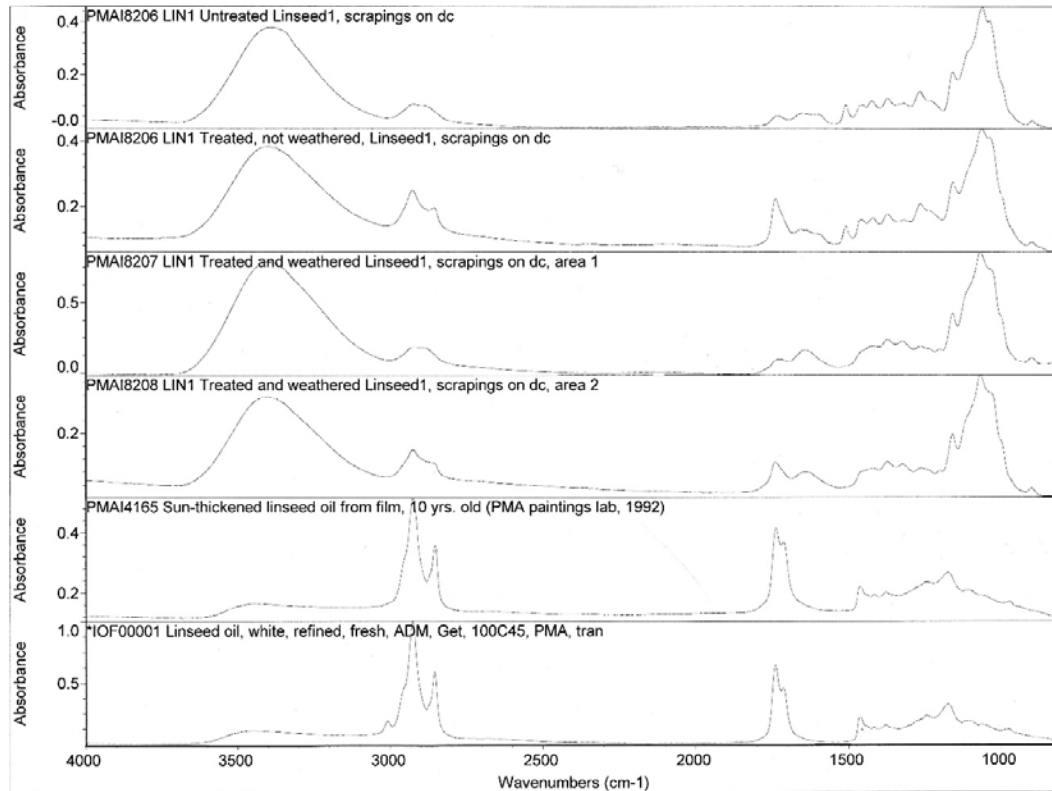
Figure 12. The spectra for the linseed oil treatment before and after weathering with standard spectra for both fresh and 10-year-old linseed oil for comparison shows retention of the treatment. Generated at the Philadelphia Museum of Art.

For this test, FTIR was used as a qualitative rather than a quantitative analysis. This judgement stems from the unknown compositions of most of the treatments. Though the relative concentrations and identities of the components are still unknown, by appraising the spectra of

the un-weathered and weathered treated samples, the existence, or lack thereof, of the treatment in the surface fabric can be indicated through the presence or absence of peaks.
