Article: Image recovery of worn-off hallmarks on silver and gold objects

Author(s): Paul L. Benson and Robert S. Gilmore

Source: *Objects Specialty Group Postprints, Volume Nine, 2002*

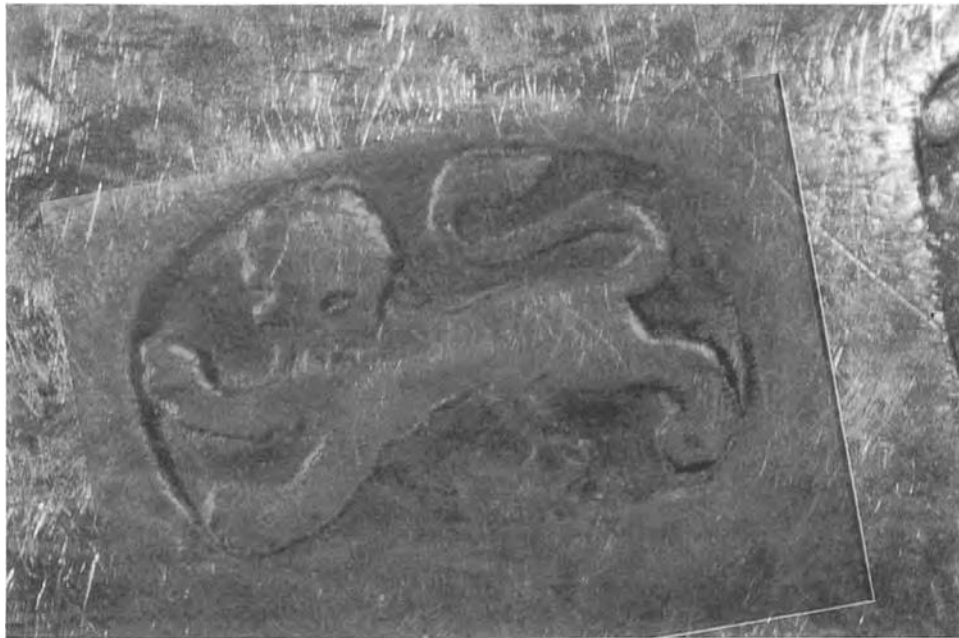
Figure 7. A recovered acoustic image of a worn-off lion hallmark overlaying a digital image of an identical hallmark from the same set of teaspoons.

Subsequent image processing comparisons with a visible hallmark from a teaspoon from this same set of spoons has confirmed that the recovered image of the lion mark is identical to the visible hallmark. A series of six acoustic images of the worn-off lion hallmark were adjusted for size and overlaid on a digital image of the visible lion hallmark. The acoustic images were made by adjusting the focal spot of the sound waves either a little higher or a little lower in the metal. With only a two hundred nanosecond difference in the travel time of the sound waves from the first acoustic image to the sixth one there was a surprising difference in the quality of the images (200-nanosecond travel time converts to an actual distance difference of 0.0026 inch). The composite acoustic images had near perfect registration on the visible hallmark which demonstrates that the illegible hallmark was struck with the same die as the visible hallmark on the teaspoon from this set of teaspoons (Fig. 7).

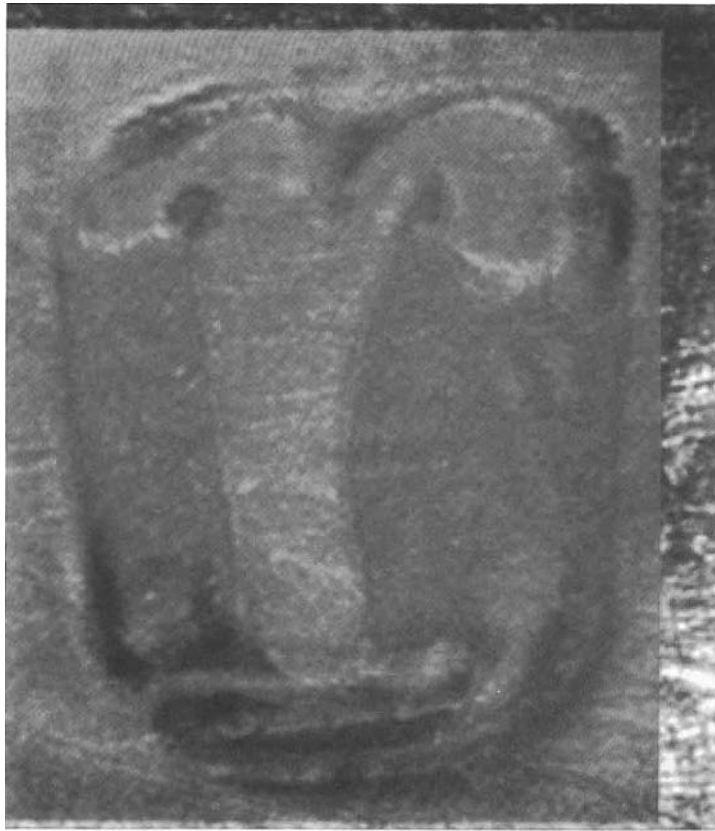
Figure 8. Recovered acoustic images of the date letter 'r' overlaying a digital image of a visible 'r' hallmark from the same set of teaspoons.

Fig. 8 shows the best results of a series of trials on recovering the date letter 'r'. Here, a series of three acoustic images of the letter 'r' were adjusted for size and orientation then overlain on top of a digital image of the corresponding hallmark from another teaspoon from the same set. Again, there is near perfect registration of the recovered acoustic image on the visible hallmark. This demonstrates that the recovered hallmark image is actually the letter 'r' and that it was struck with the same die as the visible hallmark on the other teaspoon.
