Article: One small step for man, one giant leap for conservation

# ONE SMALL STEP FOR MAN, ONE GIANT LEAP FOR CONSERVATION

This article describes the technical challenges of stabilizing and conserving 25,000 lb. (12.5 tons) of Apollo-era (1969–1972) *Saturn V* rocket engine parts that were recovered off the coast of Florida in 2013. After more than 40 years on the floor of the Atlantic Ocean, the engines had suffered extreme levels of deterioration and corrosion. Treatment was accomplished by taking a deliberate, archaeological object-based treatment approach for these composite objects that are both modern technological marvels and marine archaeological artifacts. The article describes the archaeological treatment approach adopted and the results of selected analytical work undertaken to understand the materials of construction and the deterioration processes.

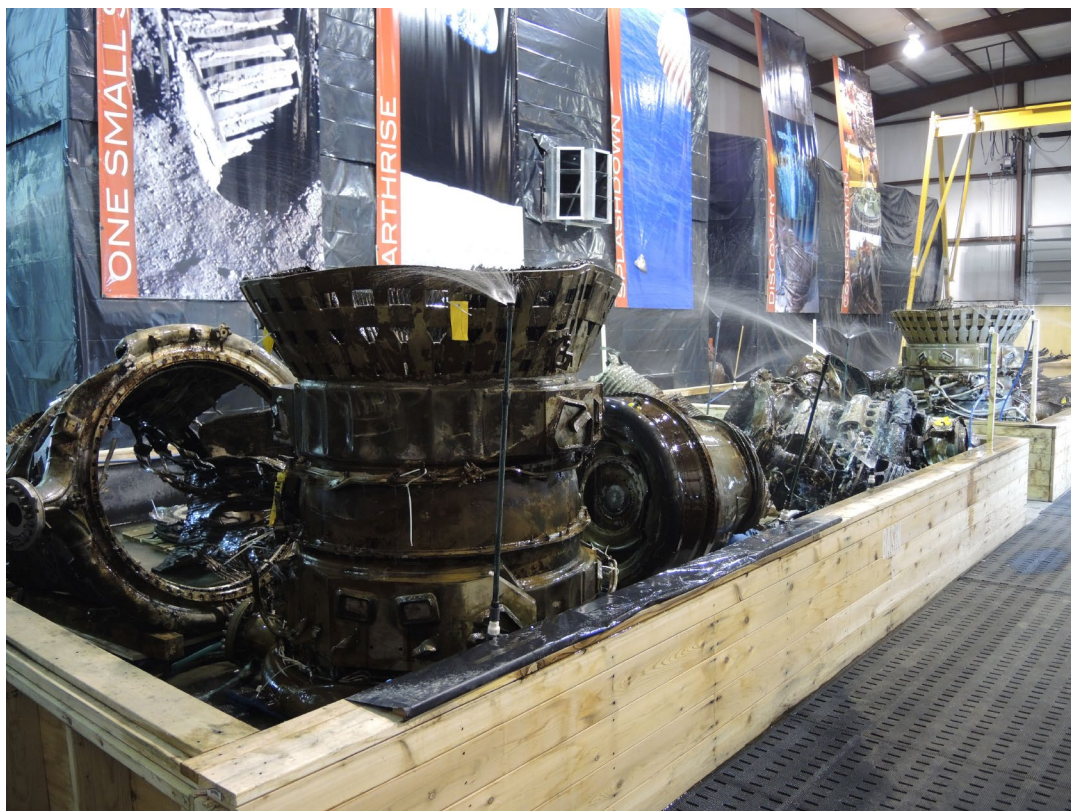
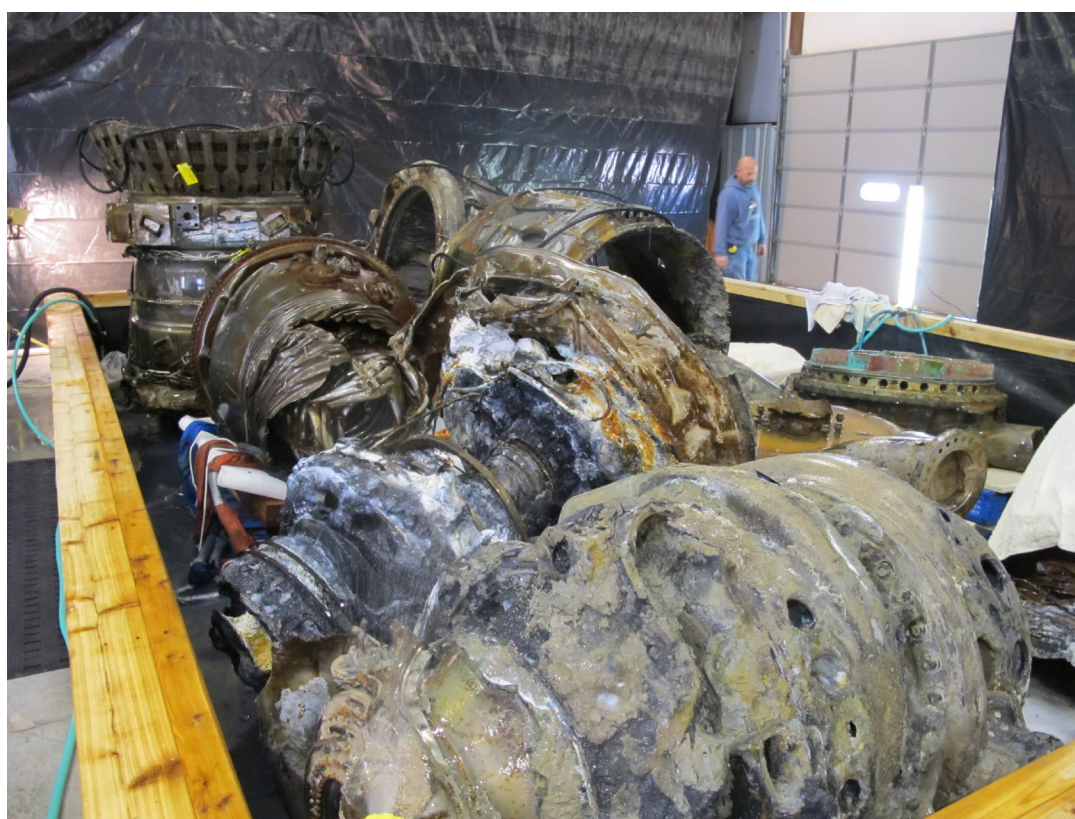
Fig. 3a. View of the lab with recently recovered artifacts in custom-fabricated basins; 3b. Detailed view of basin #1 with turbopumps in the foreground (Courtesy of Terra Mare Conservation LLC)

Keeping the entire collection wet while conservation plans were developed was achieved with a “showering system” installed around two 16 ft. × 23 ft. × 25 in. shallow custom-fabricated basins lined with a waterproof membrane covered with thick rubber pads to avoid puncture. The showering system used city water, and the artifacts were manually sprayed once per day with a 0.1% solution of FlashCorr, an anionic surfactant and multimetal corrosion inhibitor made by Cortec Corporation. Sump pumps were used for filtration and recirculation inside the basins. This flexible system was chosen for initial receipt of the engine parts in lieu of individual tanks due to the unknown size and shape of the objects. The objects remained in the showering system for up to five months, until they were ready for individual treatment. During that time, they were easily accessible for initial cataloguing, documentation, examination, and cleaning (figs. 3a, 3b). For subsequent treatment of individual engine parts, custom-made fiberglass tanks, as used in the oil industry, replaced the two large basins.

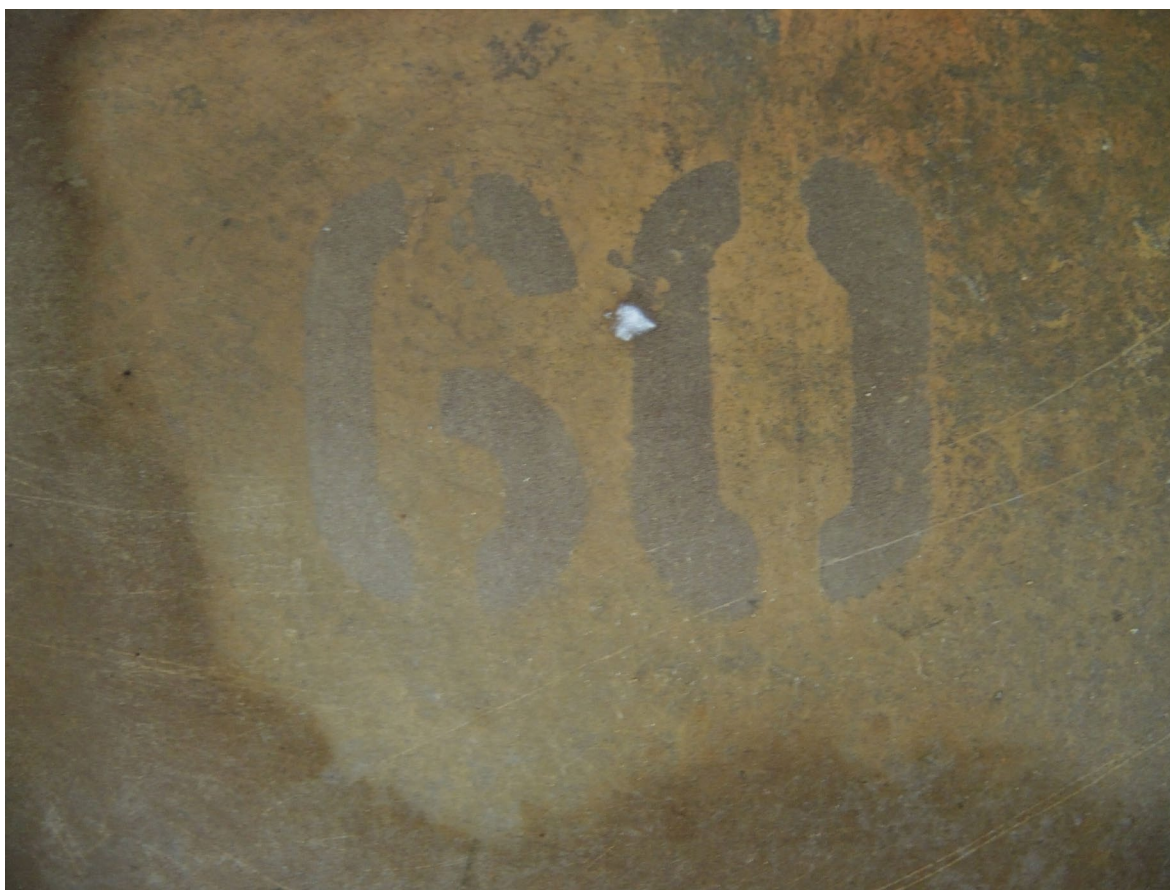
Fig. 4a. Example of a stenciled number on a thrust chamber only visible due to the presence of rust surrounding the numbers (Courtesy of Terra Mare Conservation LLC)

An additional requirement when dealing with archaeological material is to retain as much contextual information as possible, particularly from the objects' use and history. Archaeological objects are often transformed by their environment, creating difficulties of interpretation. Evidence of the firing of the F-1 engines had left subtle surface traces, some of which were ephemeral. Preserving evidence of use was critical and one of the most important components of the archaeological approach adopted for treatment (figs. 4a, 4b, 5).

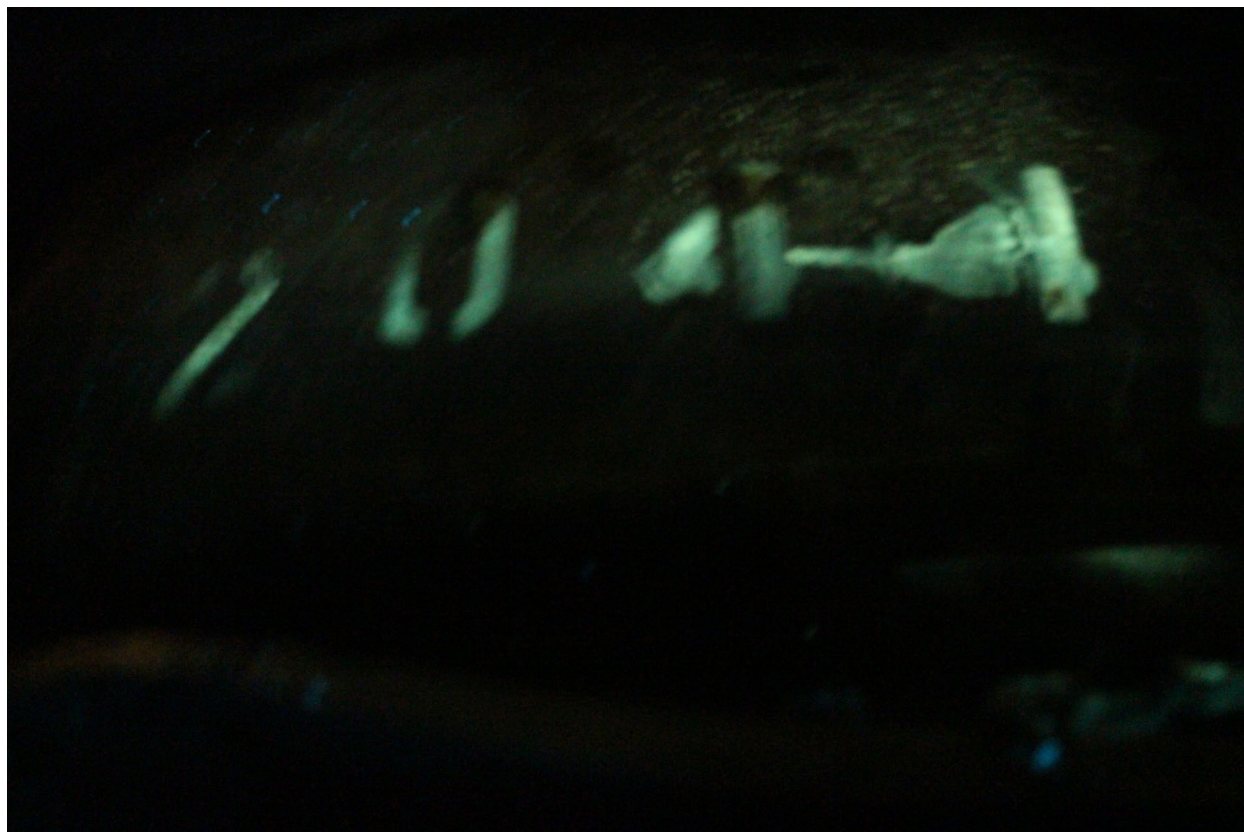
Fig. 4b. Original unit number on Apollo 11 thrust chamber only visible under ultraviolet light (Courtesy of Kansas Cosmosphere and Space Center)

components from the Apollo 11, 12, 14, and 16 missions were positively identified. An example of a stenciled area revealed under ultraviolet light on a thrust chamber belonging to engine #5 from Apollo 11 is given in figure 4b.

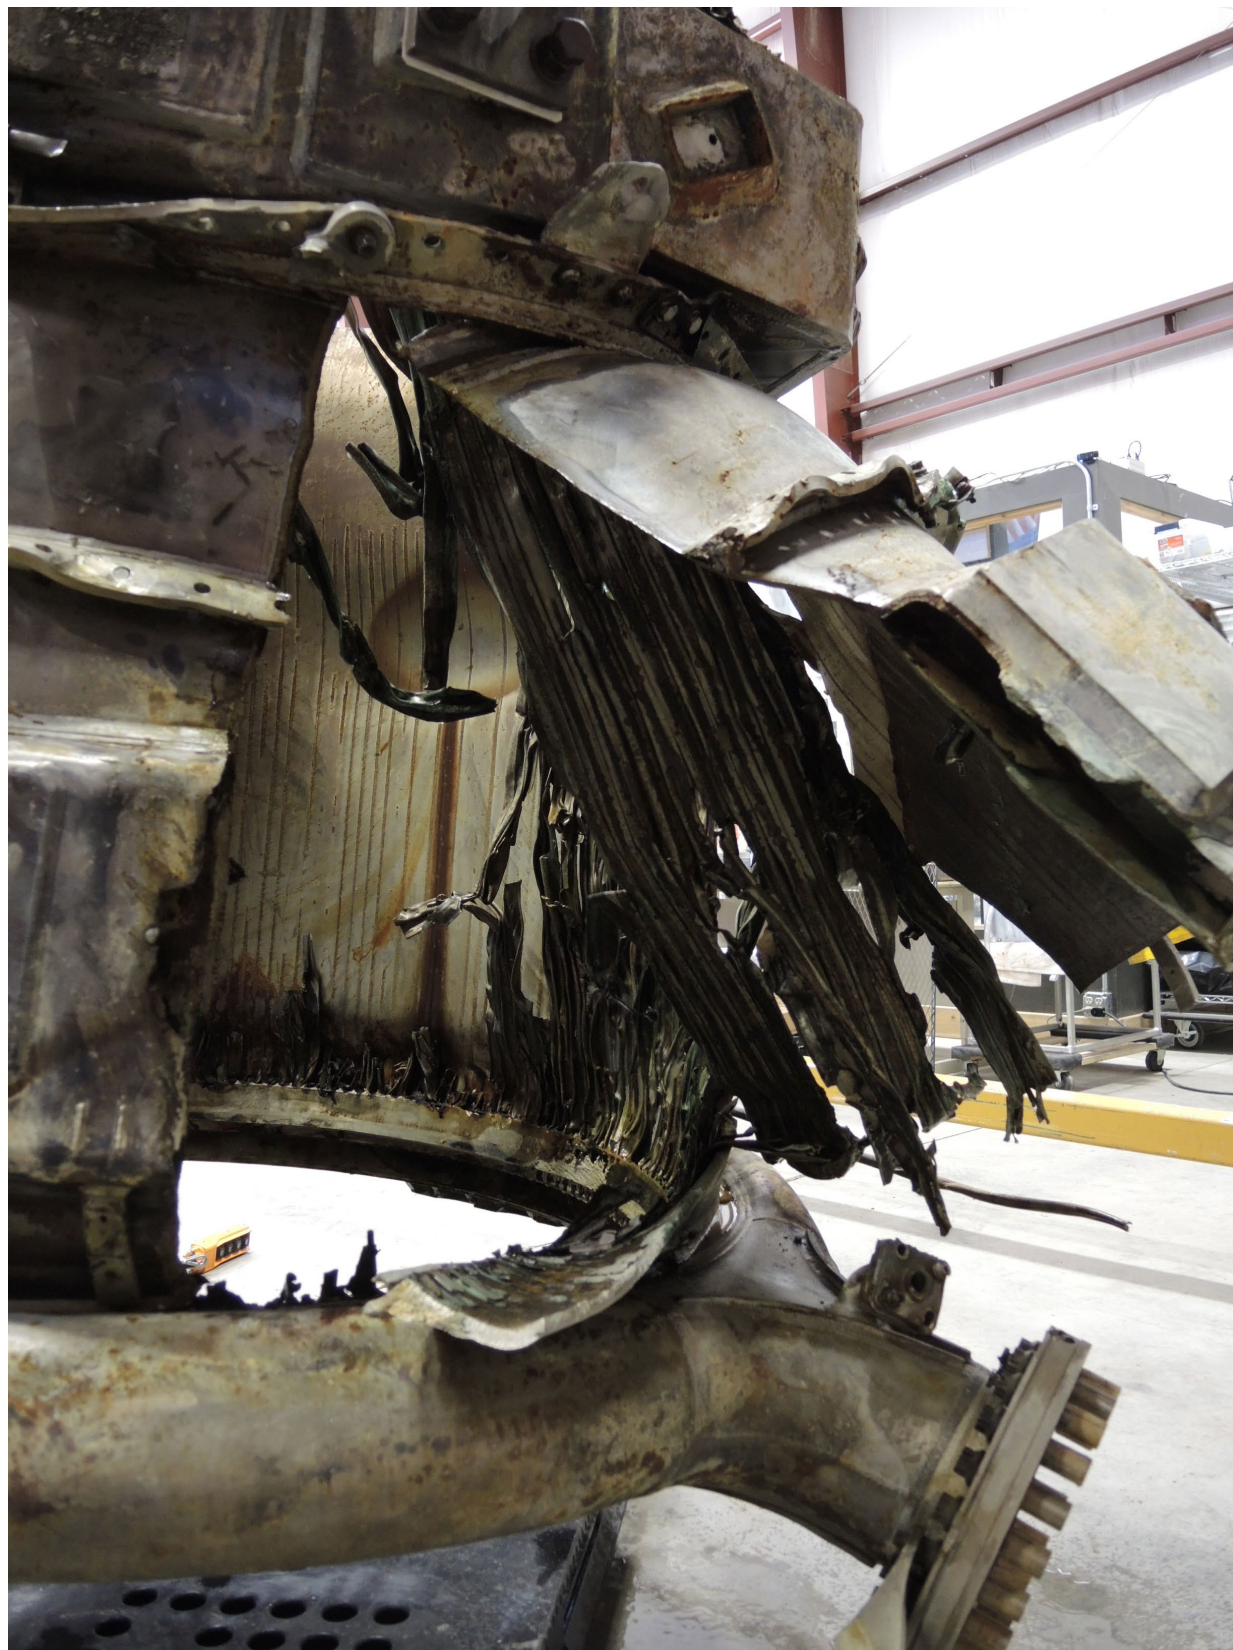
The deformation of the engines upon impact with the ocean also formed an important part of each object's history and needed to be preserved. The level of deformation was quite extensive in some cases, as shown on thrust chamber F1-2013-0005 from Apollo 11 (fig. 6).

Fig. 6. Ruptured jacket from a thrust chamber belonging to engine #5 from Apollo 11 (Courtesy of Terra Mare Conservation LLC)

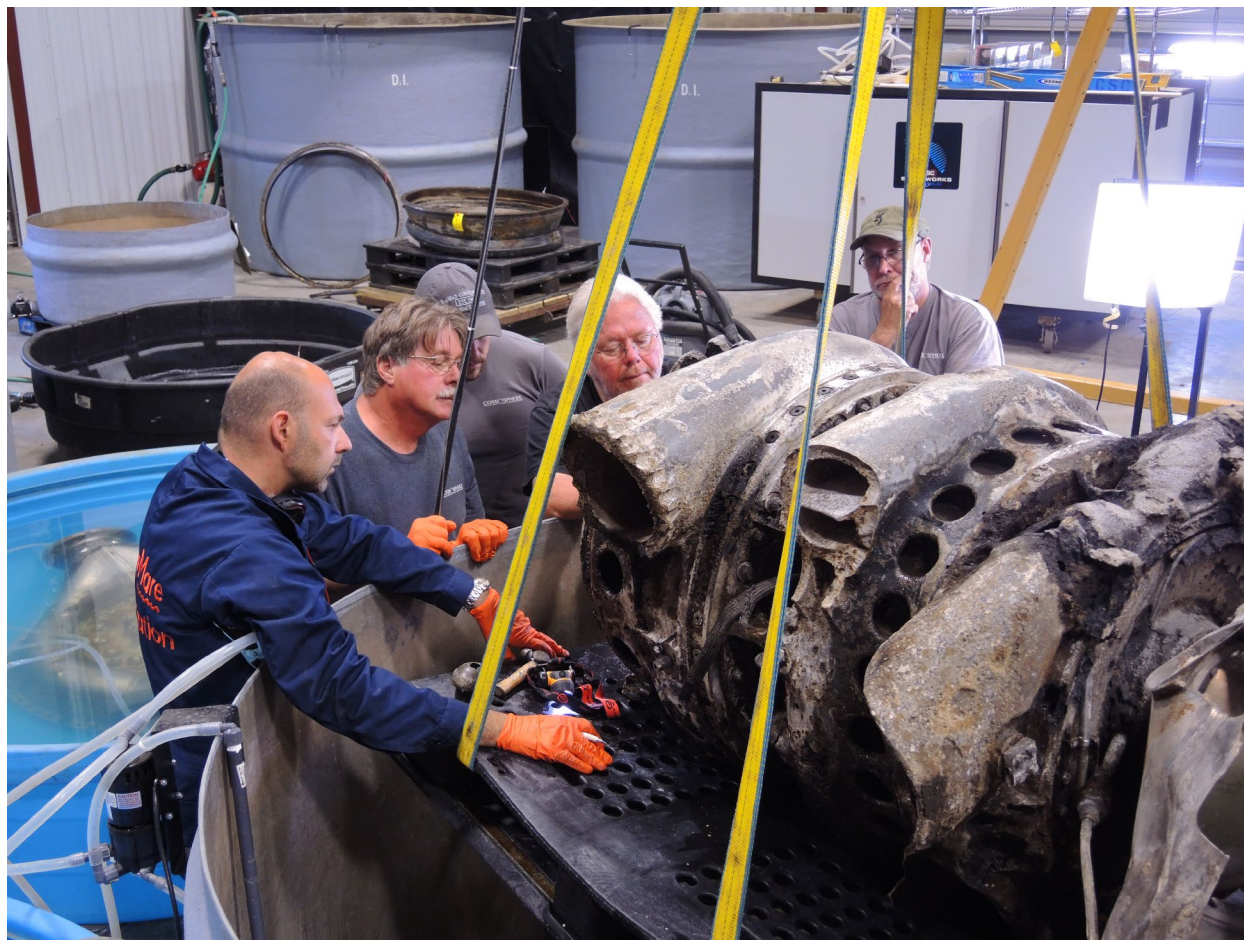
One of the biggest obstacles we faced during treatment was moving heavy, fragile, wet, and unstable objects weighing up to 3,000 lb. (1.3 tons). Moving the objects in and out of the treatment tanks, changing their position, or temporarily bracing, raising, or suspending them for examination or treatment had to be done in a careful and methodical manner to ensure safety for both the object and the team. Each move was thoroughly researched and planned by the team to ensure that the center of gravity was correctly located to accurately balance the object during moving. The combined experience of the team, encompassing engineering and technical knowledge, was invaluable at this time. Use of an overhead 5-ton gantry mobile along with a forklift and several pallet jacks allowed ease of movement. Lifting required innovative and customized modifications to allow the engines themselves to be picked up or maneuvered. Several methods were used for moving the engines. Where possible, engines were rigged with synthetic slings and lifted by their strongest component. Many of the heaviest parts were rigged and lifted with reinforced plastic pallets attached to evenly distribute the weight and avoid point load as much as possible. For some objects, the original rigging points were preserved, and, where feasible, these were fitted with new, custom lifting devices, spreader bars, connecting devices, and adaptors from which the part could then be rigged and safely lifted (fig. 8).

Fig. 8. The team examining turbopump F1-13-0045 (Courtesy of Terra Mare Conservation LLC)

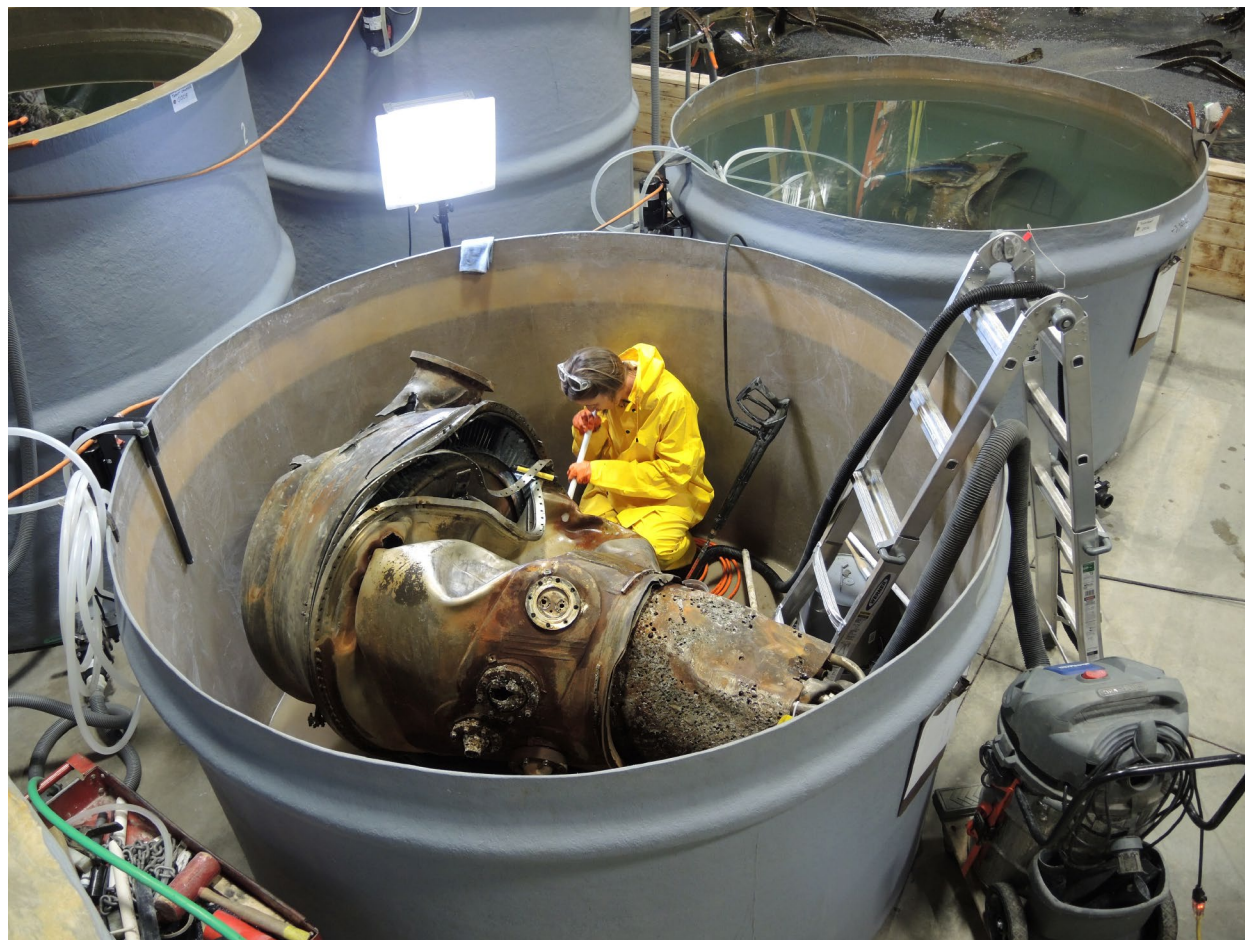
Complete removal of all sediment was necessary to enable access to the metal surface for stabilization (particularly inside the engines), to fully reveal surface details, and to improve the aesthetic appearance of the metal. The sediment, often mixed in with gelatinous corrosion products, was present in every possible cavity (even the tiniest cavities), inside the numerous instrumentation control lines, and within the cooling tubes that line the interior of the thrust chambers. The sediment was extremely stubborn, did not easily dissolve in water or other liquids, and had to be manually removed by a combination of hand cleaning and pressure washing. Multiple campaigns of cleaning were necessary, as most of the objects had extremely complex geometry that impeded access. As all sides of the objects

were gradually accessed, new pockets of sediment were revealed, which allowed for more in-depth cleaning (fig. 9).

Fig. 9. Conservator Claudia Chemello working on heat exchanger F1-2013-0046 from Apollo 16 (Courtesy of Terra Mare Conservation LLC)

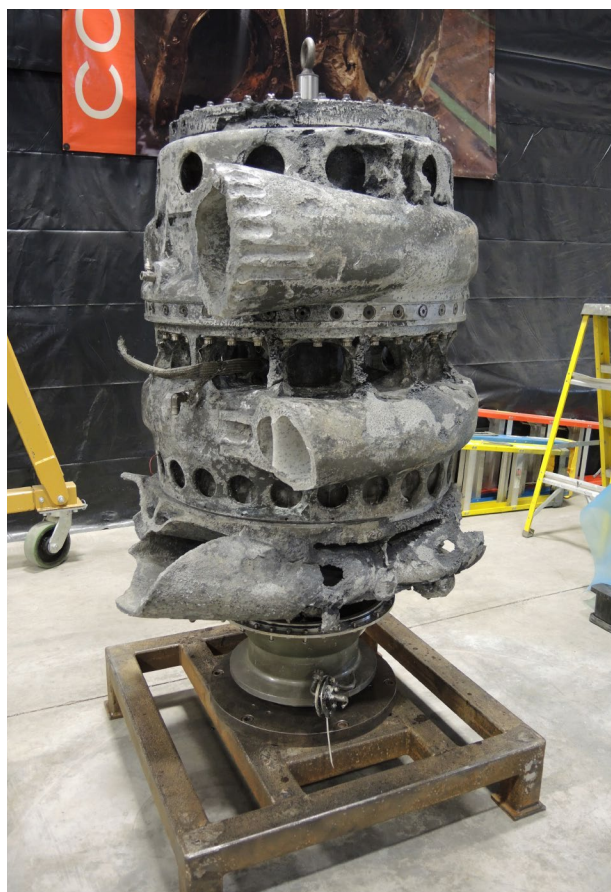
Fig. 12a. Turbopump F1-2013-0045 after conservation (Courtesy Terra Mare Conservation LLC); 12b. Original photo showing a similar turbopump on the assembly line (Courtesy Rocketdyne Harold C. Hall Collection)

Stabilization was achieved using a 0.5% solution of sodium metasilicate in deionized water, a corrosion inhibitor used in industry for inhibition of aluminum, and successfully employed for the treatment of artifacts made from aluminum and steel recovered from freshwater sites (Degrigny 1995). The object was placed under electrolysis to facilitate chloride extraction at a cathodic potential of  $-1$  V versus  $\text{Ag}/\text{AgCl}_2$  reference electrode ( $-0.8$  V vs. standard hydrogen electrode). Chloride extraction was tracked on a weekly basis and required six months to achieve a consistent chloride reading under 2.5 ppm in solution. The solution was then renewed and the object was maintained in treatment for an additional two months. During treatment, more detailed cleaning occurred, particularly to the heavily corroded shaft bearings. Conserved turbopumps are shown in figures 11 and 12.

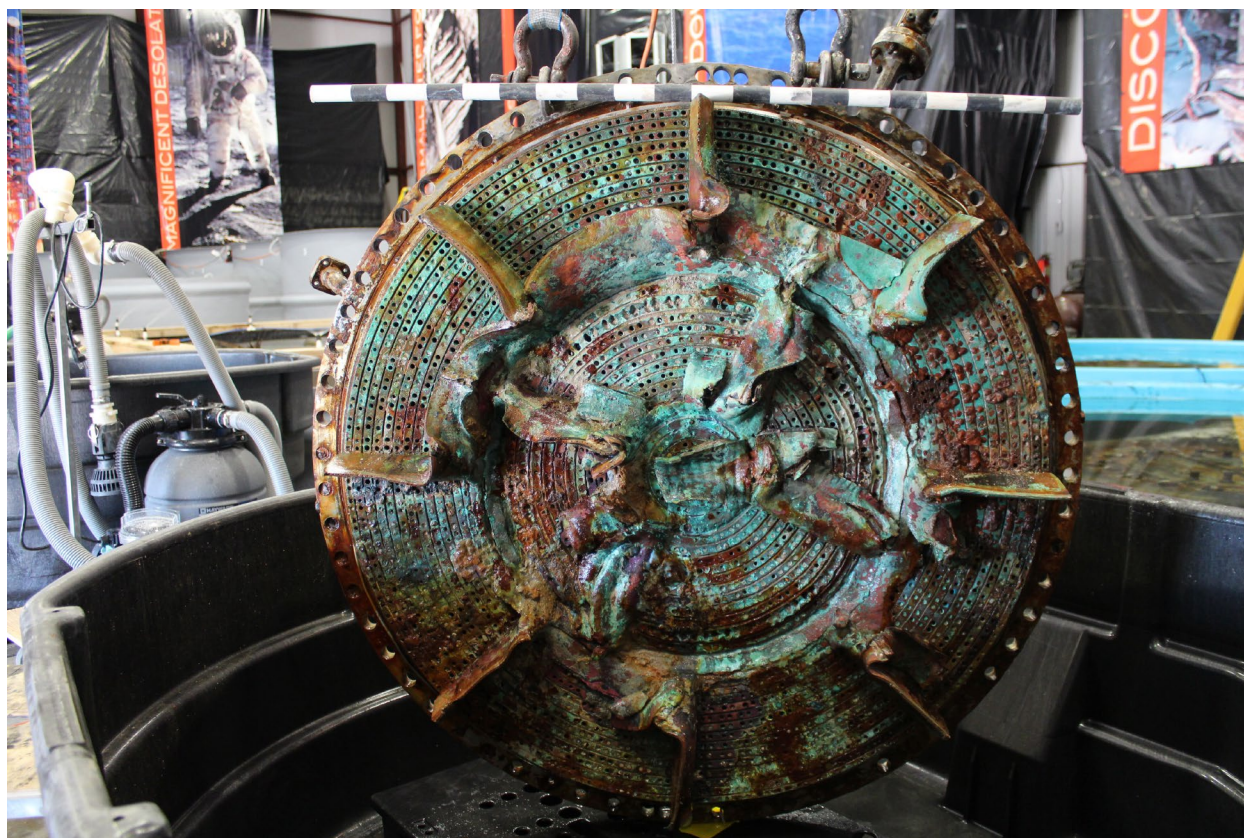
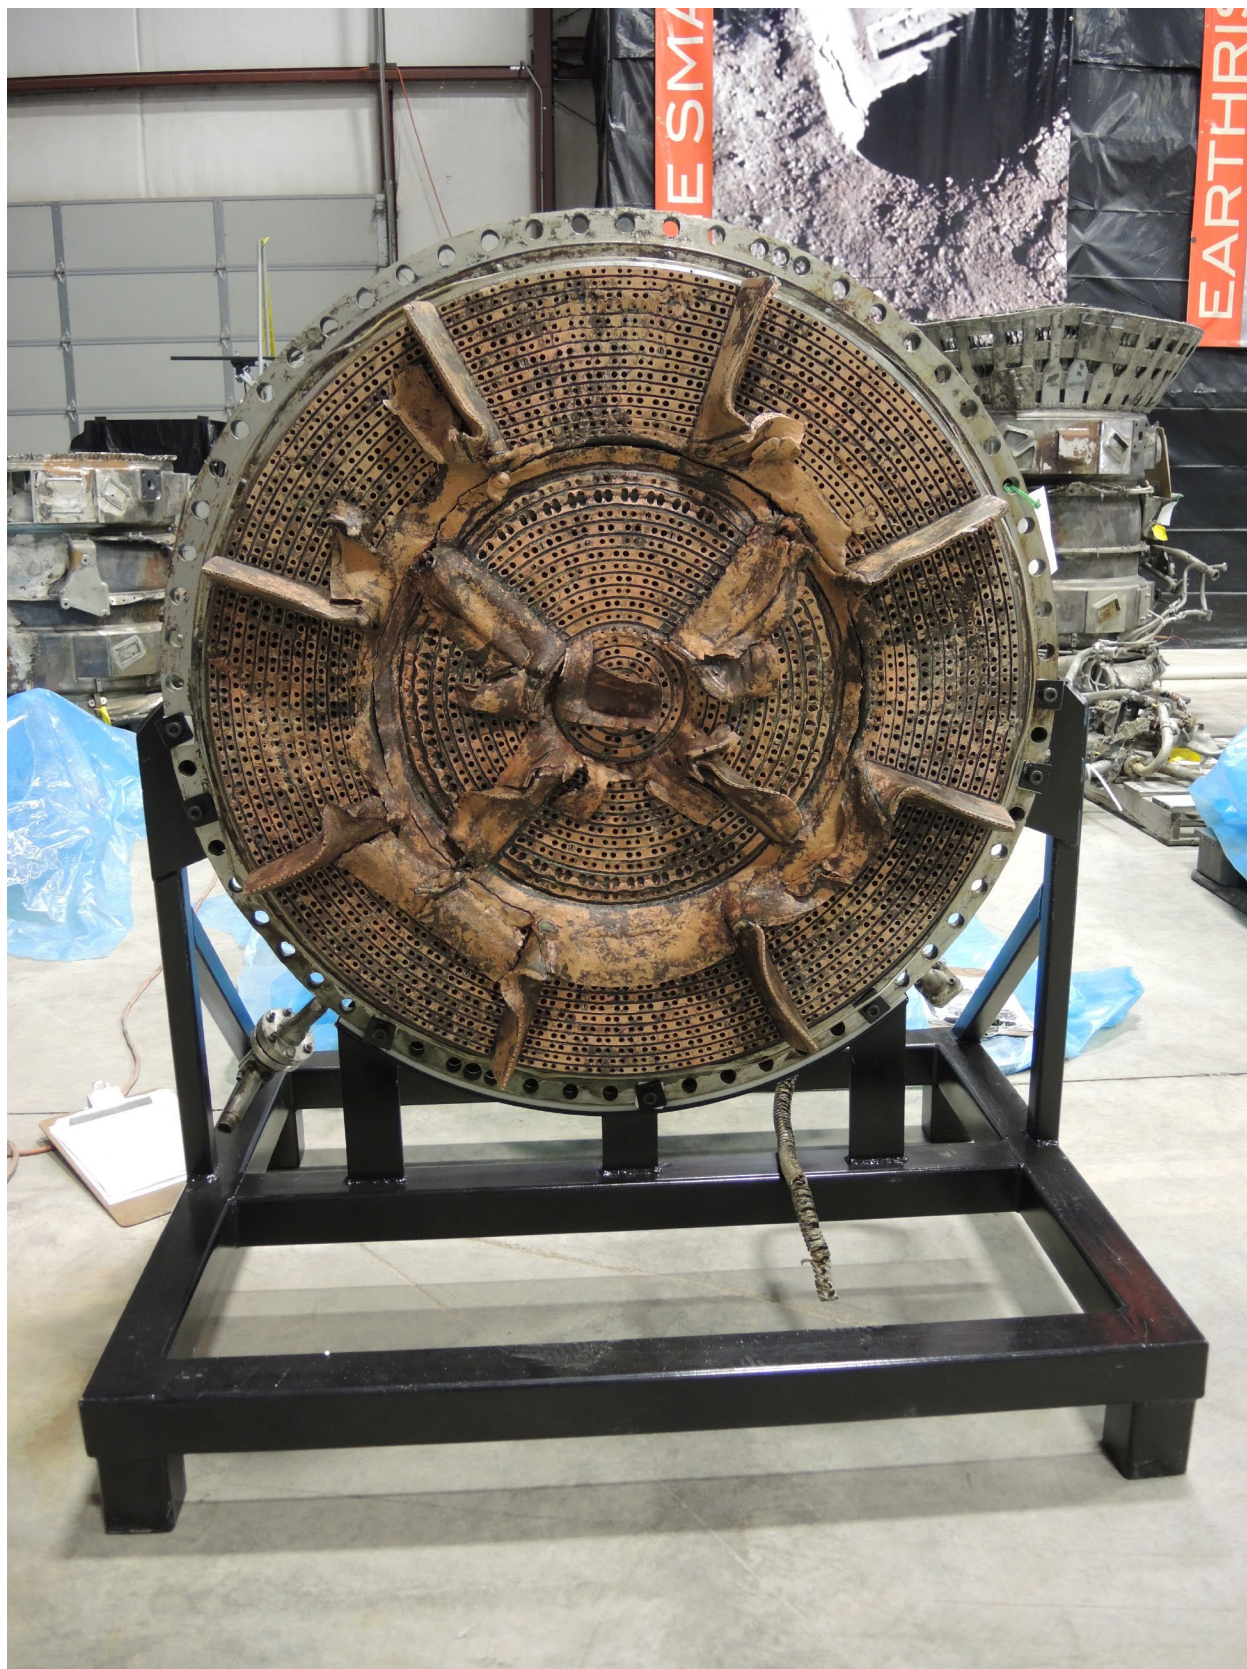
The three fuel injectors, made primarily from copper alloy and 3xx series stainless steel, most likely 304, were found in their original position, sandwiched between an Inconel LOX dome and Inconel thrust chamber. The copper alloy side of the injector was heavily corroded, with bright green corrosion covering the surface, almost certainly due to severe galvanic corrosion. The stainless steel side was also heavily corroded and pitted. The choice of stabilization treatment had to be compatible with both materials, as the object was constructed as one unit and could not be dismantled.

Fig. 13a. View of the fuel injector F1-2013-0005-2 from Apollo 11 before conservation

Fig. 13b. The fuel injector after conservation (Courtesy of Terra Mare Conservation LLC)

The fuel injectors were initially stabilized in a recirculated solution of 1% sodium sesquicarbonate in deionized water to begin chloride extraction, whereas analysis with Raman spectroscopy and x-ray diffraction was undertaken to determine what corrosion products were present. The copper chloride species atacamite and paratacamite were identified, confirming the need for a more interventive treatment to arrest corrosion and stabilize the objects. This was accomplished using a modified version of alkaline Rochelle salts, a treatment familiar to conservators treating archaeological copper alloys. A 0.1M solution (3.9 g/L of sodium hydroxide and 28.2 g/L of sodium potassium tartrate) in 200 L of deionized water was used, and the chloride and copper levels were tracked in the treatment solution. Once the green corrosion products were reduced, the fuel injectors were thoroughly rinsed with a pressure washer, mechanically cleaned to remove corrosion inside the fuel holes, and returned to a 1% solution of sodium sesquicarbonate for final chloride removal. When the chloride levels remained consistently under 2.5 ppm for two months, the rinsing process began. Fuel injector F1-2013-0005-2 is shown before and after conservation in figure 13.

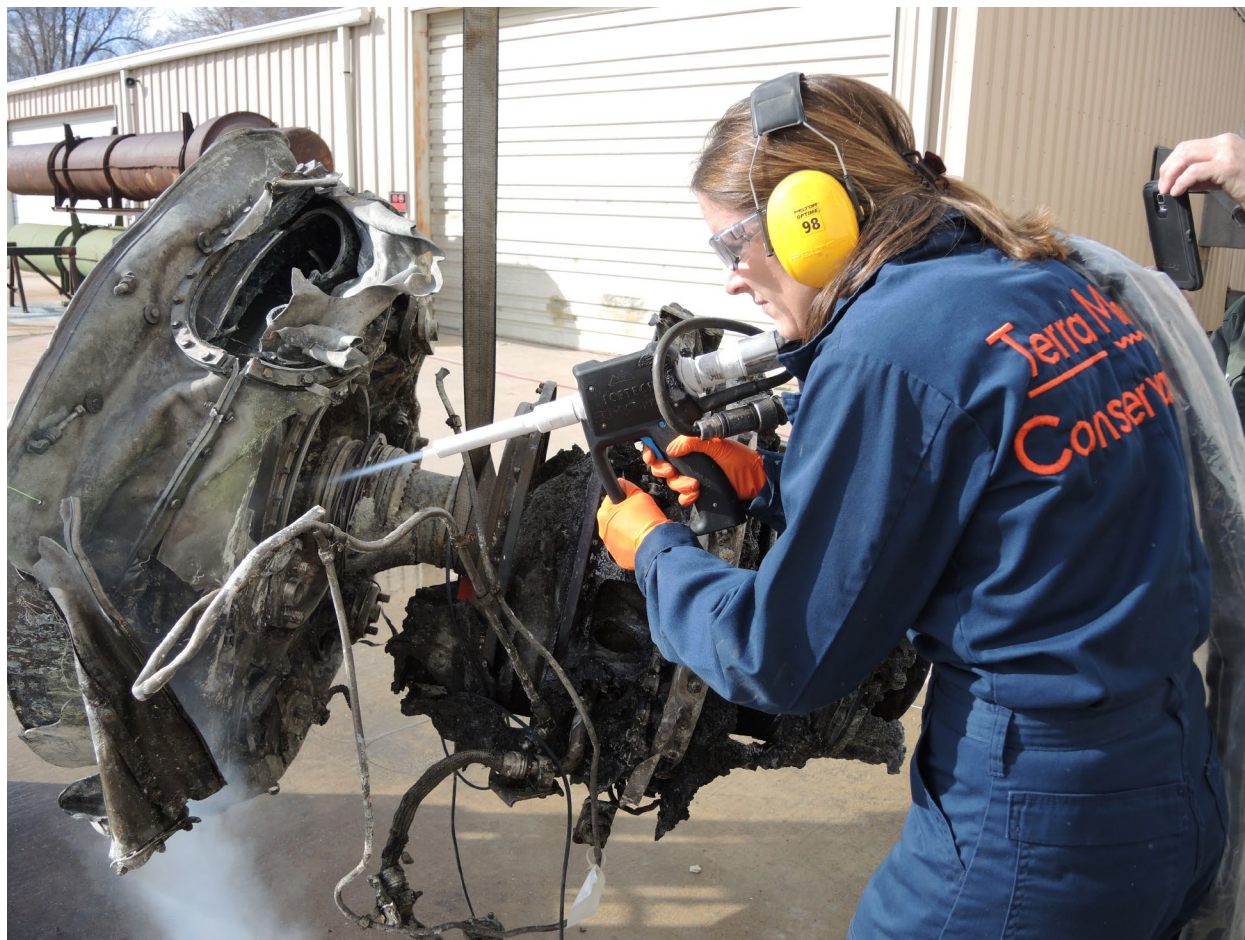
Fig. 14. Conservator Claudia Chemello cleans turbopump F1-2013-0012 with dry ice (Courtesy of Terra Mare Conservation LLC)

After removal of sediment and surface staining, hard, white deposits were still visible on certain parts of the engines. These were assumed to be calcium carbonate from the burial environment. These deposits were tenacious, generally unaffected by the chelating properties of FlashCorr, and were reduced or eliminated with dry ice cleaning after stabilization.
