Hidden Under the Skin: Examination of an Ecuadorian Polychrome *Madonna of the Immaculate Conception*

Bianca M. García • 2016 Graduate Fellow, Winterthur/ University of Delaware Program in Art Conservation • ANAGPIC 2015

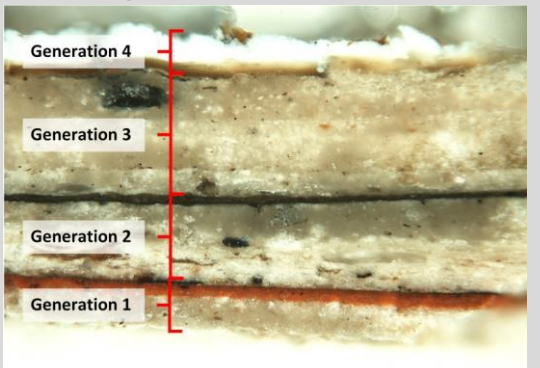
Sample 3

Cross-section microscopy performed on the sites identified in red revealed the presence of four generations of paint. A layer of gilding with paint applied over it in the first generation implies the use of the *estofado* technique. A layer of metal leaf was identified in the second generation. UV fluorescence and fluorescence indicate the use of a carbohydrate and protein binder in the first three generations of paint and an oil binder for the fourth generation.

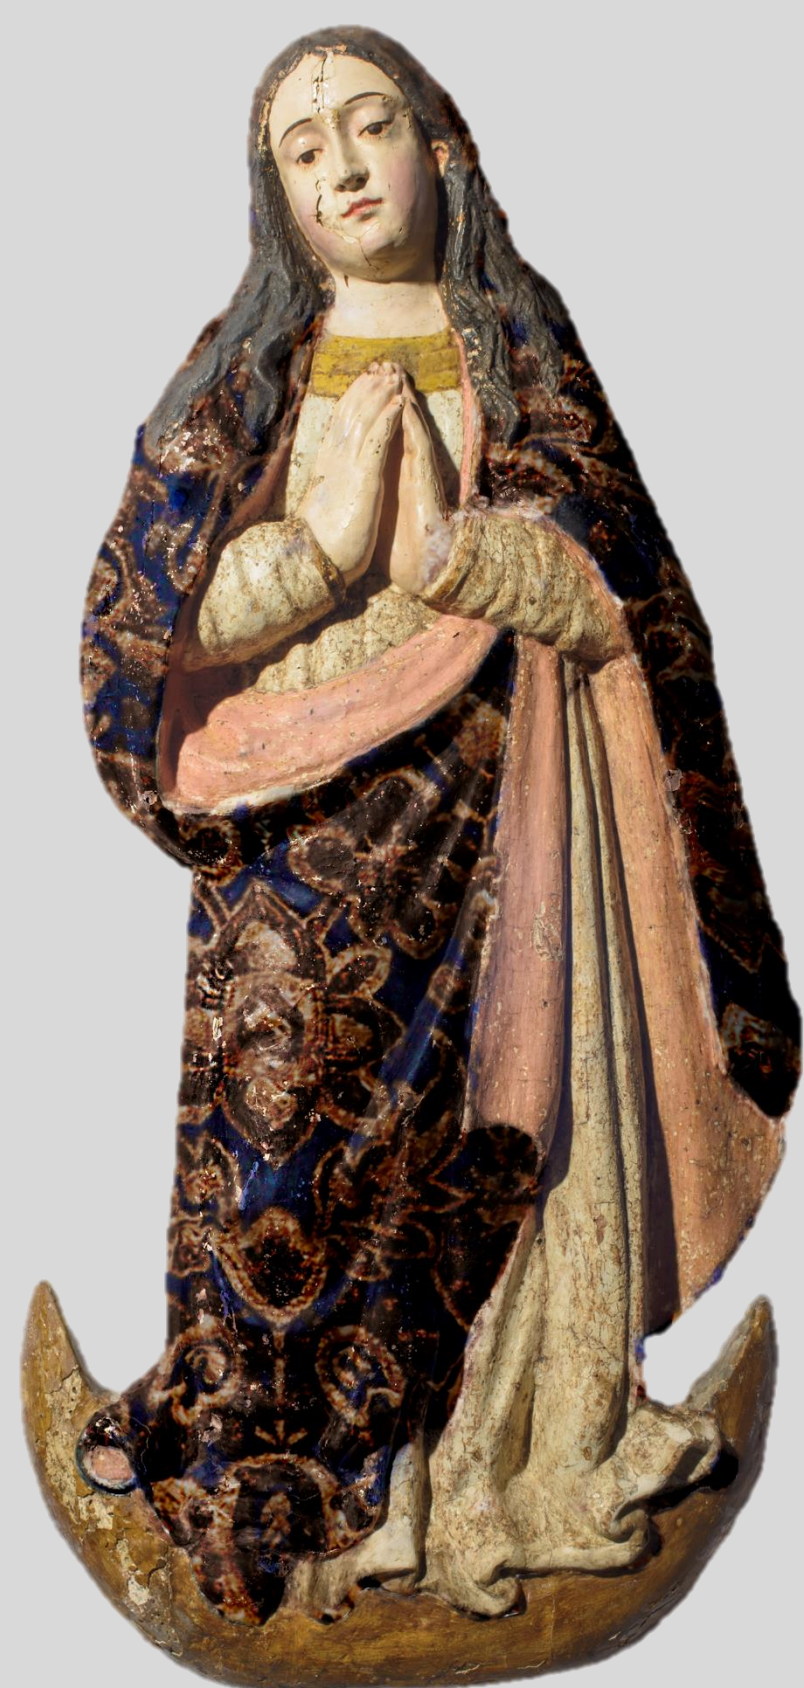
The image on the right is a digital reconstruction of what the sculpture may have originally looked like in the 17th c. The pink and white areas of the drapery and the moon would have also been gilded.
