Haddon Dine

Winterthur/University of Delaware Program in Art Conservation

A 19th-Century Aquarium:

How Collaboration Informed the Technical Study and Treatment

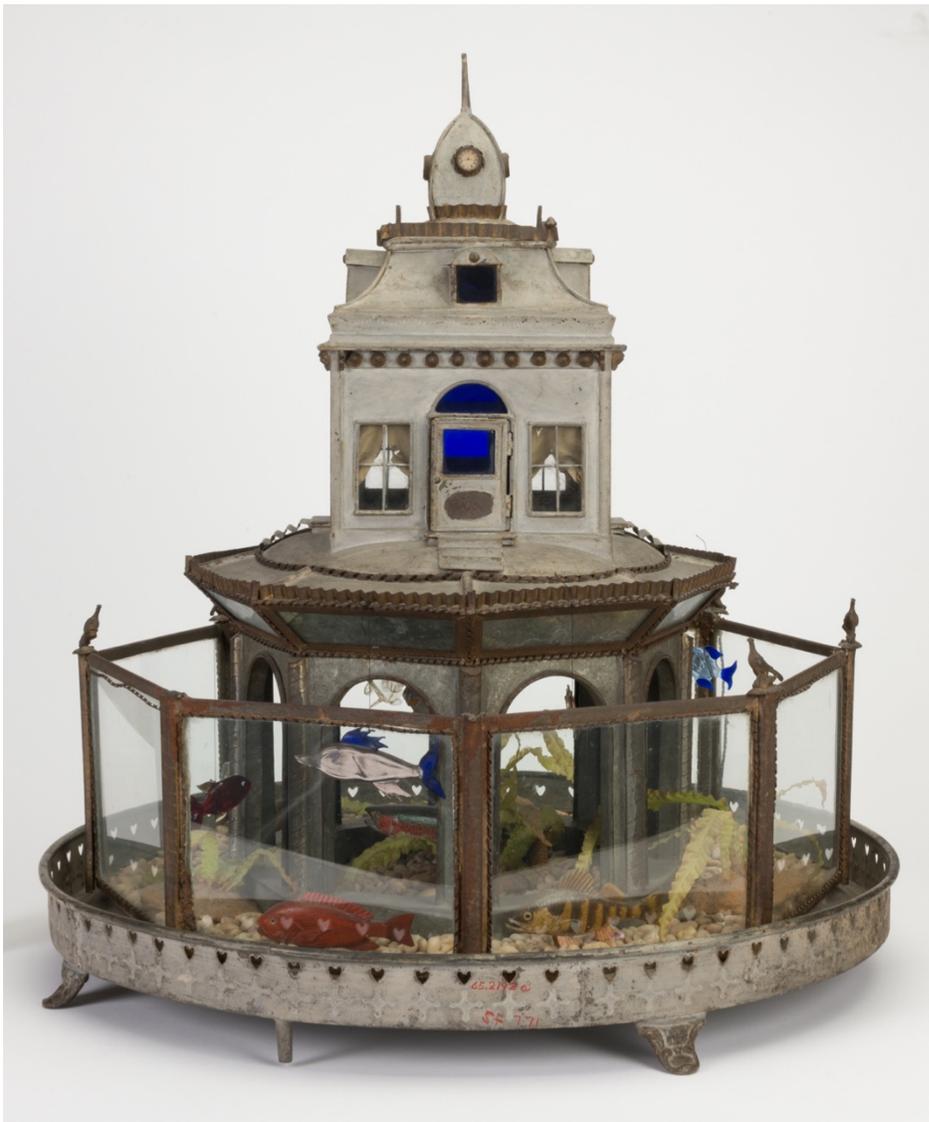
Fig. 1. Overall front view of the aquarium before treatment. Winterthur Museum, Garden & Library. Dimensions: overall height: 23.74 in. (60.30 cm), overall width (diameter): 22.13 in. (56.20 cm). Bequest of Henry Francis du Pont 1965.2192

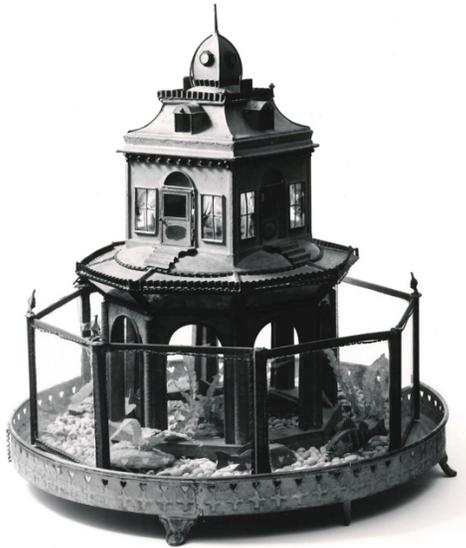
the pavilion would not be parallel to the tank sides, as they were most recently displayed (fig. 1). The 1948 photo of the aquarium from the antique dealer shows the pavilion offset, and sitting inside two of these tabs (fig. 5). There is an undated photo in the Winterthur object file in which the sides are parallel (fig. 8). Due to the absence of the glass fish, that photo is likely earlier than a 1979 photo that shows the architectural structure offset again (fig. 9). It seems the orientation was changed over the years.

Fig. 8. Undated photo in Winterthur object file, with the architectural structure in the parallel configuration.
 Courtesy, Winterthur Museum, Aquarium, 1840-1880, England or United States, Tinned sheet Iron, Bequest of Henry Francis du Pont, 1965.2192

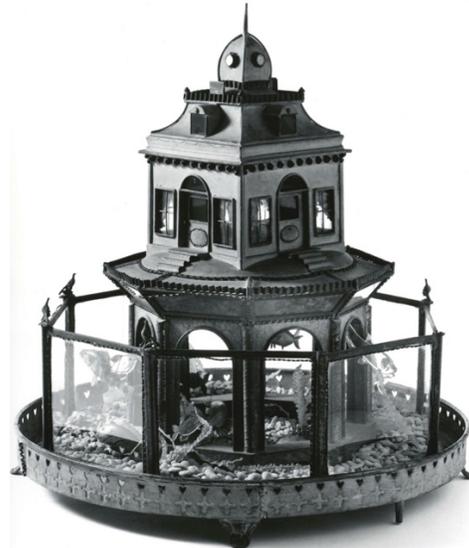
Fig. 9. 1979 photo of the aquarium, with the architectural structure in the offset configuration.
 Courtesy, Winterthur Museum, Aquarium, 1840-1880, England or United States, Tinned sheet Iron, Bequest of Henry Francis du Pont, 1965.2192

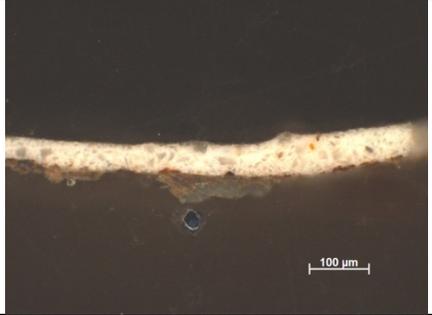
Sample Number	Sample Description	Sampling Location	Normal Light Photomicrograph of Cross Section (20x)	Layers
Sample 1	grey paint, from proper right side of building, dormer window, edge just above blue glass

<ul style="list-style-type: none"> • Grey paint • particles of tin
Sample 2	gold/bronze-colored paint, from Side 1 of the octagonal tank, upper right edge

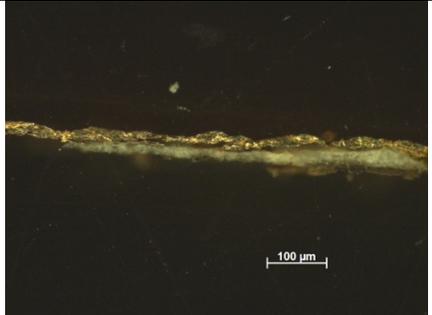
<ul style="list-style-type: none"> • Metallic flake paint • Possible size layer? • Paint layer with similar appearance to paint in Sample 1 • particles of tin

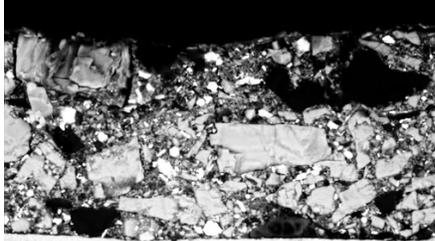
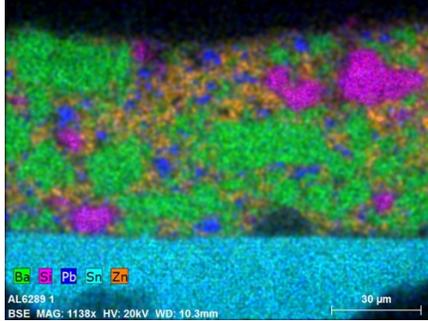
Sample Number and Backscatter electron image	False Color EDS Map	Elemental Results	Identification
<p>1: Grey paint on architectural structure</p>

<p>AL6289 1 BSE MAG: 1138x HV: 20kV WD: 10.3mm</p>	<p>Grey paint layer: Ba, Si, Pb, Zn, and some Ca, Si, Al.</p> <p>Tin on the bottom</p>	<p>zinc white (zinc oxide) with barium sulfate, or lithopone (zinc sulfide coprecipitated with barium sulfate).</p>
<p>2: Metallic paint on tank</p>

There are areas of iron in both cross sections, probably corrosion coming up from below the tin (figs. 12 and 13).¹⁰

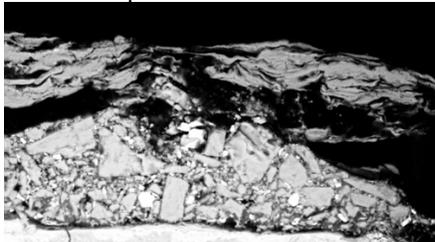
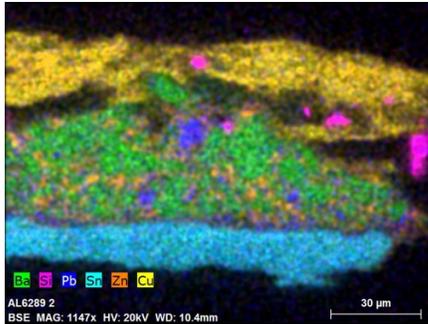
<p>AL6289 2 BSE MAG: 1147x HV: 20kV WD: 10.4mm</p>	<p>Metallic flake layer: Cu and Zn</p> <p>Paint layer: Ba, Zn, Pb</p> <p>Tin on the bottom</p>	<p>The metal is brass (copper and zinc) – bronze powder paint. The paint layer appears similar to the paint in Sample 1.</p>

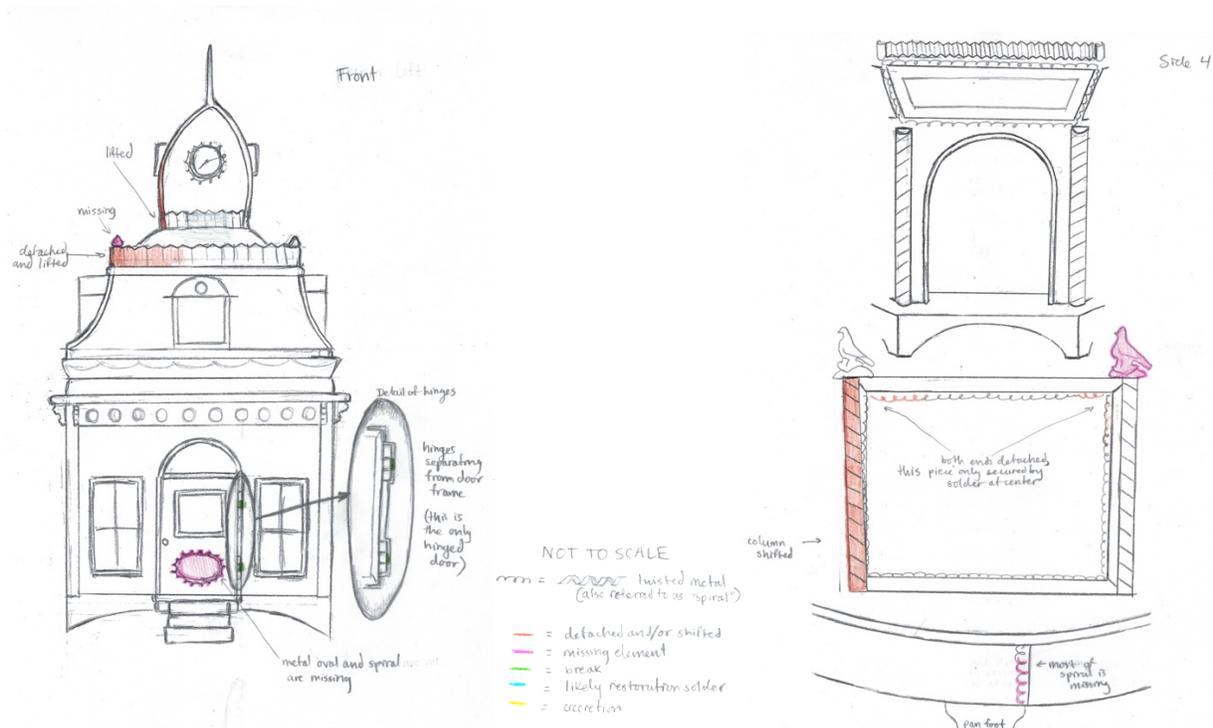
Figs. 18. I made four of the diagram on the left for the four sides of the building, and eight of the diagram on the right, including corresponding pavilion sides, tank sides, and sections of the pan.

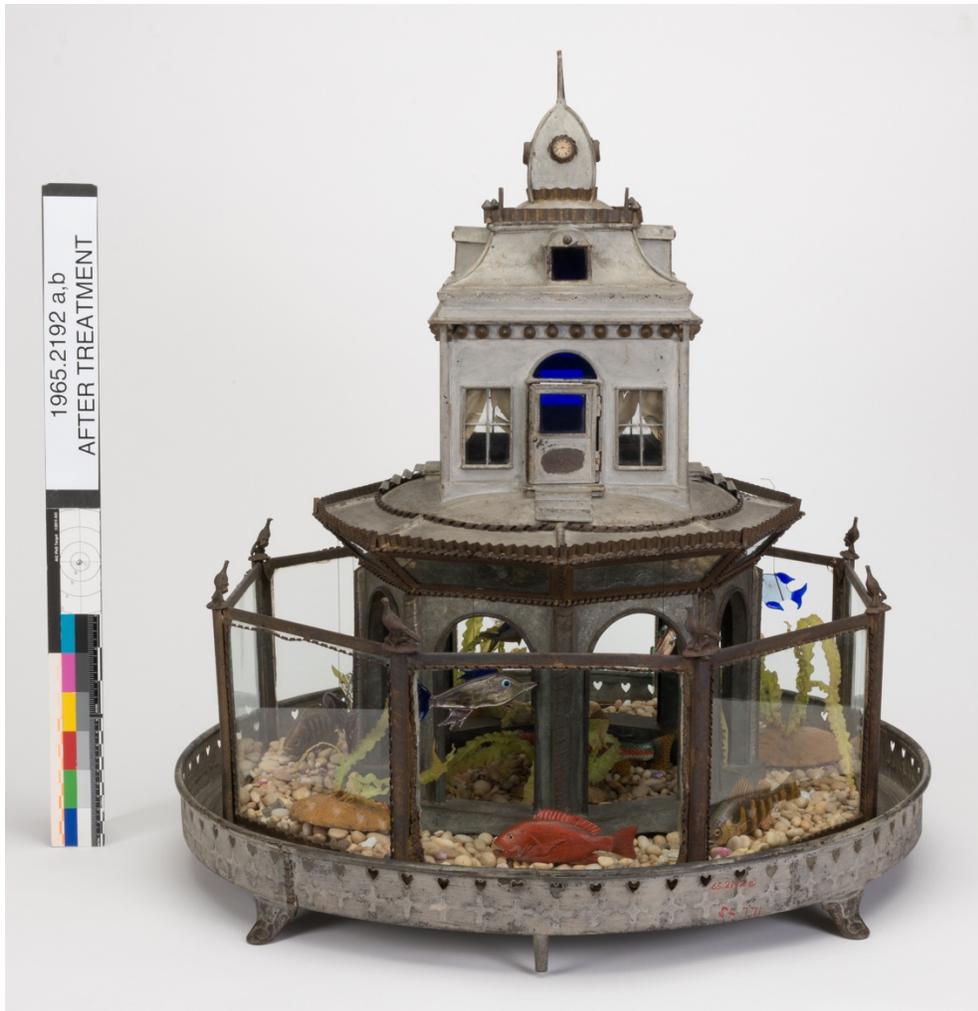
Fig. 25. After treatment photograph of the aquarium. Bequest of Henry Francis du Pont 1965.2192

Finally, the components of the aquarium were reassembled (fig. 25). Before reassembly, inscriptions on the inside of the tank were photographed (these seemed to include calculations or measurements and the word “Front”). The architectural structure was placed back in the tank, with the sides offset, after a discussion with curator Ann Wagner.
