**Gregory Bailey
Buffalo State College**

**About Time:
Analysis and Conservation of a 17th-Century Table Clock**

CNS 695 SPECIALIZATION PROJECT

May 7, 2010

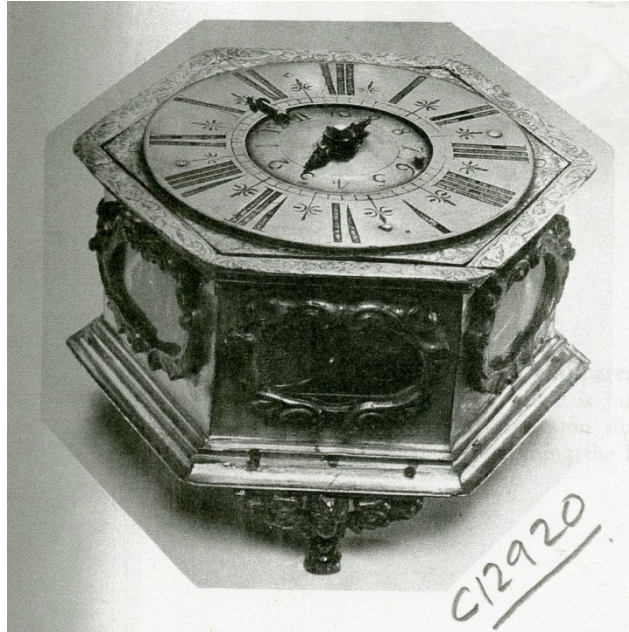
Figure 2, Cummings, V. L. 1965. P. 15

This description is more superficial than that printed in 1937, and may indicate that the clock was not disassembled for this later article. However, inspection of the accompanying picture suggests that the current condition of the clock is similar or

identical to its condition in 1965. Cracks in the metal, abrasions to the gilding, and losses to the hour numeral inlay appear extremely similar. Interestingly, the hour hand in the 1965 picture reads approximately 7:30, whereas the current position of the hand reads 5:30. The alarm set appears in the same position. This may indicate that the hour train was wound and set to going sometime between 1965 and 2009. As the drive spring for this train was partially wound and under tension when this clock was received (as revealed by x-ray radiography), this is a distinct possibility.

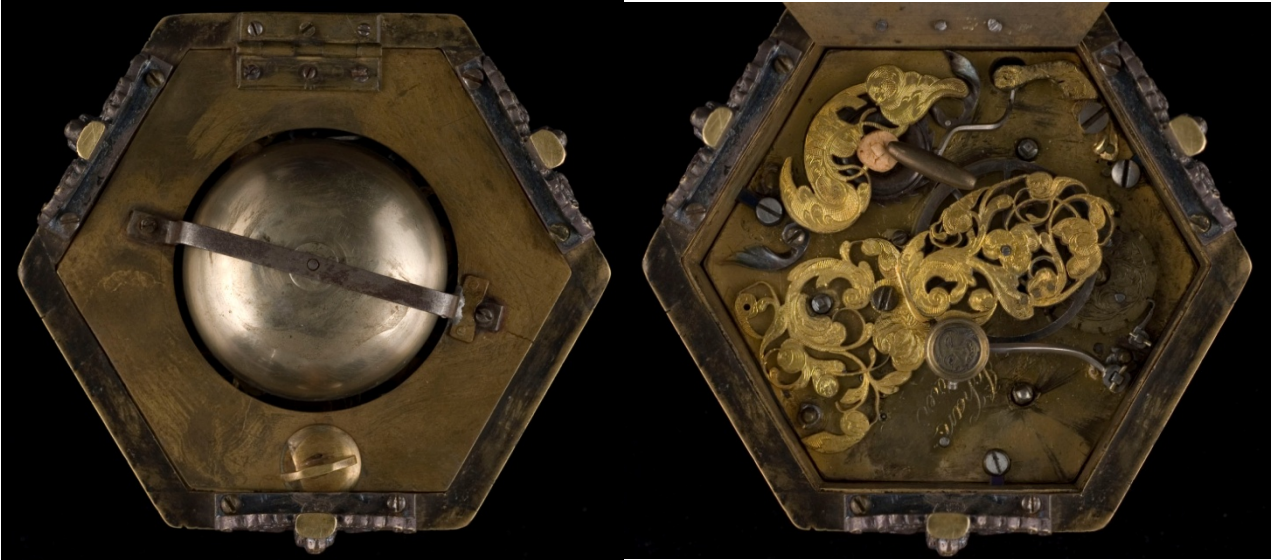
Figure 6, Buffalo Scheirer clock before treatment Left: Bottom, bell plate closed Right: Base plate, bell plate opened

table clocks with anthropomorphic or grotesque heads is quite common, and not indicative of a particular location.¹⁵ Other works visible on the base plate of the Buffalo clock show signs of alteration or repair, including the bushing, drilling, and filing of pivots, the cutting and addition of part of a cock, and the addition of a cork raiser.

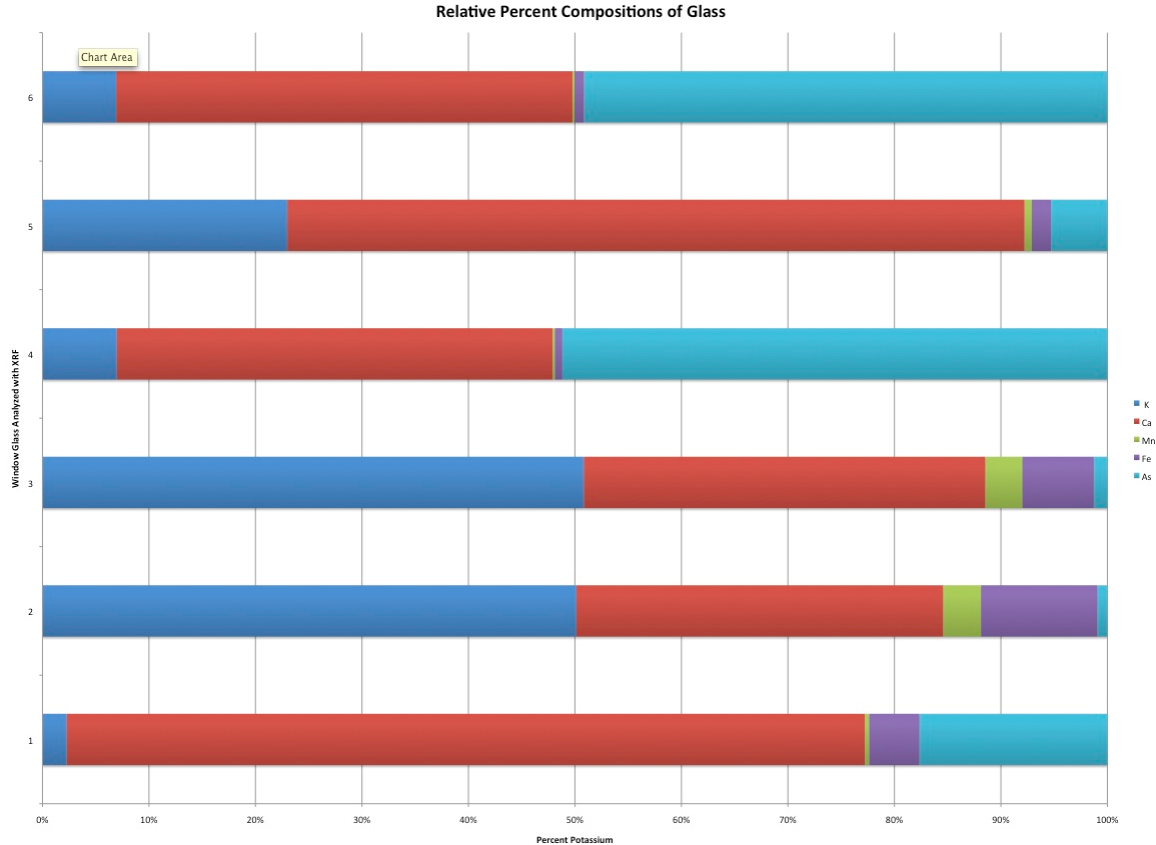
Figure 11, chart showing relative percent composition of glass windows analyzed with XRF. Note: components 1-6 correspond to window glasses 12 o'clock to 10 o'clock.

The glass windows at 2 and 4 o'clock appear very similar in elemental composition. Potassium was identified as the primary flux agent, with substantial amounts of calcium likely present as a network stabilizer. Small but significant amounts of iron and manganese were found to be present in both glass windows. Iron is present as an impurity in most glass, imparting a green/brown color. Manganese has traditionally been used as a "clarifying agent" to counteract the color of iron by imparting a pink/purple color. This ancient method of producing transparent glass often results in a faint blue/green color, which is observed on both of these examples.²⁹ The presence of trace amounts of a metal such as strontium in the glass at 4 o'clock may account for its faint fluorescence under UVA and UVC.³⁰

Interestingly, the XRF spectrum for the window glass at 8 o'clock exhibits a strong peak for zinc, which is not typically employed in the manufacture of glass. This may indicate a surface deposit of zinc-containing material, or may indicate the presence of a complex glass corrosion product.

alkaline environment can result from the leaching of calcium and potassium ions during glass corrosion. It is possible that corrosion of this glass facilitated the dezincification of the brass with which it was in contact, in turn forming a complex glass corrosion product.

Microscopic examination of the glass surface, however, does not show the microscopic network of fissures that typifies glass corrosion. Instead, the surface appears to be covered in what resemble drying spots. This suggests that the zinc peak observed with XRF may in fact be due to a material applied to the surface purposefully or accidentally.

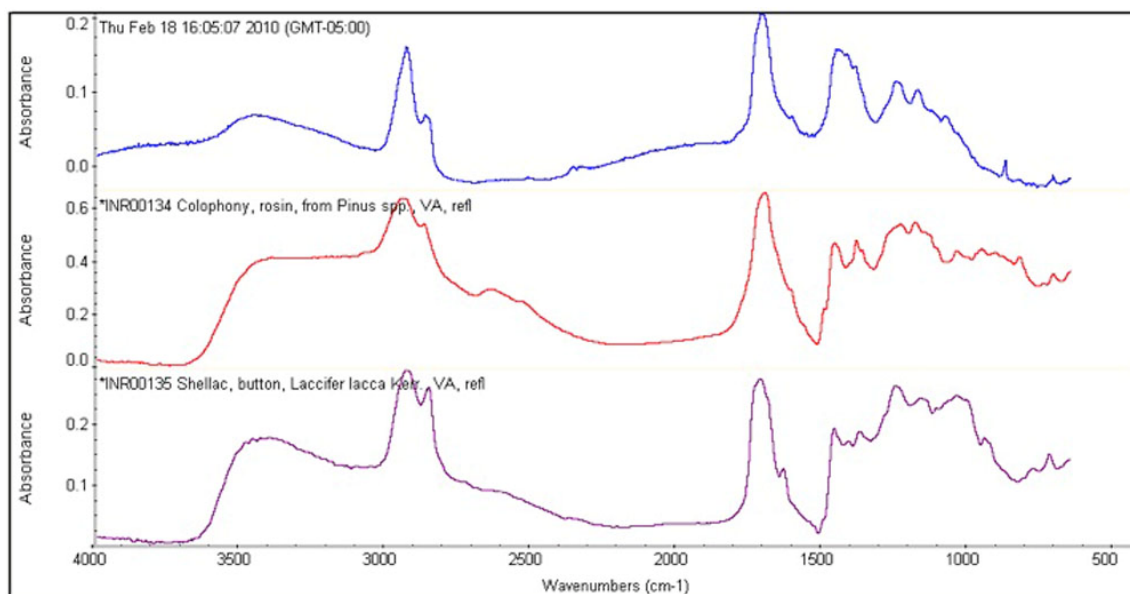
Figure 13, FTIR spectra for unknown fill material (top, blue), known sample of rosin (center, red), and known sample of shellac (bottom, purple).

The material used to fill the engraved Roman numerals on the chapter ring of the clock appears dark, cracked, and is brittle when probed. The fill material fluoresces in the visible range under long wave ultraviolet radiation, suggesting that it is organic in nature. To better characterize this material, transmission Fourier Transform Infrared Microscopy (FTIR) was undertaken (See Appendix XIV i b: FTIR).

Analysis with FTIR suggests that the material used to fill the numerals is a softwood resin or pitch, though the similarity to other natural resins, such as that of the lac insect, makes it difficult to identify the material with absolute certainty. Pine pitch or

rosin is a traditional material that has historically been widely used as a fill material.³⁵ Pitch or rosin has been widely available for millennia, and may have been chosen for this application because it is easily applied as a fill, and its dark color would have contrasted with the original bright silver of the chapter ring, enhancing the legibility of the numbers.

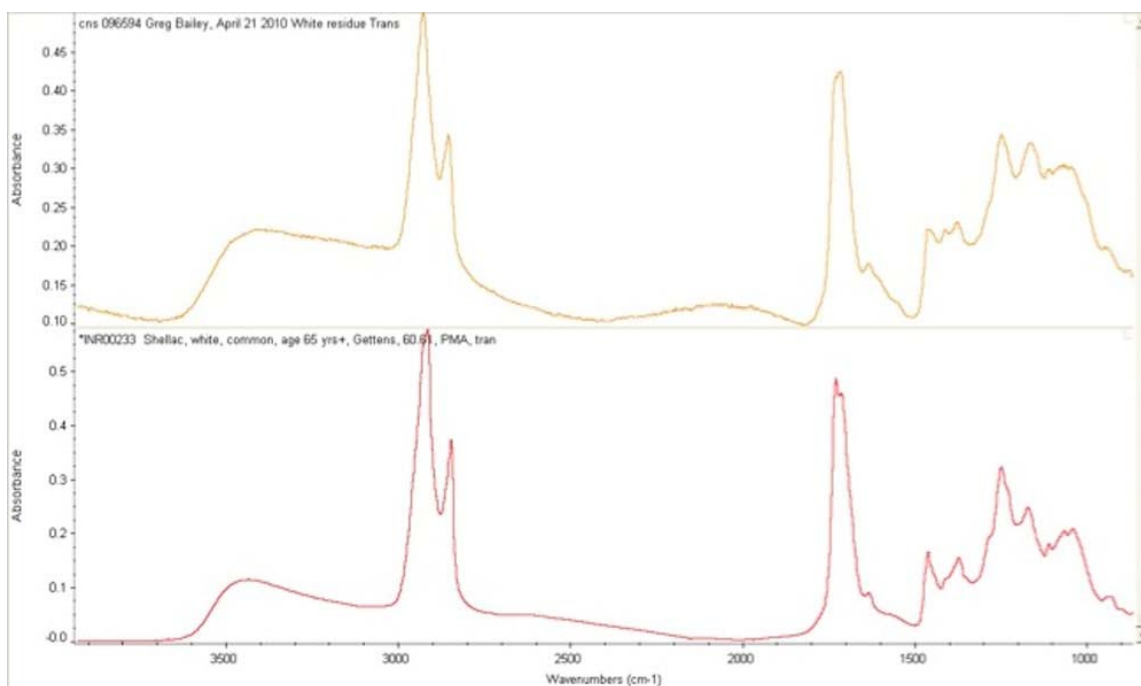
Figure 16, FTIR spectra for unknown residue (top, yellow), and known sample of aged white shellac (bottom, red)

To better characterize the residue and identify any potential coating on the silvered surfaces, FTIR analysis was performed on a sample of the hazy white residue from the exterior of the clock case at 4 o'clock. The spectrum for the sample was an extremely close match to white shellac, a form of processed shellac from which nearly all of the red lac dye has been removed. This shellac was likely applied as a protective coating to the silvered frames after they were polished at some time in the past two hundred years. Shellac was not in common use in Europe in the seventeenth century, and the coating is therefore unlikely to be original.

This finding may explain why FTIR analysis of fill material from the Roman numerals suggested the presence of shellac. The hour chapter ring was originally silvered, and may have been polished and shellacked at the same time as the other silvered elements. Though the silver and the shellac have been removed, it is possible that traces of shellac remain in the fill material.

Analysis with FTIR clearly identified the presence of a deteriorated protective coating. Accordingly, appropriate solvents were used during cleaning and polishing to facilitate the removal of the degraded shellac.

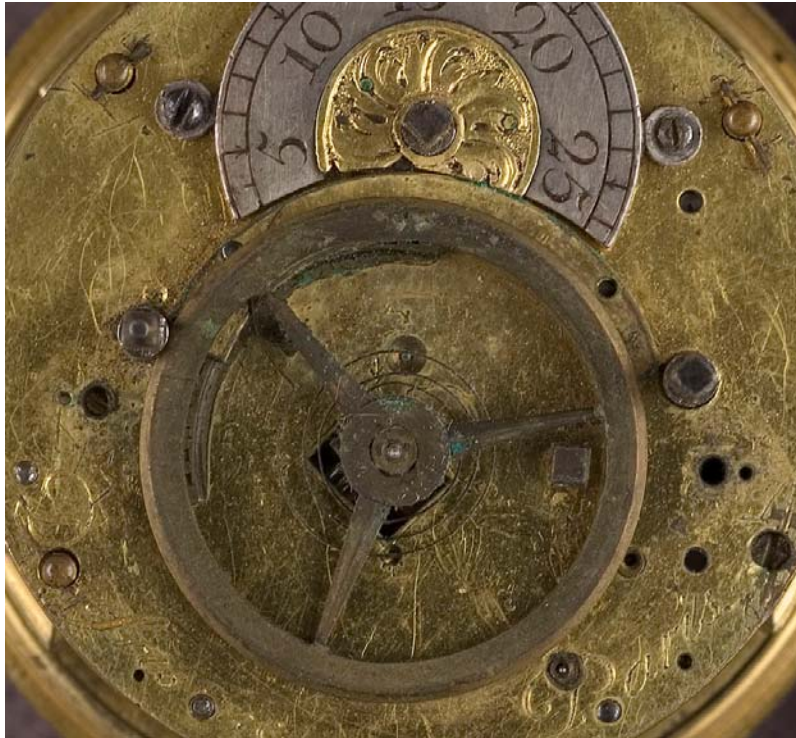
invention of the spring balance wheel. This watch has a double-footed cock that entirely covers and protects the balance wheel. The balance wheel is made of brass, as is the verge escapement and the rest of the movement. The spring is integrated into the guard, and no secondary guide is present. The spring is rather long, and coiled several times around the arbor of the escapement. No holes, fills, or scratches are present on the base plate, suggesting that no structural alterations have been made and that the extant movement is original.

Figure 26, DuFresne, Paris, 1698. Original late-seventeenth-century spring balance

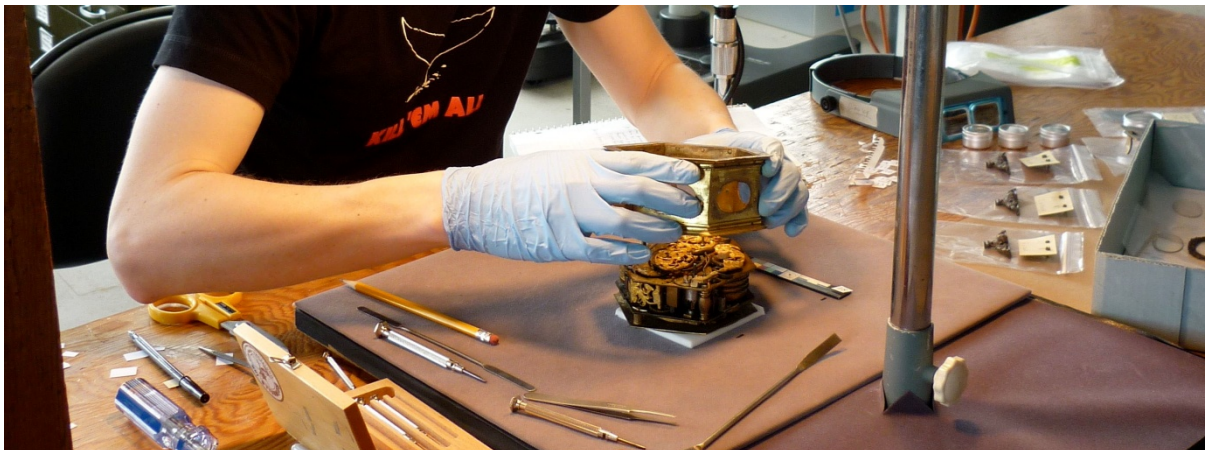
Figure 28, Pulling the works from the case

The clock works and case were partially disassembled for purposes of analysis and documentation. Minimal intervention in the functioning of the works was deemed appropriate, and accordingly, treatment was largely restricted to cleaning, polishing, and lacquering.

All metal surfaces were cleaned initially with acetone rolled on cotton swabs to reduce dirt and grime. Glass was cleaned using a 50%-50% mixture of deionized water and ethanol rolled on cotton swabs.
