Article: An Examination of Duplicating Film Damaged by Water in 1986

Author(s): Robin Siegel

Topics in Photographic Preservation, Volume 8.

Conservator, National Geographic Society

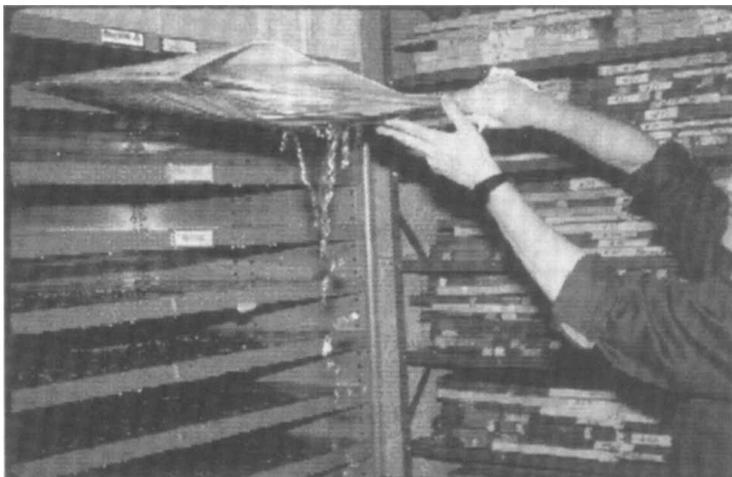
All that was affected was one small area of the second floor where photographic and photomechanical engraving materials were stored. The engineers had spent the afternoon removing water from the floor, not realizing how much water had intruded into the boxes and envelopes of photographs. Having dried the rug as much as possible, the engineers left at around 11:00, giving us a little more room to work. Each of more than 100 envelopes and boxes of film, ranging from two feet long up to four feet by four feet square had to be opened and checked.

Fortunately, most of boxes were dry inside, so we moved to the shelved envelopes of engravers dupes. Starting from the bottom, we began removing them from file, draining enough water so that they could be transferred downstairs to the main floor. Many of the envelopes were filled with water, increasingly so as we moved up the shelves.
