Source: *Objects Specialty Group Postprints, Volume Nine, 2002*

TEN YEARS OF SCULPTURE AND MONUMENT CONSERVATION ON THE MINNESOTA STATE CAPITOL MALL

Paul S. Storch

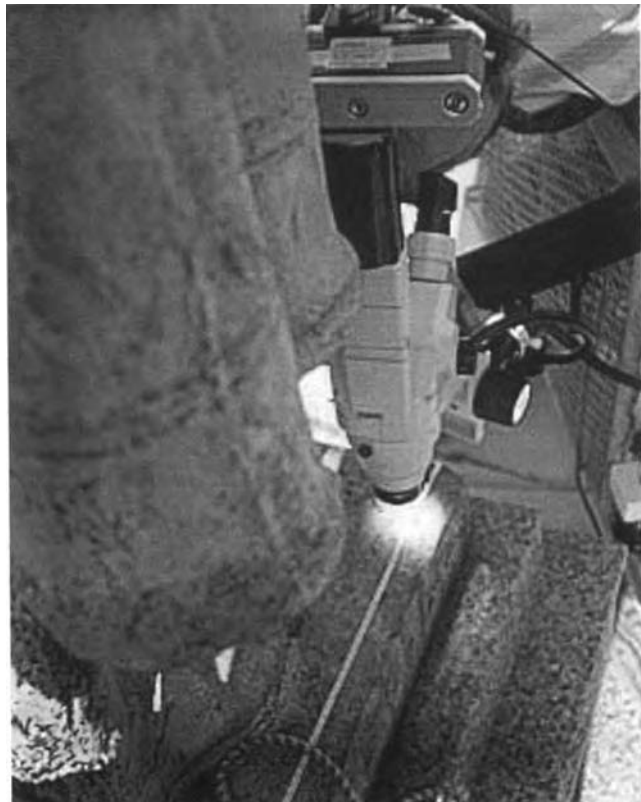
properly maintained. It had weathered and corroded from its original “Roman bronze” patination to a dull, mottled greenish-tan. The Italian-American Society requested that the treatment be completed in time for the 500th Columbus Day anniversary celebration in October 1992. The project was submitted for bids from contract conservation firms, and Fine Objects Conservation Inc. (FOC, Inc.) was awarded the bid. Based on her work on the Garfield Memorial at the US Capitol, Linda Merck-Gould, president of FOC, Inc., proposed that the bronze be cleaned with medium pressure water (1000-1400 psi), followed by an application of benzotriazole, chemical patination, and coating with Incralac and carnauba wax. Ms. Merck-Gould devised an on-site testing project that would take place prior to the actual treatment of the sculpture in order to finalize the treatment specifications. The exact details and results of the testing done on the Columbus sculpture in coordination with the MHS conservation department were published in a paper presented by Ms. Merck-Gould at the 1993 ICOM Committee for Conservation Conference (Merck-Gould 1993) (Fig. 7).

Figure 7. The author taking photo-micrographs of the medium water pressure cleaning test results on the self base of *Christopher Columbus*, in 1992.

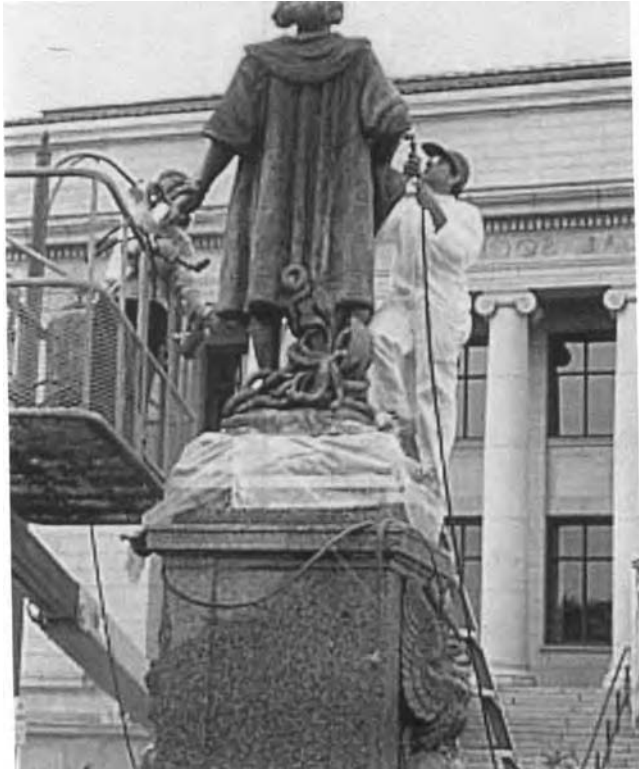
- Patina application can be done with greater fineness and results in a more subtle patina (Fig. 8).
- The bronze surface does not undergo any deformation, based on tests published by Andrew Lins in 1989 using 750 psi. Even “softer” abrasives such as walnut shells and corn cobs cause loss of surface metal (Lins 1992).
- The health hazard from inhalation of dust to the operator and passersby is eliminated.
- There is no expended abrasive to clean up around the site. This is especially a concern on the heavily trafficked Mall.
- The technique takes less time to perform than particulate abrasive techniques and is therefore less costly.
- The appearance of the bronze surface is very similar to that left by walnut shell cleaning, and does not leave a bright metal surface.

Figure 8. FOC, Inc., re-patinating *Christopher Columbus* in 1992.

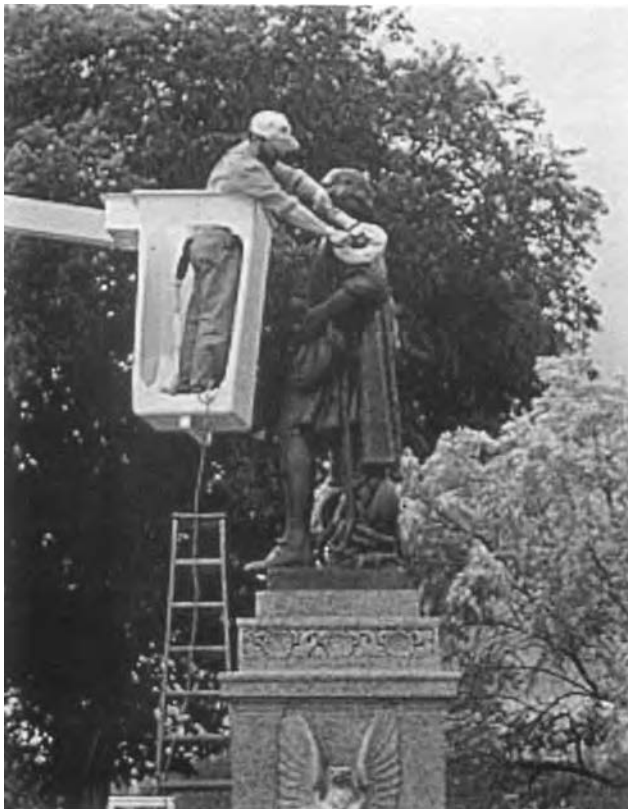
Figure 11. The author performing annual maintenance on *Christopher Columbus*, 1995.

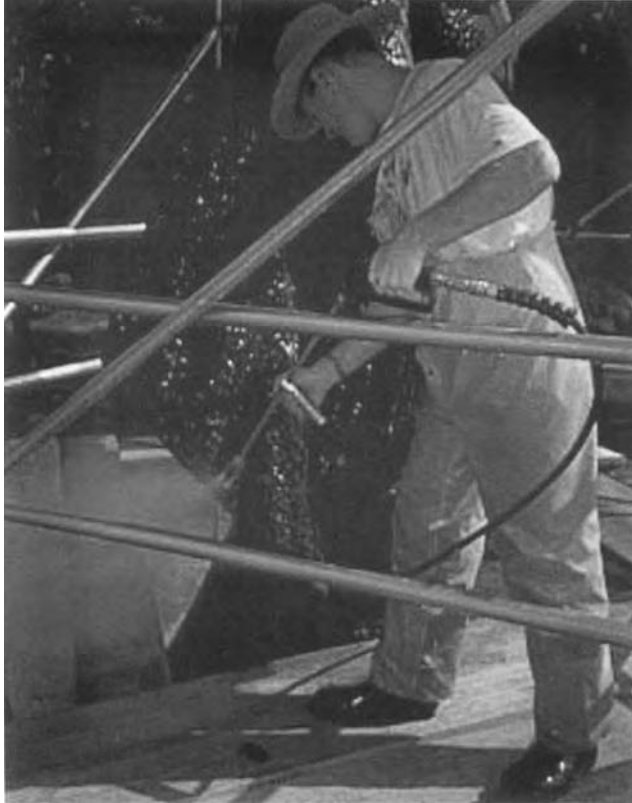
Figure 12. CTA staff cleaning *Leif Erickson*, 1996.

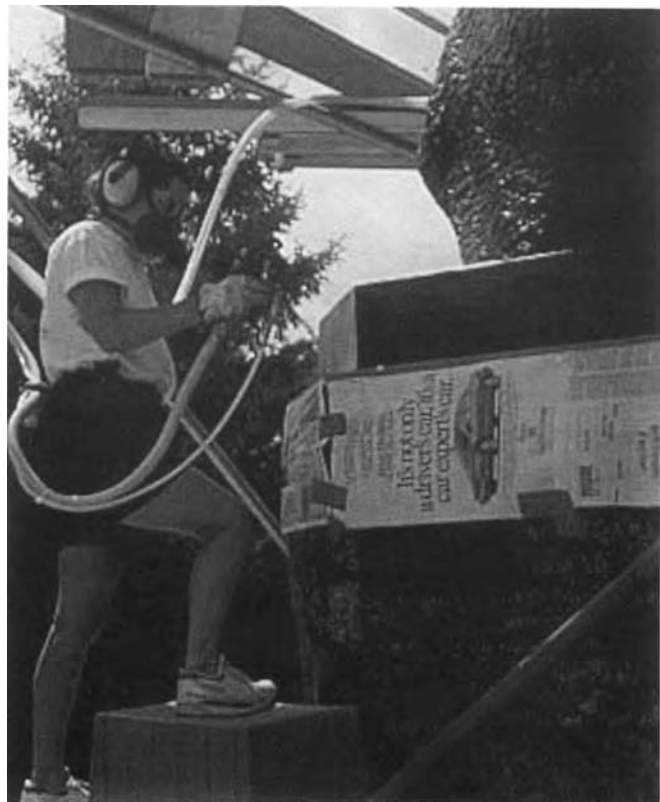
Figure 13. CTA staff applying Incralac lacquer to the self base of *Leif Erickson*, 1996.

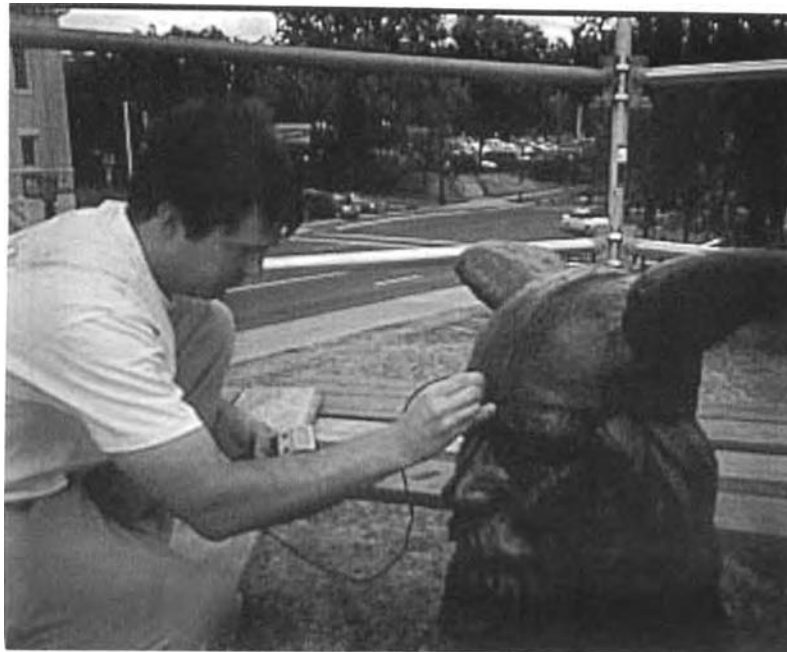
In 1995, the Sons of Norway, a local benevolent society, having seen the success of the conservation of the Columbus statue, donated money to the state for the treatment of John Karl Daniels 1949 bronze statue of Leif Erikson. Again, Linda Merck-Gould's firm, now known as Conservation Technical Associates, LLC, was awarded the bid for the contract. The statue was treated with medium pressure water at 3800 psi. (Fig. 12), chemically patinated, and coated with Incralac (Fig. 13). The innovation used in this treatment was developed by Joe Sembrat, who was working for CTA at that time. Joe had researched paint and coating industry thickness testing methods and how they could be applied to outdoor sculpture conservation treatments. A DeFelsko Corporation NSI Positector 6000 thickness tester was used to verify that the manufacturer recommended thickness of 1.0 mil +/- 0.1 mil for the Incralac coating was indeed obtained (Figs. 14 and 15). The electronic instrument operates on the Eddy Effect, which is used to gauge the distance of a magnetic coil probe to a non-metallic surface. As the probe is moved close to the object surface, the inductance decreases and the resistance increases, which allows the thickness of an intervening surface coating to be measured. The instrument is zeroed-out on an uncoated area, then a series of 10 readings are taken over the coated areas and averaged together. The instrument is accurate to +/-0.1 mil. The difficulty in using the instrument on such a heavily textured sculpture as this one is the problem of finding a large enough flat area for a precise reading. The self-base lends itself to such an instrument. The textured areas, however, have a large variance in the readings. This method was used to verify the coating quality at the time of

Figure 14. CTA staff taking coating thickness measurements on the head of *Leif Erickson* after treatment, 1996.

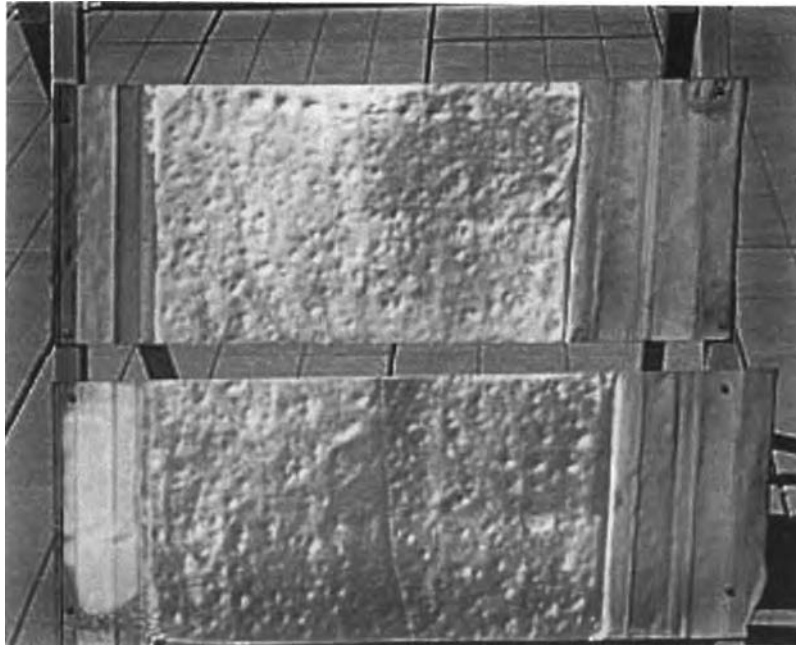
corrosion on the test panels. The rack will be left in place as a control and reference to track on-going weathering effects on the Quadriga.

Figure 19. Gilding test panel set up on the State Capitol roof to track weathering changes, 2001.

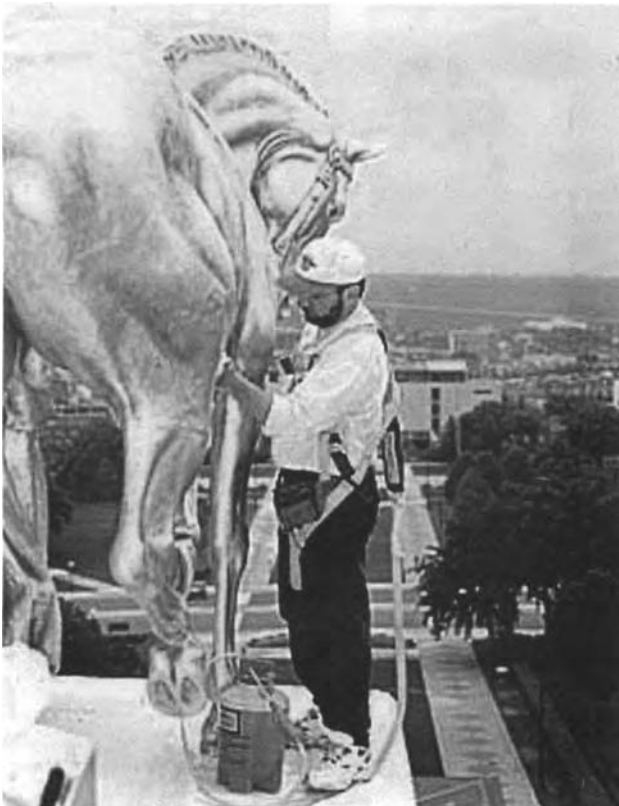
Figure 20. The author performing annual maintenance on the Quadriga, washing and waxing gilded surfaces, 1998.
