Article: Three case studies of outdoor sculpture with problematic intent issues

Author(s): Michael Belman

Source: *Objects Specialty Group Postprints, Volume Nine, 2002*

THREE CASE STUDIES OF OUTDOOR SCULPTURE WITH PROBLEMATIC INTENT ISSUES

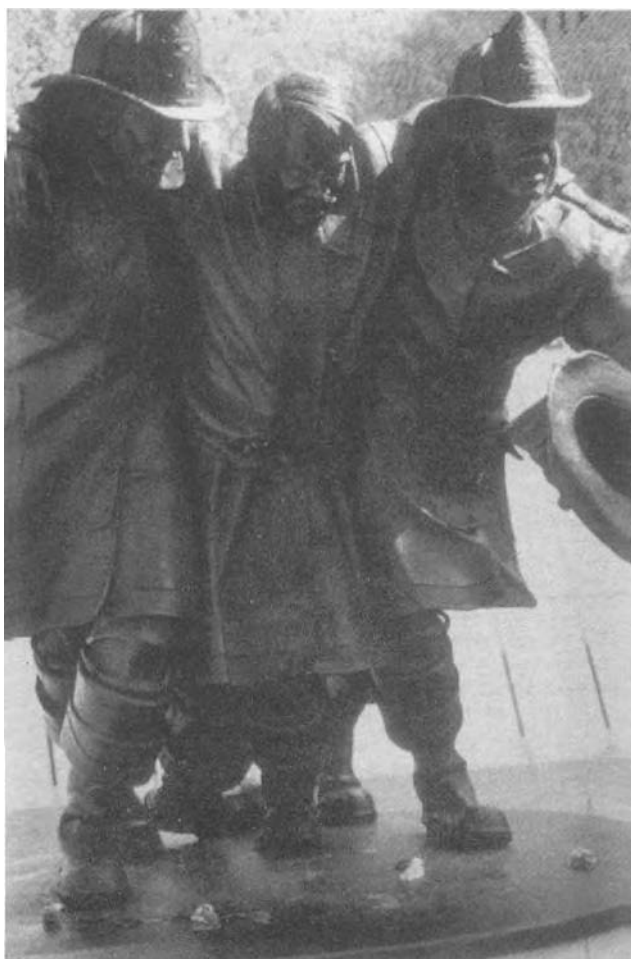
Figure 1. *The New York State Fallen Firefighters Memorial*. Robert Eccleston, 1998, bronze. (11' 4" x 6' 5" x 7' 3") Empire State Plaza Art Collection.

In the process of maintaining the memorial, objects conservators from the Williamstown Art Conservation Center observed that the public often places flowers both against the wall of names and on the wide, flat base surrounding the sculpture. It is unclear if it was ever intended for flowers to be put on the base, or if they should only be placed against the wall.

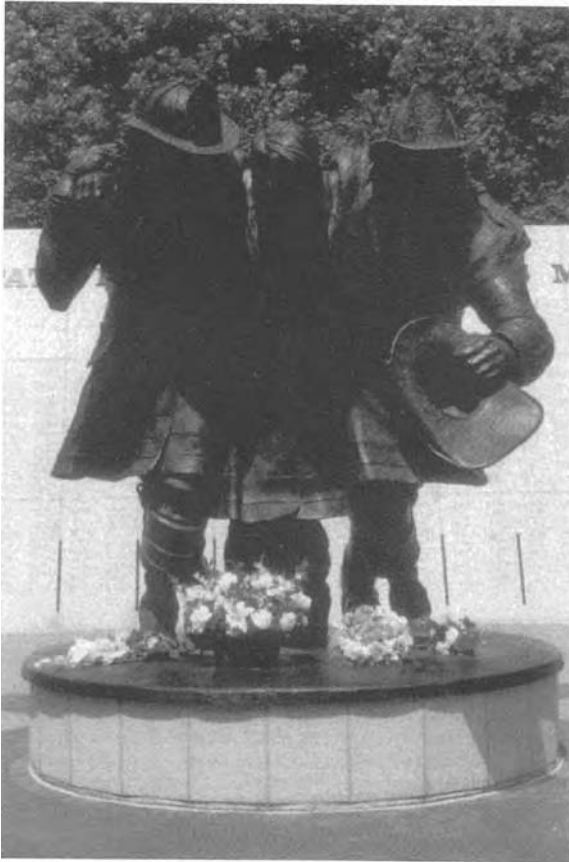
A Williamstown representative attended the ceremony only a few days later, and observed that someone had cleared off the 911 memorial objects and a new group of more formal, funeral type flowers were accumulating (see Fig. 4). It was reasoned that those who were lost in the World Trade Center in 2001 should not eclipse the memory of the firefighters who died in 2000. There were many speeches given by chaplains, rabbis, the governor and other politicians. Fig. 5 shows the dramatic highpoint, when wreathes were laid on base of the sculpture accompanied by a bagpipe. Objects conservators visited the plaza during the week after the ceremony and noticed that the 911 memorial objects were back on the sculpture again.

Figure 4. *The New York State Fallen Firefighters Memorial*. Robert Eccleston. Overall view with flowers commemorating the firefighters that died during the year 2000. Photo taken October 6th, 2001.

Williamstown Art Conservation Center recommended that New York State develop a set procedure for sharing the monument, one that would involve sensitively collecting the memorial items in order to minimize the prolonged contact that causes such damage. A protective mat could be laid out on the base during ceremonies or other periods of remembrance. Another solution, although one that would significantly change the current use pattern, is to set a small sign into the base respectfully asking to please put flowers against the wall.

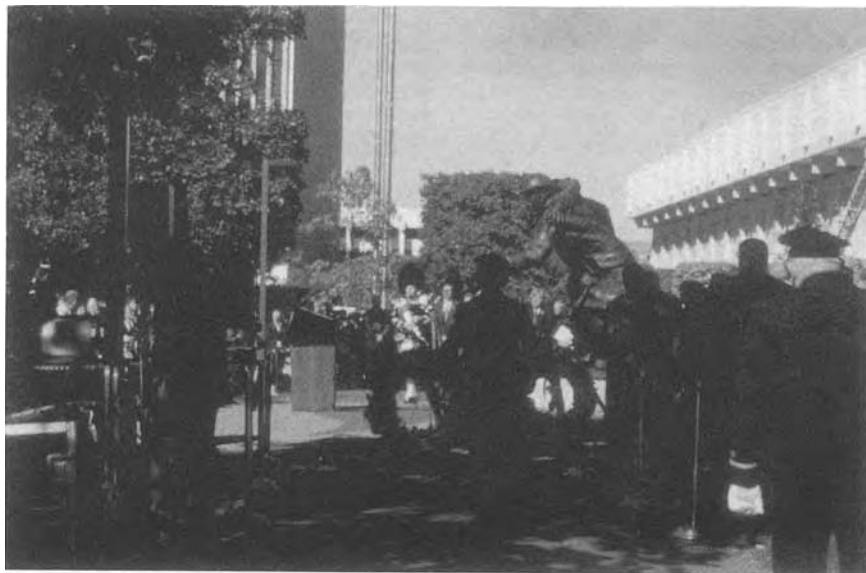
Figure 5. *The New York State Fallen Firefighters Memorial*. The dramatic highpoint of the Rededication Ceremony, when wreaths were laid on the base of the sculpture, accompanied by a bagpiper. Governor George Pataki can be seen in the background. Photo taken October 9th, 2001.

It is unfortunate that the design of the base can invite recurrent damage. At the same time, however, it seems completely appropriate that the accumulated wear comes from those who are in the process of remembering. While the wall contains the names of the fallen, the sculpture provides a more tangible visual focal point. In the act of placing flowers on the base, mourners intuitively get a different sense of their loved ones heroic sacrifice. The accumulating wear can be viewed as evidence of this interaction.

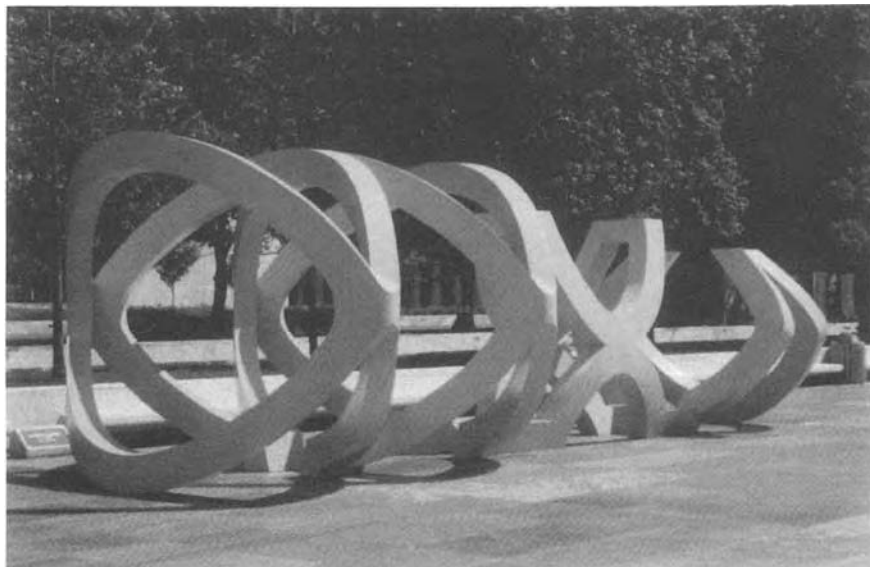
Figure 6. *Trio*. George Sugarman, 1968-71, painted aluminum. (10' x 32' x 13') Empire State Plaza Art Collection.

When the sculpture arrived from the fabricator, structural cracks had developed in the relatively small contact points where the arching shapes come together. As early as 1979, a condition report from the Albany Institute for History and Art pointed out that since its installation, the weight of people climbing on the un-reinforced sculpture had worsened the original damage. Fabricated from a weak aluminum alloy, the report recommended that structural repairs be made by re-welding the cracked areas and that the work should be bolted down in an area that is not as heavily traveled by pedestrians. The report also stated that some attempt should be made to educate the public that *Trio* is a sculpture and not a Jungle Jim, and that periodic cleaning should be undertaken to remove hand prints, grease and accumulated grime (Albany Institute for History and Art 1979).

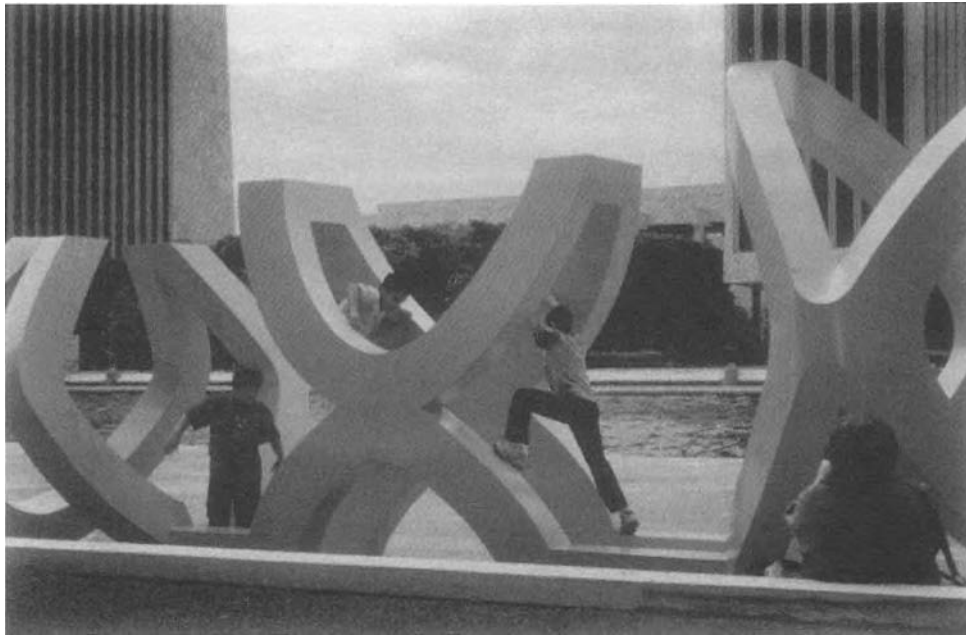
Figure 9. *Trio*. A typical example of the intended public interaction with the sculpture.

On any given day there will be children playing on *Trio* (Fig. 9). Tourists inspect it closely when they walk by. It serves as a bleacher for a nearby performance space on the Plaza and gives off a lot of stimulus with its playful form and color. Much of the wear that *Trio* accumulates is evidence of this interaction. However, skateboarding and BMX riding may be beyond what the artist envisioned. It may be possible to install an unobtrusive barrier such as staggered rows of low concrete bumps that will still allow physical contact with the sculpture and keep out skateboarders and BMX riders.

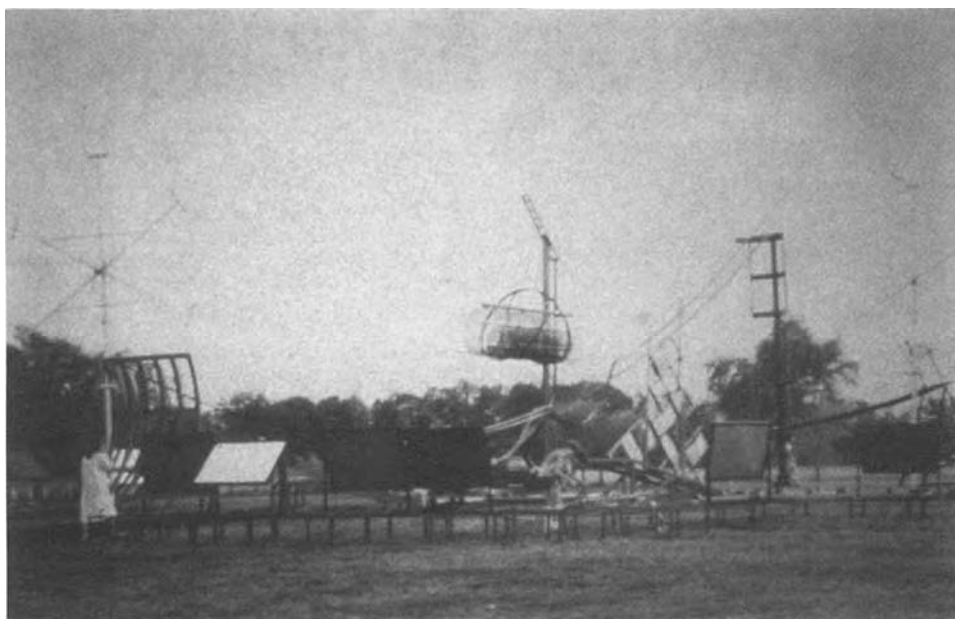
Figure 10. *Formula Compound #1*. Dennis Oppenheim, 1983, painted steel and aluminum. (70' x 70' x 25') Collection of the Roland Gibson Gallery, SUNY Potsdam College. Overall view of the sculpture just after its installation at Potsdam College in 1983.

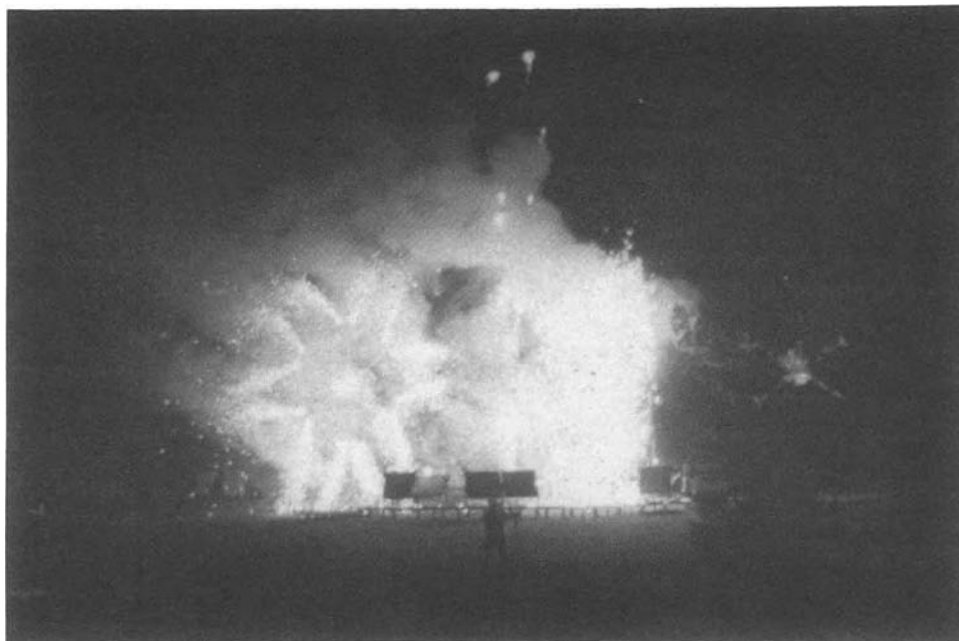
Figure 11. *Formula Compound #1*. The Fall 1983 fireworks performance at Potsdam College.

Six thousand people attended the display, which was for the most part successful. Apparently, Oppenheim's assistant, who attended the performance on the artist's behalf, said that the fireworks did not capture the true essence of the piece. Afterwards, the college was left with the lingering material from *Formula Compound #1* as well as installation bills, and they turned their attention away from the spent sculpture to other emergencies. The staff changed within the art department and in time the sculpture was largely forgotten, eclipsed by budget droughts that are common at small state colleges. Even at the time of the fireworks display there was a difference of opinion as to whether or not the piece was meant to be permanent. After the performance the artist was unreachable and the future role of *Formula Compound #1* and its intended life span were never clarified (Price 2002). Eighteen years went by, and the sculpture was brought back to the attention of the art department by Potsdam college groundskeepers, who claimed that it had become a safety hazard.
