Source: *Objects Specialty Group Postprints, Volume Six, 1999*

AFTER THE FIRE AT THE CHURCH OF LA COMPAÑIA DE JESUS, QUITO, ECUADOR

Constance Stromberg

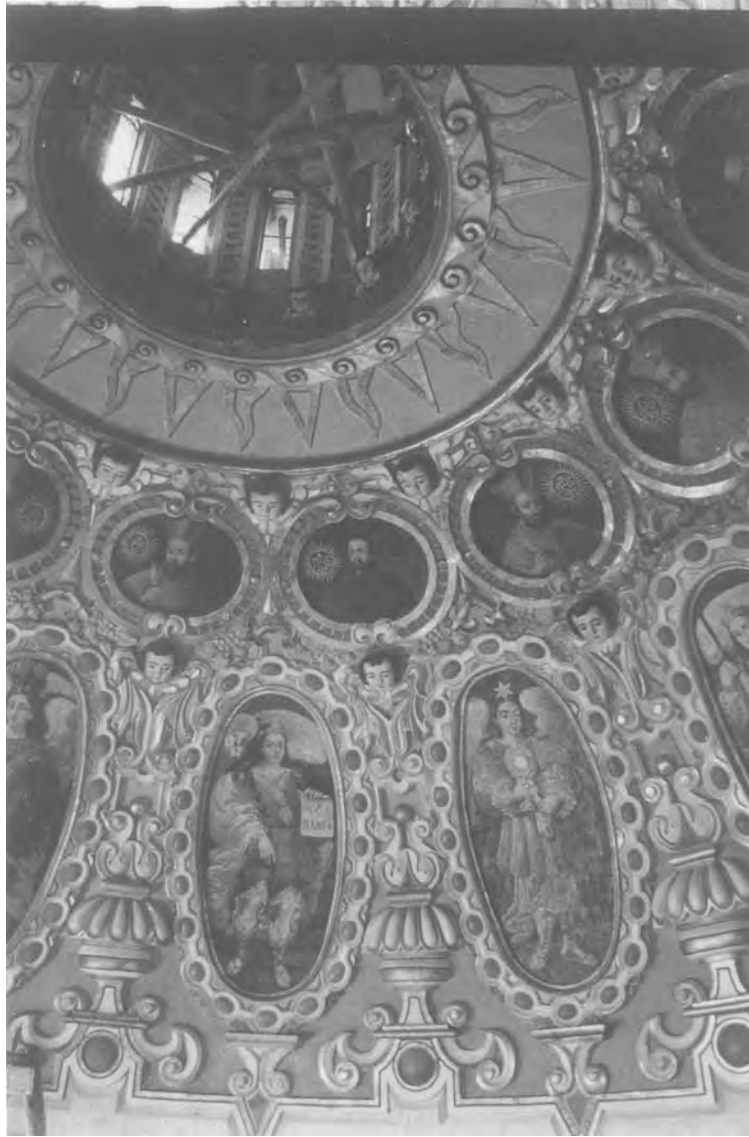
La Compañía is said to contain seven tons of gold leaf in its approximately 70 meter long by 25 meter high interior. There is a main altar, a pulpit, a high central nave and eight floor-to-ceiling altarpieces (*retablos*) in vaults along the sides containing paintings and polychrome and gilded wood balconies, balustrades, columns and sculptures (fig. 4). Four high relief, life-size polychrome evangelist figures are just below the central cupola, and there is a smaller cupola over the main altar. Mural paintings of the 12 archangels, lunettes of 12 cardinals, 37 polychrome wood winged cherub heads, and molded and painted plasterwork adorn the central cupola (fig. 5).

Figure 5. Mural paintings, cherub heads and plasterwork, central cupola, La Compañía de Jesús.
