Article: Restoring the M.R. 1750 public clock: History, analysis, experimentation, and re-creation

Author(s): Steven W. Dykstra, Donald Saff, and Lee W. Badger Source: *Objects Specialty Group Postprints, Volume Thirteen, 2006*

# RESTORING THE M.R. 1750 PUBLIC CLOCK: HISTORY, ANALYSIS, EXPERIMENTAION AND RE-CREATION

Steven W. Dykstra, Donald Saff and Lee W. Badger

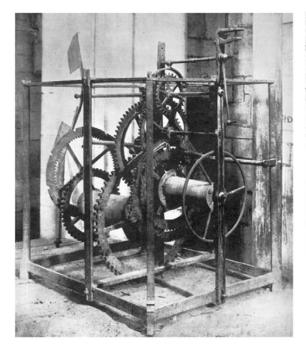
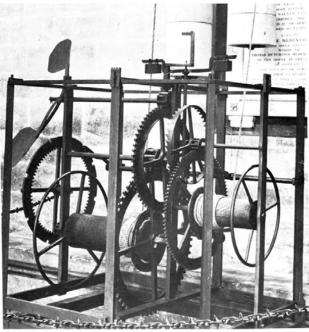
When this clock was restored to functionality in 1956, the national authority responsible for the project removed and replaced several crucial parts of the mechanism and pursued other alterations in order to achieve a representation of how the clock looked and worked in its first decades of operation. Before and after treatment photographs illustrate the extent to which the existing clock was altered to represent its late 14<sup>th</sup> century configuration (Fig. 8). Although this may be an extreme example of the degree of re-creation necessary to represent a functional object at a particular date in its history, this treatment was considered as an important precedent because the Salisbury Cathedral clock and the *M.R. 1750* clock have many categorical similarities. Additionally, in the field of horological repair and restoration, critically worn,

Figure 8. Before (left) and after (right) treatment photographs of the Salisbury Cathedral clock. The arrows indicate the old 18th c. escapement on the left, and the new reproduction 14th c. escapement on the right.
