PHOTO BUTTONS ON THE MEND: REPAIRING LARGE SPLITS IN PHOTO BUTTONS

Sara Shpargel and Irene Brückle Art Conservation Department Buffalo State College

ABSTRACT

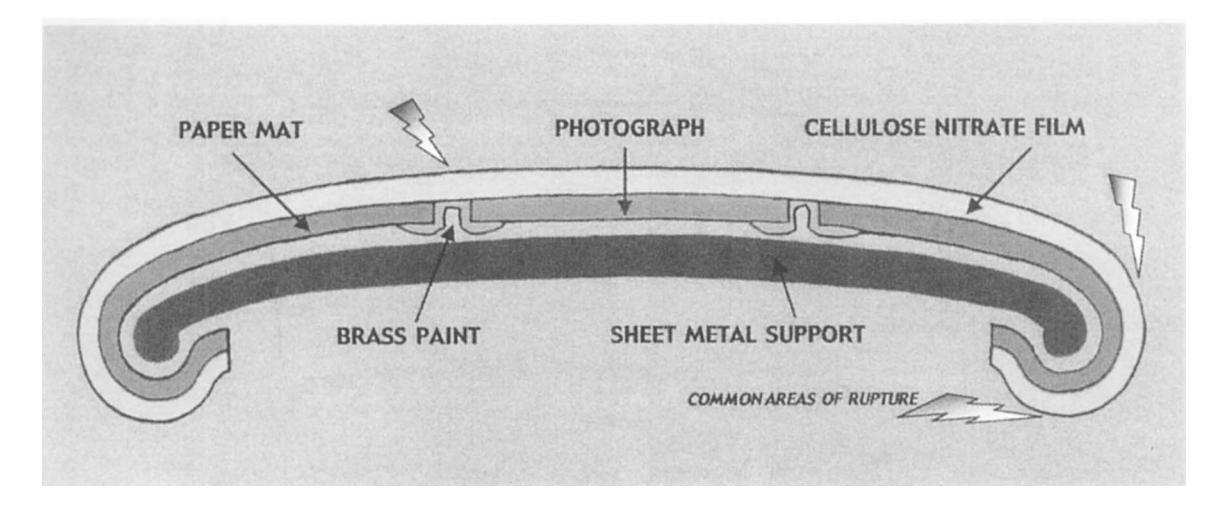
Figure 1. Cross-sectional diagram of a photo button with a photograph in the center and a surrounding paper mat (layers of button structure are inflated so they can be distinguished easily).

A photo button is a composite structure consisting of a paper photograph sealed with a plastic laminate and pressed around a metal support (Fig. 1). The button contains a photograph set into the opening of a paper mat. While original photographs could be used, photographic or printed copies of them were also employed in button manufacture. The paper mat usually features one or two oval or rectangular openings for the insertion of photographs. It consists typically of a smooth machine-made paper that is printed on the front with geometric designs or floral motives using (offset) lithography or relief printing. Before the paper mat was assembled with a button, these printed designs were sometimes enhanced through local application of watercolors. The edges of the photograph were usually trimmed slightly smaller than the opening of the decorative paper mat, leaving a space 2-4 mm wide between the two. Both the photograph and the paper mat were faced with a plastic film. Late 19th-century and early 20th-century photo buttons examined in this study were faced with a cellulose nitrate film (as plastic technology evolved and became available during the 20th-century, buttons were also faced with acetate-based, polyester and other clear plastic covering films). The plastic film united the paper mat and photograph, protected the button surface during display and use, and contributed to its smooth appearance that was probably considered an attractive characteristic of all buttons. The lamination of the photograph to the clear covering film gave the image a glossy (sometimes also matte) surface that enhanced the contrast and saturation of color.

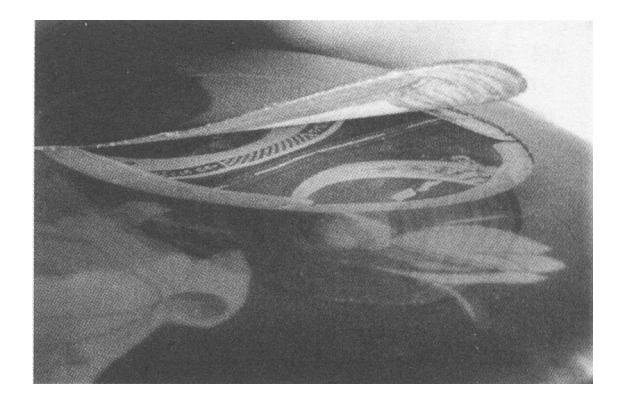
Figure 2. Detail view of a photo button split along the brass-painted border surrounding the photograph. One side of the split edge has lifted out of plane, revealing a layer of newsprint that had been crimped around the metal support together with the photo and paper mat laminate. A strip of the G-10 repair support material is positioned underneath the split area.

Some photo buttons contain a sheet of newsprint between the metal support and paper layers. Underneath one split photo button, portions of newsprint were revealed that show an advertisement for photo buttons (Fig. 2). The decorative paper mat of one button depicted in the advertisement showed a design similar to that associated with a button studied during this project. Because paper mats were commercially produced, it is common for multiple buttons to have the same paper mat designs.

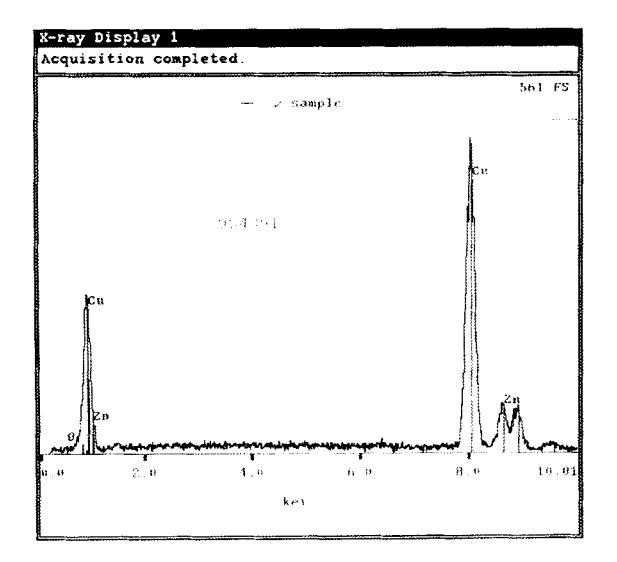
Figure 3. SEM spectrum showing the predominance of copper and zinc in the brass paint of a photo button (family of Martin Penszak, see fig. 12).

SEM analysis on the brass-colored paint of the two damaged photo buttons treated as part of this project revealed nearly identical compositions of copper and zinc (results of one of the two analyses can be seen in Fig. 3). It seems that the brass powders used for producing the two paints were quite similar in composition, even though the buttons were likely manufactured by different companies.

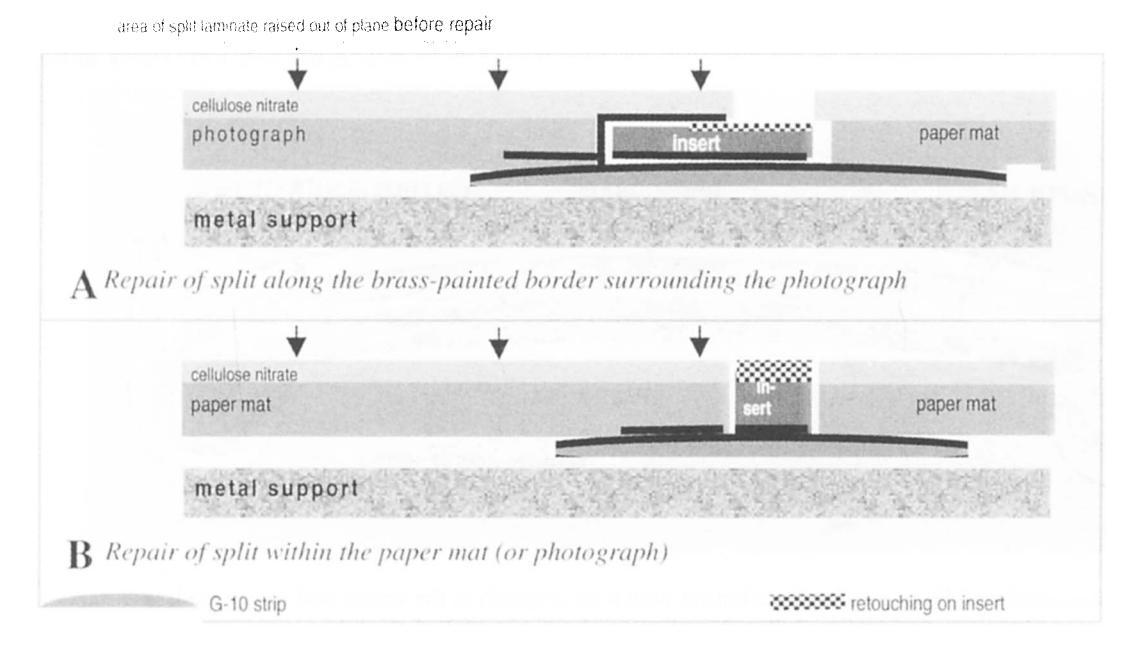
Figure 4. Cross-sectional diagram of repaired splits in photo buttons, showing the placement of repair materials and areas of their attachment to the button structure.

Two techniques of constructing inserts during the process of repairing split edges of photo buttons are presented below (Fig. 4). One technique (Fig. 4.A) can be used to make inserts along splits within the brass-painted borders surrounding the photographs. Here, the brittle cellulose nitrate film is supported by neither photograph nor paper mat. The insert paper is attached to the raised side of the split before it is adhered to the G-10 support. The insert extends underneath the cellulose nitrate providing it with permanent support. Another technique (Fig. 4.B) is suggested for the repair of splits running through the paper mat. In this case, the two split edges are adhered to the G-10 support before insertion of the inserts. This repair technique is also suitable for making inserts along splits running through the photograph. The first technique (Fig. 4.A) is simpler and faster to execute than the second technique (Fig. 4.B) but the latter produces more inconspicuous results. A detailed description of the two techniques follows.

Repair of split along brass-painted border surrounding the photograph (Fig. 4.A):

- 1. The strip of G-10 is prepared as described earlier, positioned underneath the split area and adhered along the edge of the split that remains in plane (Fig. 10).
- 2. A strip of Beva film is applied with a heated spatula to the underside of the raised edge. Excess Beva film along the edge is trimmed with a scalpel.
- A paper strip matching the curvature of the split is inpainted with gouache and coated with B-72 in ethanol to match the button's brass paint border. Beva film is adhered to the underside of the paper insert for its later attachment to the G-10 strip.
- 4. The insert is attached to the underside of the raised edge by heat-activating the Beva film already present there.
- 5. At this point, the insert will likely be too wide to fit the gap between the split edges. By pressing the raised edge with the insert attached into plane, the insert can be trimmed with a

6. The split edge with the trimmed insert attached is now secured into plane. As the diagram (Fig. 4.A) shows, two layers of Beva now lay in contact with each other to ensure good adhesion of the previously raised edge to the G-10 strip. The adhesive is activated with a heated spatula that is panned across the surface of the button through a silicone-coated polyester sheet (Fig. 5).

Repair of split within the paper mat (or photograph) (Fig. 4.B):

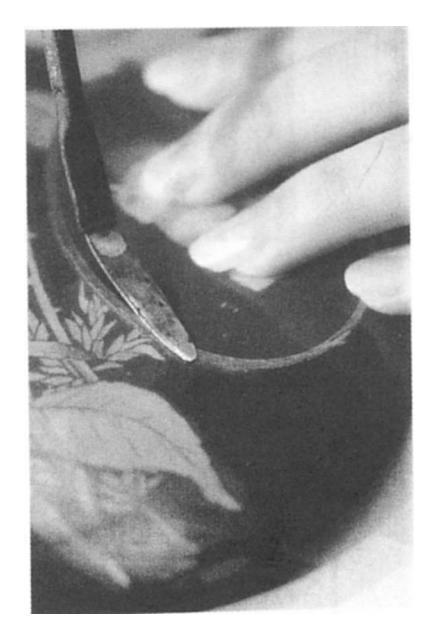
Figure 5. The photo button laminate raised along the area of a split is set into plane and adhered with Beva 371 film to a G-10 support strip positioned underneath the split.

- A strip of Beva film is applied with a heated spatula to the underside of the raised edge. Excess Beva along the edge is trimmed with a scalpel. The raised edge is secured into plane by heat-activating the Beva that adheres it to the G-10 strip (refer to Fig. 5).

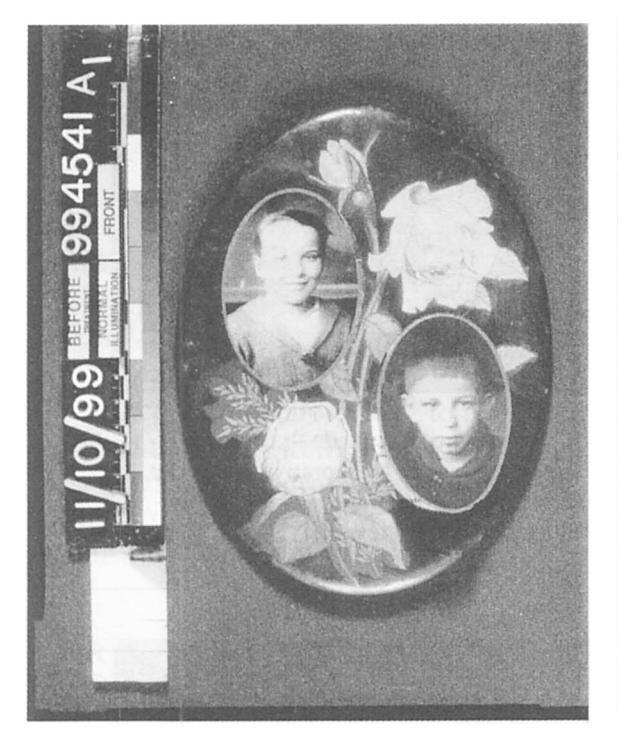
Figure 6. Photo button with separate portraits of an unknown boy and girl $(5 \frac{3}{4} \times 7 \frac{3}{4} \text{ in.})$. Origin of the button is unknown, date estimated 1920-1930s. It was purchased October 1999 at the flea market in Clarence, N.Y. Both portraits are likely silver gelatin developing out paper photographs. The normal illumination view before treatment illustrates splits along the brass-painted border that surrounds each photograph.

An example of the results of this treatment technique can be seen in Figures 6 and 7. An extended split along the brass-painted areas surrounding the two photographs of two children was repaired. Figures 8 and 9 provide detail views before and after treatment of an area along the portrait of the girl.

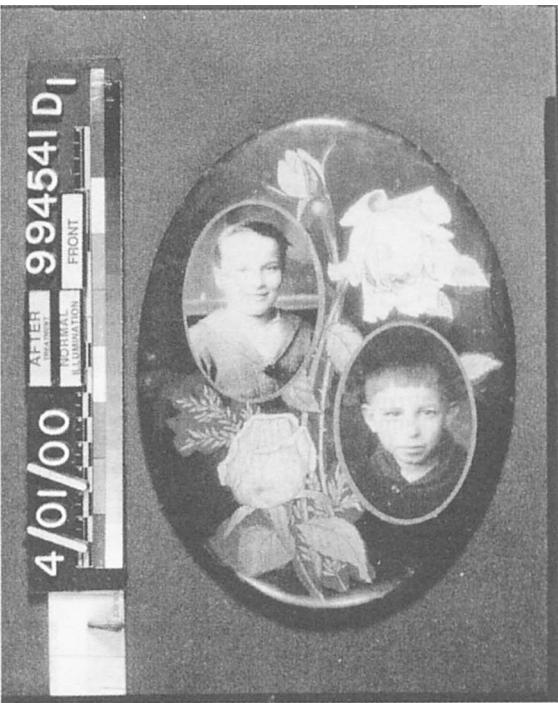
Figure 7. Photo button with two separate portraits seen in normal illumination after treatment. The splits along the brass-painted borders of both photographs were repaired using the technique illustrated in diagram "A" in Fig. 4.

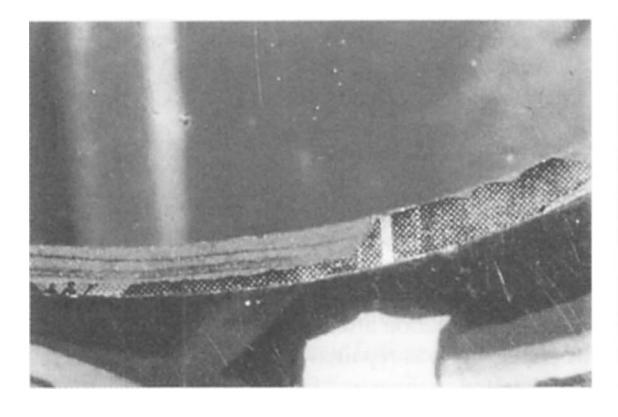
Figure 8. Detail of Fig. 6 showing the brass-painted border surrounding the portrait of the girl. Normal illumination view before treatment.

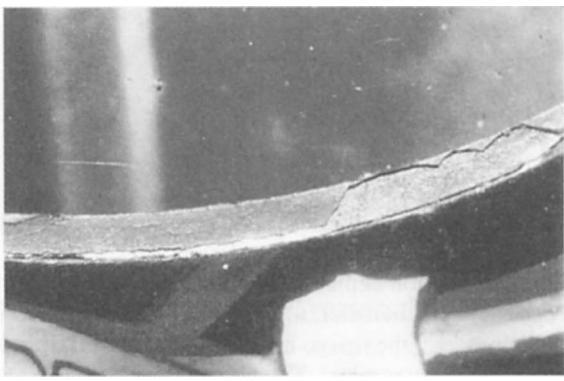
Figure 9. Detail of Fig. 7 showing the brass-painted border surrounding the portrait of the girl. Normal illumination view after treatment.

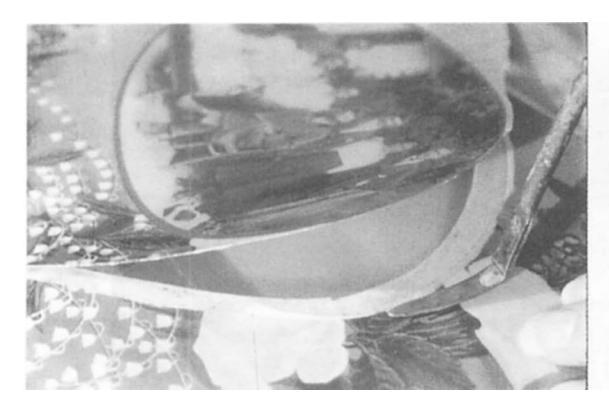
Figure 10. The G-10 support strip is adhered with Beva 371 film underneath the split of the photo button laminate that remains in plane.

- 1. The strip of G-10 is prepared as described earlier, positioned underneath the split area and adhered along the edge of the split that remains in plane (Fig. 10).

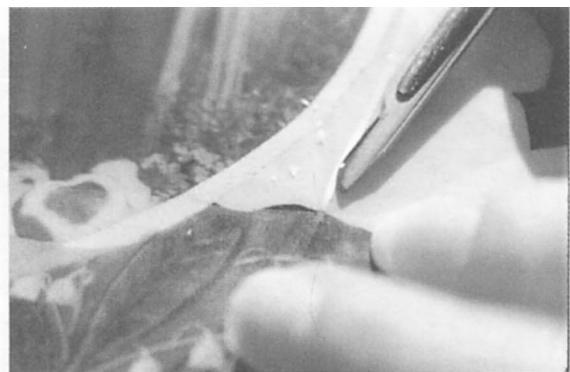
Figure 11. A paper insert is made to fill the gap between the split edges of a decorative paper mat. The surface of the inserted paper strip is shaped with a scalpel to achieve a level fit.

- 4. A final layer of insert paper (again, we used "Yale") is adhered over the fill paper with wheat starch paste. The paper may first require sanding to fit the depth of the gap and improve its workability. The moisture contained in the paste softens the paper and allows it to be worked into the space. Where necessary, the insert is shaved to achieve a level surface with the cellulose nitrate (Fig. 11).

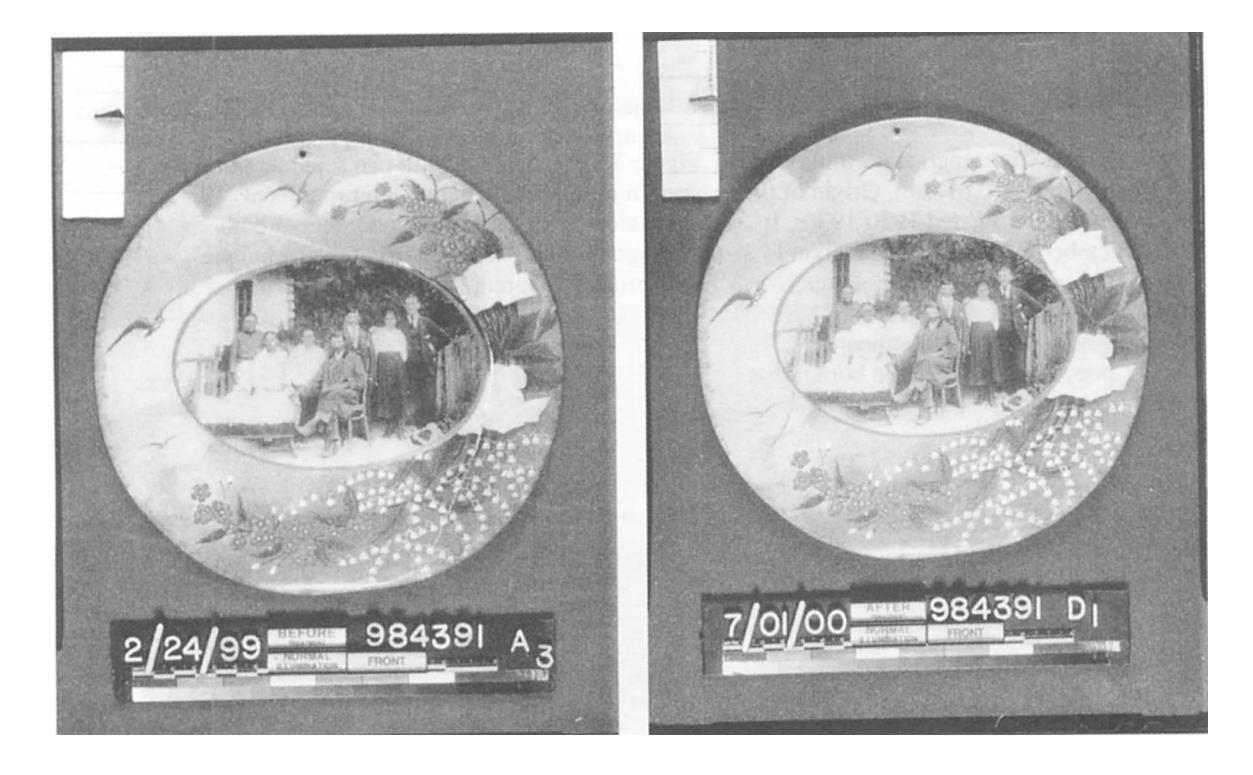
Figure 12. Photo button depicting the family of Martin Penszak (9 in. diameter, unknown photographic process; the image is locally enhanced with red and green watercolor). The portrait was likely taken in the late 19th-century in Poland and button assembled 1910-1920s after Penszak's arrival in the United States. The normal illumination view before treatment shows a large crescentshaped split that runs through the decorative paper mat.

Figure 13. Photo button (family of Martin Penszak) seen in normal illumination after treatment. The split in the paper mat was repaired using the technique illustrated in diagram "B" in Fig. 4.

An example of this treatment can be seen in Figures 12 and 13. The split in the decorative paper mat of this 9-inch diameter button extended across its entire center. In addition to repairing the split on the front of the button, a small tear along the crimped edge on the reverse of the button was reinforced with medium-weight Japanese tissue paper adhered with wheat starch paste. A thin spray coat of B-72 was applied to the metal support to protect it.
