Article: Saving Grand Canyon river running history

Source: *Objects Specialty Group Postprints, Volume Fifteen, 2008*

# SAVING GRAND CANYON RIVER RUNNING HISTORY

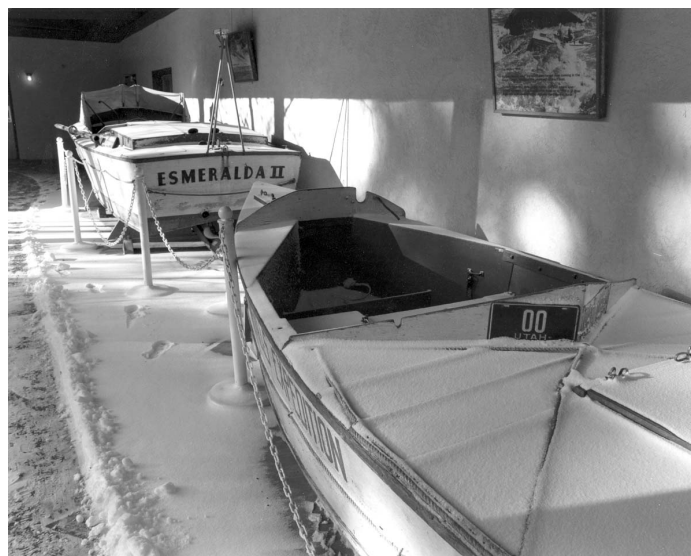
Fig. 4. Two boats in the courtyard with snow (Photograph courtesy of Grand Canyon NP collections)

The collection of boats grew at the park over many years through donations. Nine were placed in an open courtyard for display in the 1960s and there they sat for over 40 years, neglected due to budgetary constraints. With interest from concerned boat lovers and a newly appointed cultural resources manager, preservation efforts began in 2003. The boat lovers came from the existing river running community including boat enthusiasts, admirers, expedition companies and families of the historic people that were involved with these boats. As conservators dedicated to the parks in the Rocky Mountain region, the lab was called to perform a condition survey. This survey eventually enabled the park to acquire funds from the National Park Service and the river running community to stabilize all 20 boats. The lab started the ball rolling right away using this fan club to get the boats out of the courtyard and inside for storage, thorough examinations, and stabilization so they can be displayed again in the future. During the move the lab replaced their custom-made cradle mounts. The project gathered good press in the area with regional newspaper articles. The community really grabbed hold of the project. Construction drawings were made by an architect to document the design. This was a priority for the boating community. The drawings helped incredibly with boat terminology for conservation treatment documentation.

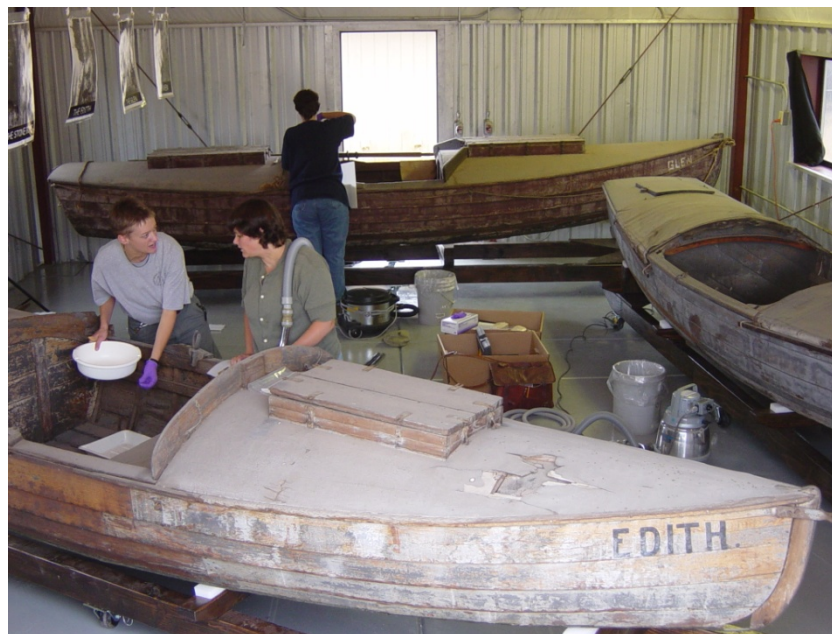
While in the courtyard, the boats suffered a lot of surface damage but luckily they were in great structural condition. The park museum staff began first with dry cleaning the three oldest wooden boats using a brush and vacuum. The boats were extremely dirty with loose dust, dirt, lint, and plant debris.

Fig. 5. Dry cleaning the wooden boats (Photograph by M. Quinn)

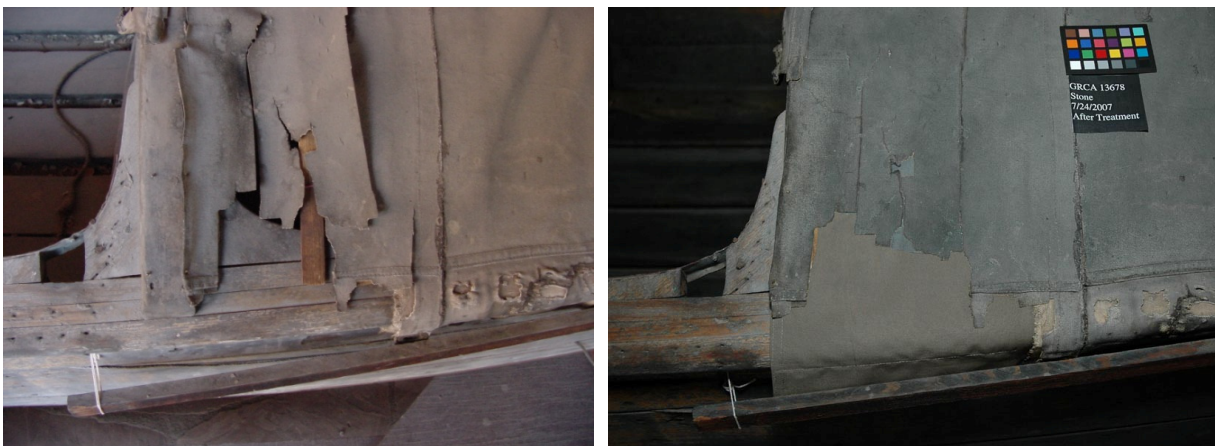
Two of the oldest boats had extensive tears to their canvas covered decks. One section had a severely torn and distorted tear. Humidification and flattening to realign allowed the area to be set in place with heat set BEVA film and muslin.

Fig. 6. Before (left) and after (right) treatment of the canvas deck on the *Stone* boat  
(Photographs by Brynn Bender)

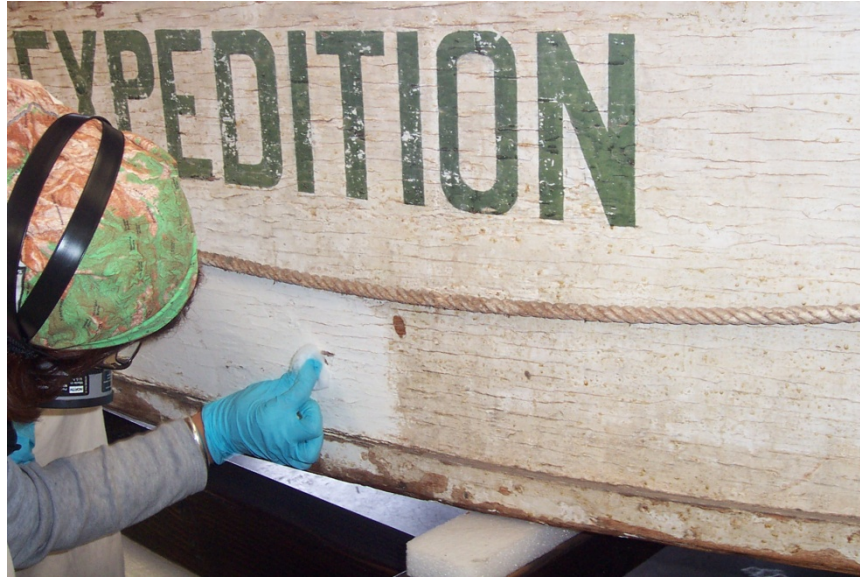
On one boat, the 1938 *WEN*, the linseed oil had gathered dirt and yellowed. We removed the dirt layer using the same 3% triammonium citrate solution followed by a water rinse. The cockpit was particularly thick with a well-adhered layer of dirt. The oil layer was then removed by swelling with warm water compresses followed by removing with acetone or ethanol depending on the sensitivity of the underlying paint. The results were great, exposing original white and green colors.

Fig. 7. During treatment cleaning of *WEN* boat (Photograph by Brynn Bender)

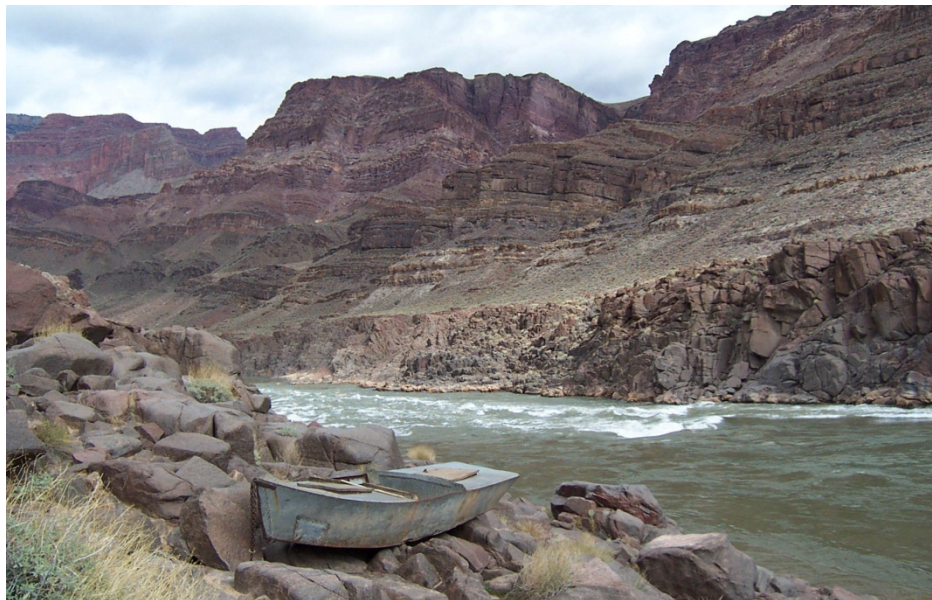
We are still deciding on treatment for some boats, like the 1915 *Ross Wheeler* that is still on the river. It is such a cultural landmark for boat tours that the park is reluctant to remove it. However, more recently, items from the boat have gone missing and graffiti has occurred. When visiting it in 2004, we discovered an inflatable raft stashed inside, boulders pushing in the bottom, and corrosion on the floor. So this is an ongoing process to balance our wishes to helicopter it out of the river with the community's wishes. Future plans involve getting the *WEN* boat on exhibit at the visitor's center, more treatments, including two boats at a river history museum in Utah, and filling the WWII inflatable neoprene raft with polystyrene beads. It has been wonderful to witness the attachment the community has to this collection and their strong desire to promote the history of their river running culture.

Fig. 8. Ross Wheeler boat on Colorado River, 2004 (Photograph by Brynn Bender)
